INVESTIGATION NO. 3113  
THE BALTIMORE AND OHIO RAILROAD COMPANY  
REPORT IN RE ACCIDENT  
AT ALIDA, IND., O.  
JUNE 30, 1947

Accident at Alida, Ind., on June 30, 1947, caused by a train entering an open switch at a high rate of speed, as a result of approach and home signals of an interlocking displaying false proceed indications.

Inv. No. 3113  
 Baltimore and Ohio Railroad  
 Alida, Ind.  
 June 30, 1947

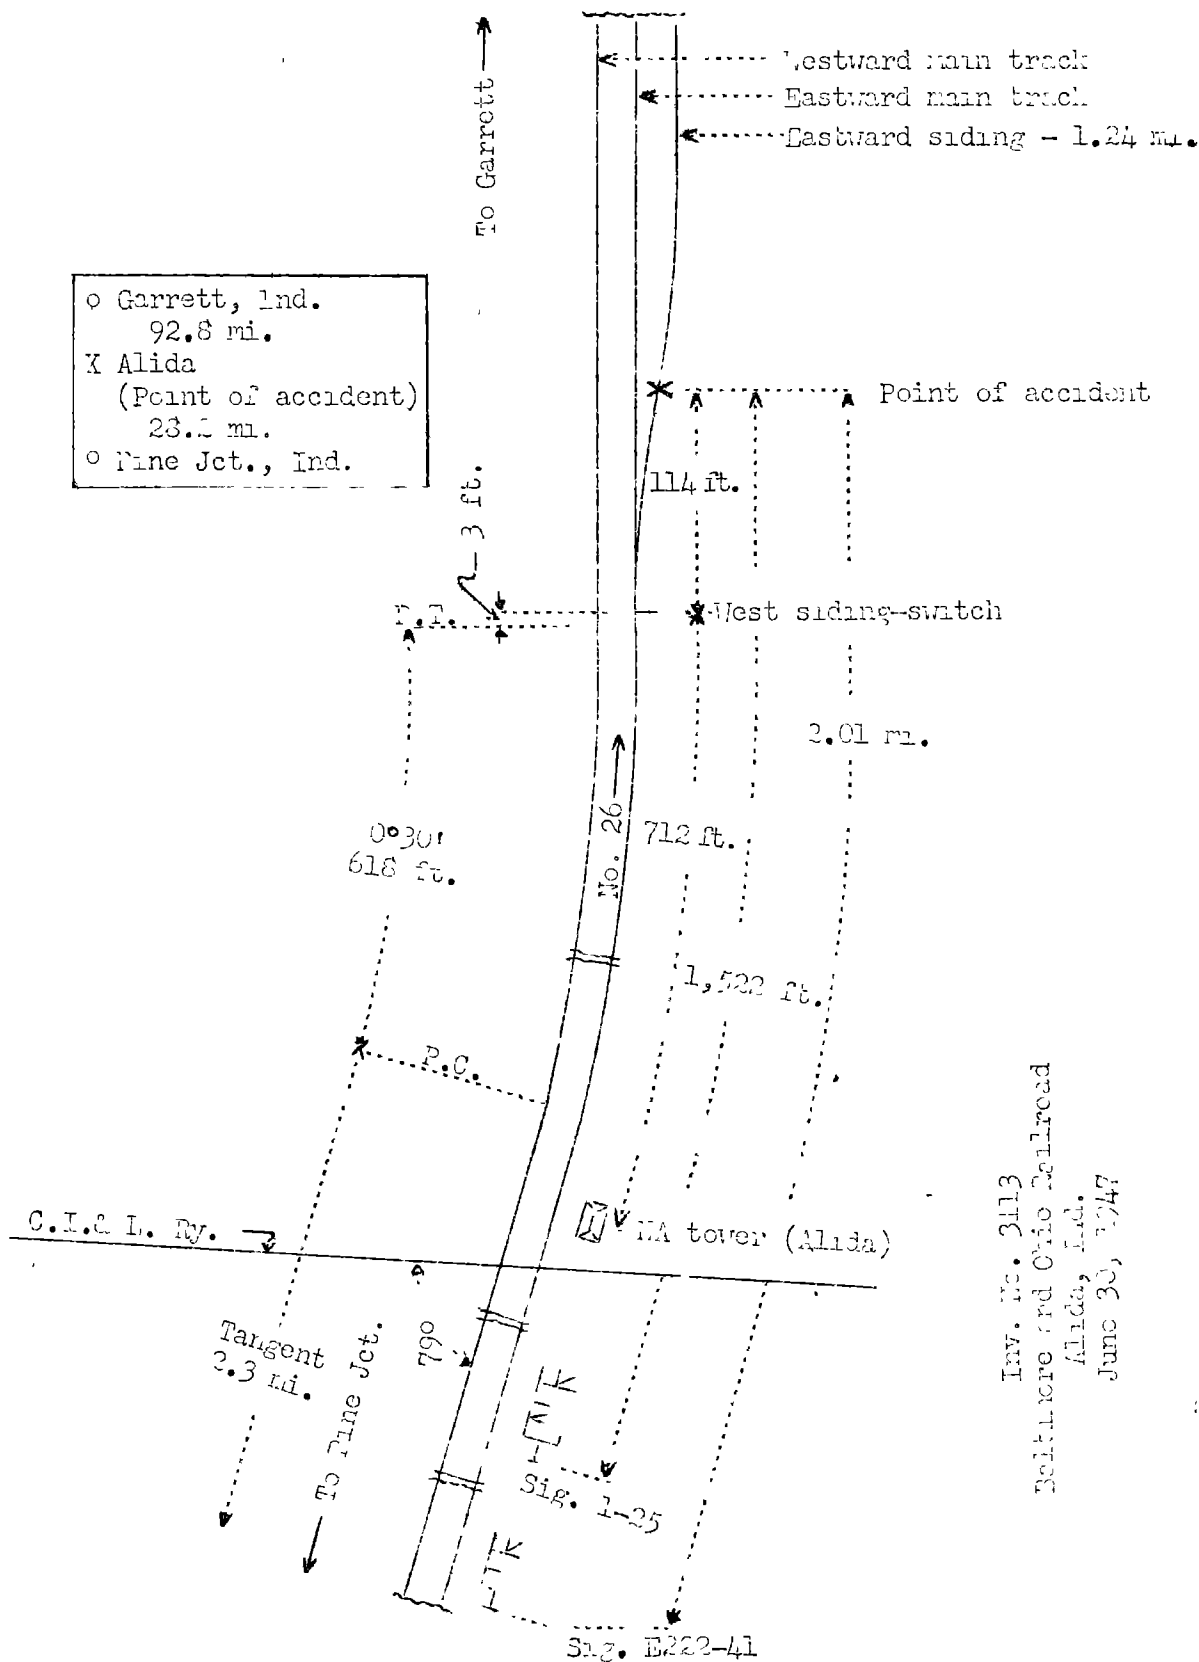
Location of Accident and Method of Operation

This accident occurred on that part of the Chicago Division extending between Pine Jct. and Garrett, Ind., 121 miles, a double-track line in the vicinity of the point of accident, over which trains moving with the current of traffic are operated by signal indications. At Alida, 28.2 miles east of Pine Jct., a single-track line of the Chicago, Indianapolis and Louisville Railway crosses the tracks of the Baltimore and Ohio Railroad at an angle of 79°. This crossing is protected by an interlocking which is controlled from NA tower, located 36.4 feet east of the C.I.& L. main track and 10 feet south of the B.& O. eastward main track. At Alida the eastward siding, which is 1.24 miles in length, parallels the main tracks on the south. The west switch is within interlocking limits and it connects the eastward main track and the eastward siding at a point 712 feet east of NA tower. Entry to the siding at the west switch is made through a No. 16 turnout. The derailment occurred on this turnout 114 feet east of the switch. From the west on the main tracks there are, in succession, a tangent 2.3 miles in length, a 0°30' curve to the left 618 feet, and a tangent 3 feet to the west siding-switch and a considerable distance eastward. The grade is 0.2 percent ascending eastward.

The turnout of the west siding-switch consists of 131-pound switch rails and rail sections, a No. 16 rail-bound frog 23 feet in length, and one-piece guard rails 9 feet 3 inches in length. The switch rails are 24 feet long and move on 20 switch plates. The curvature of the turnout is 2°40'34", and the angle of the frog is 3°34'37". The distance from the switch points to the frog point is 120.5 feet. The turnout is laid on 100 switch ties, and is ballasted with gravel to a depth of 12 inches. No superelevation is provided. The distance between the centerlines of the eastward main track and the eastward siding is 13 feet 1 inch. The switch points are arranged for a throw of 4-1/2 inches, and the points are maintained in proper relation by two switch rods 3 inches wide by 1 inch thick and secured to the points by clips bolted through the webs and the reinforcing bars of the switch points. A front rod is bolted to the ends of the switch points and connected to the facing-point locking rod. The No. 1 switch rod is provided with an adjusting basket to which the operating rod is attached. The operating rod is 5 feet long and 1-1/4 inches thick, and is reduced in diameter at its outer end to a tang end 1 inch in diameter and 7 inches long, for insertion into the end of the operating pipe-line from the interlocking machine. The rod is threaded throughout a length of 1-1/2 inches

Approach signal E222-41 and home signal 1-25, governing east-bound movements on the eastward main track, are, respectively, 2.01 miles and 1,522 feet west of the point of accident. Signal E222-41 is of the two-arm, upper quadrant, semaphore type. Signal 1-25 is of the three-arm, upper quadrant, semaphore type. These signals are approach lighted, and the day aspects, and corresponding indications and names are as follows:
