REPORT NO. 1955

Railroad: Baltimore & Ohio
Date: December 18, 1934.
Location: Big Gunpowder, Md.
Kind of accident: Rear-end collision
Trains involved: Two freights
Casualties: 1 trespasser injured
Cause: Failure of engineman properly to obey
signal indications and failure of
flagman to provide full flag protection.

REPORT OF THE DIRECTOR OF THE BUREAU OF SAFETY CONCERNING AN
ACCIDENT ON THE BALTIMORE & OHIO RAILROAD AT BIG
GUNPOWDER, MD., ON DECEMBER 18, 1934.

February 28, 1935.

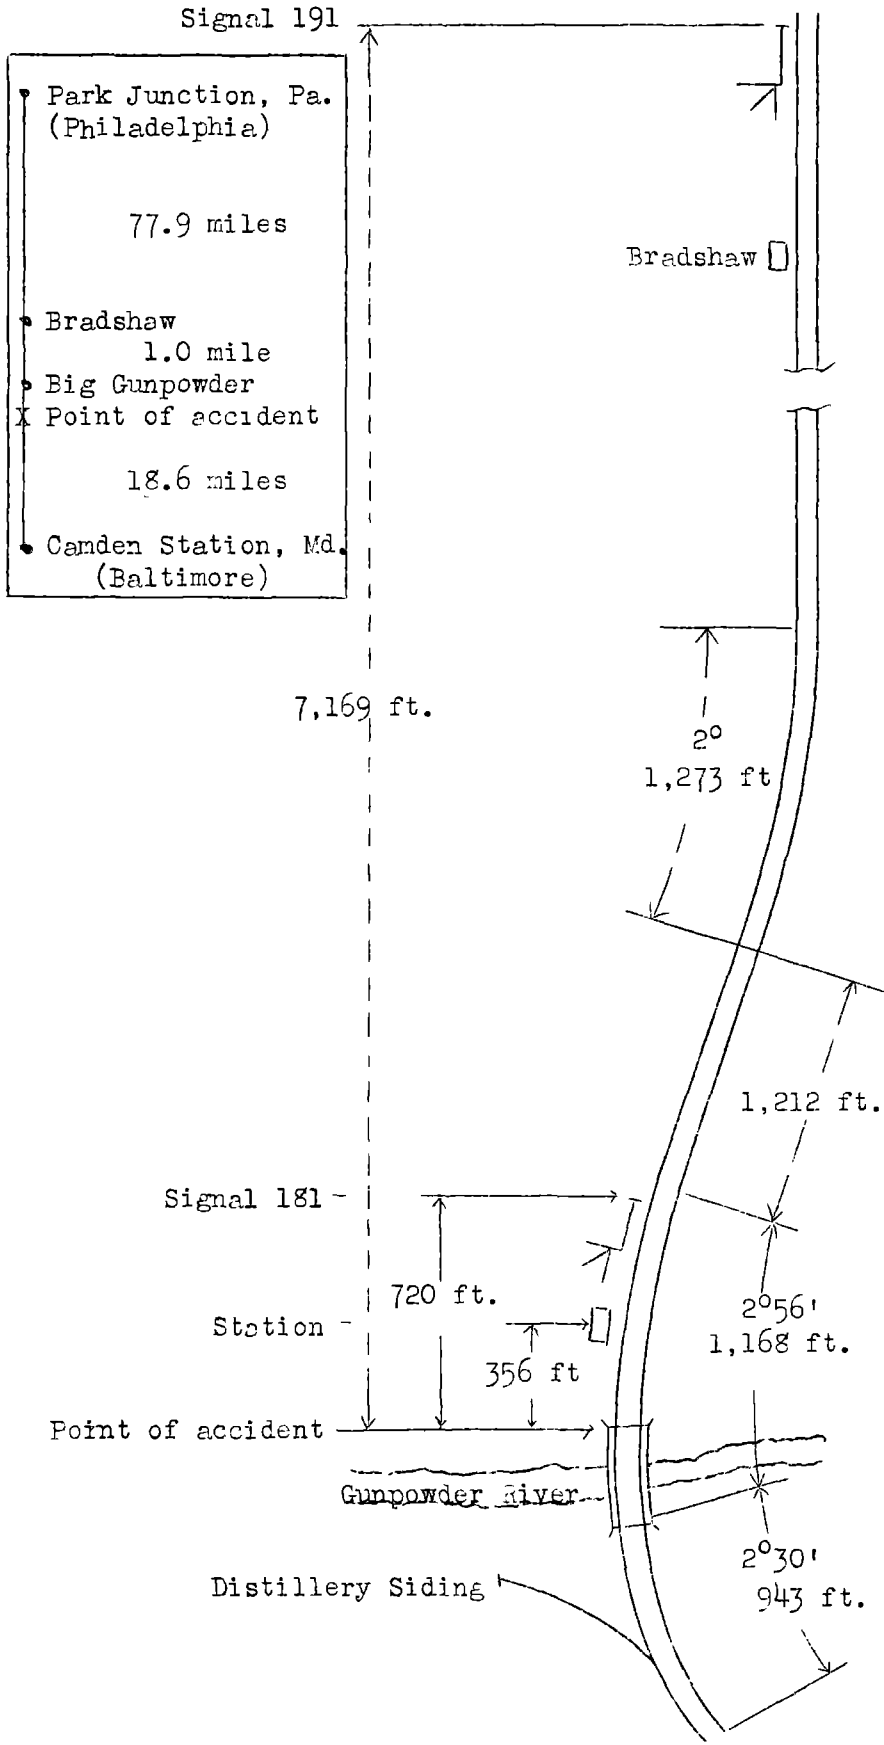
Inv. No. 1955
Baltimore & Ohio R.R.,
Big Gunpowder, Md.
Dec. 18, 1934

The signals involved, Nos. 191 and 181, are located 7,169 and 720 feet, respectively, east of the point of accident, and are of the 3-position, upper-quadrant, semaphore type, approach lighted, the night indications being red for "stop and proceed"; yellow for "prepare to stop at next signal, train exceeding medium speed must at once reduce to that speed"; green for "proceed". Signal 181 is equipped with a circular disc with the letter "P" thereon, which under special instructions contained in the time table indicates that trains with 80 percent of
