ACCIDENT ON THE
BALTIMORE & OHIO RAILROAD

BRANCHVILLE, MD.

NOVEMBER 11, 1936

INVESTIGATION NO. 2113

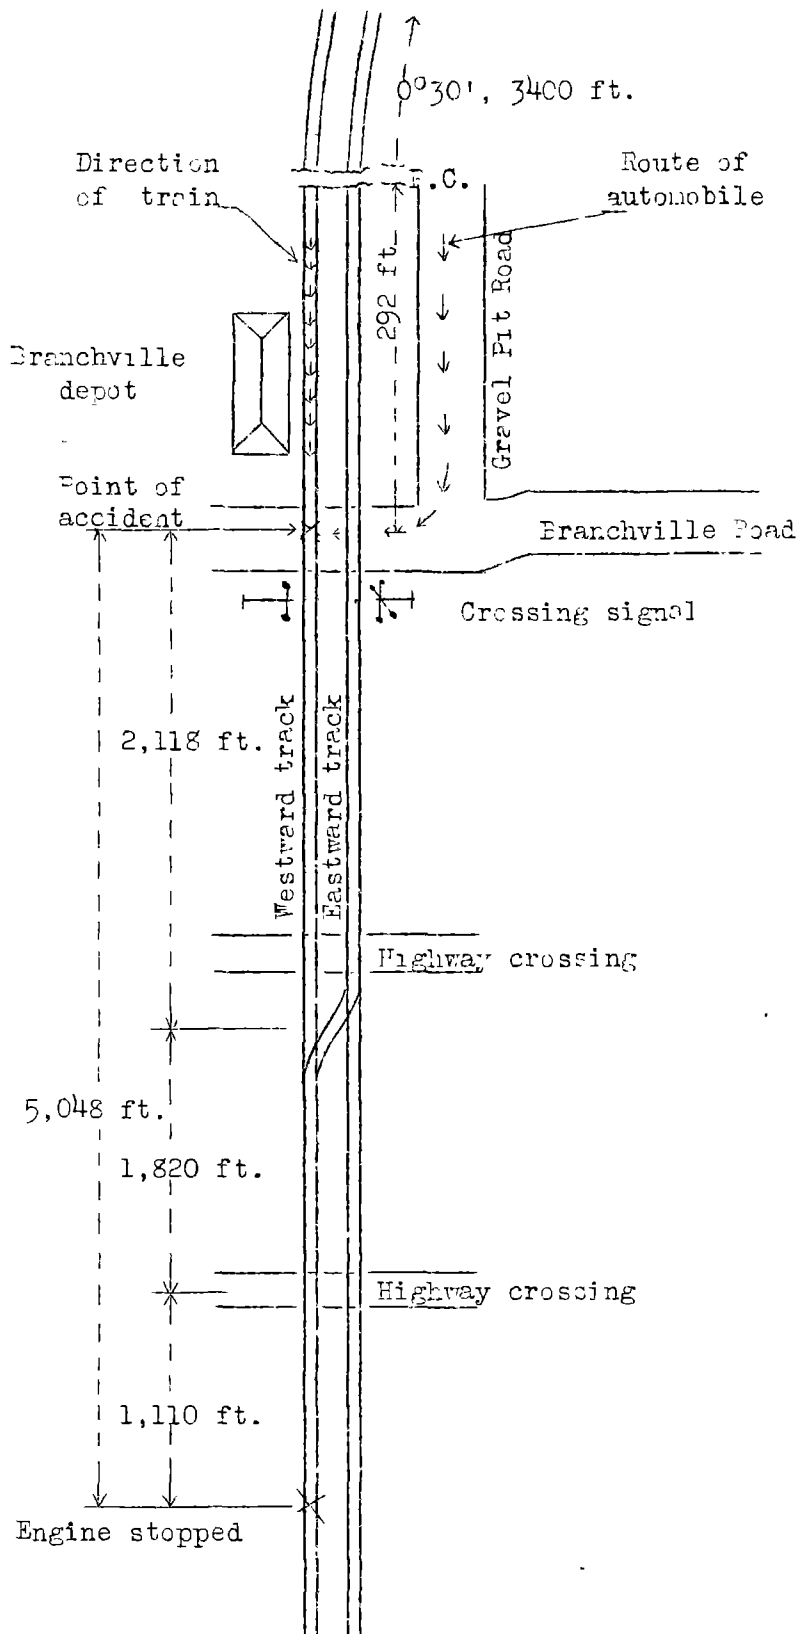
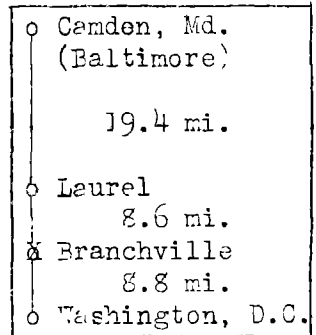
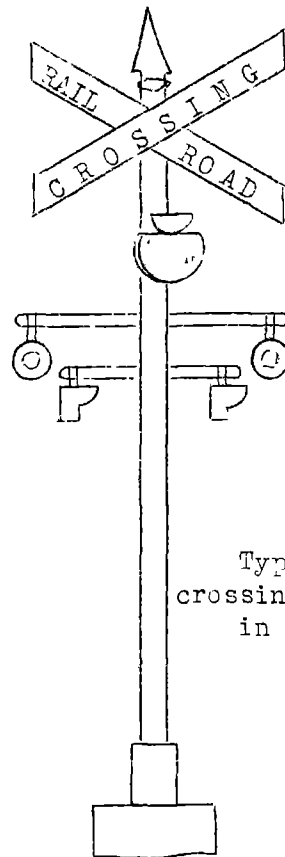
Type of crossing signal in use.
