INVESTIGATION NO. 2861
THE BALTIMORE & OHIO RAILROAD COMPANY
REPORT IN RE ACCIDENT
AT CARROLL, MD., ON
JANUARY 17, 1945

Accident at Carroll, Md., on January 17, 1945, caused by
failure to obey an interlocking signal indication.

Inv. No. 2861
 Baltimore & Ohio Railroad
 Carroll, Md.
 January 17, 1945

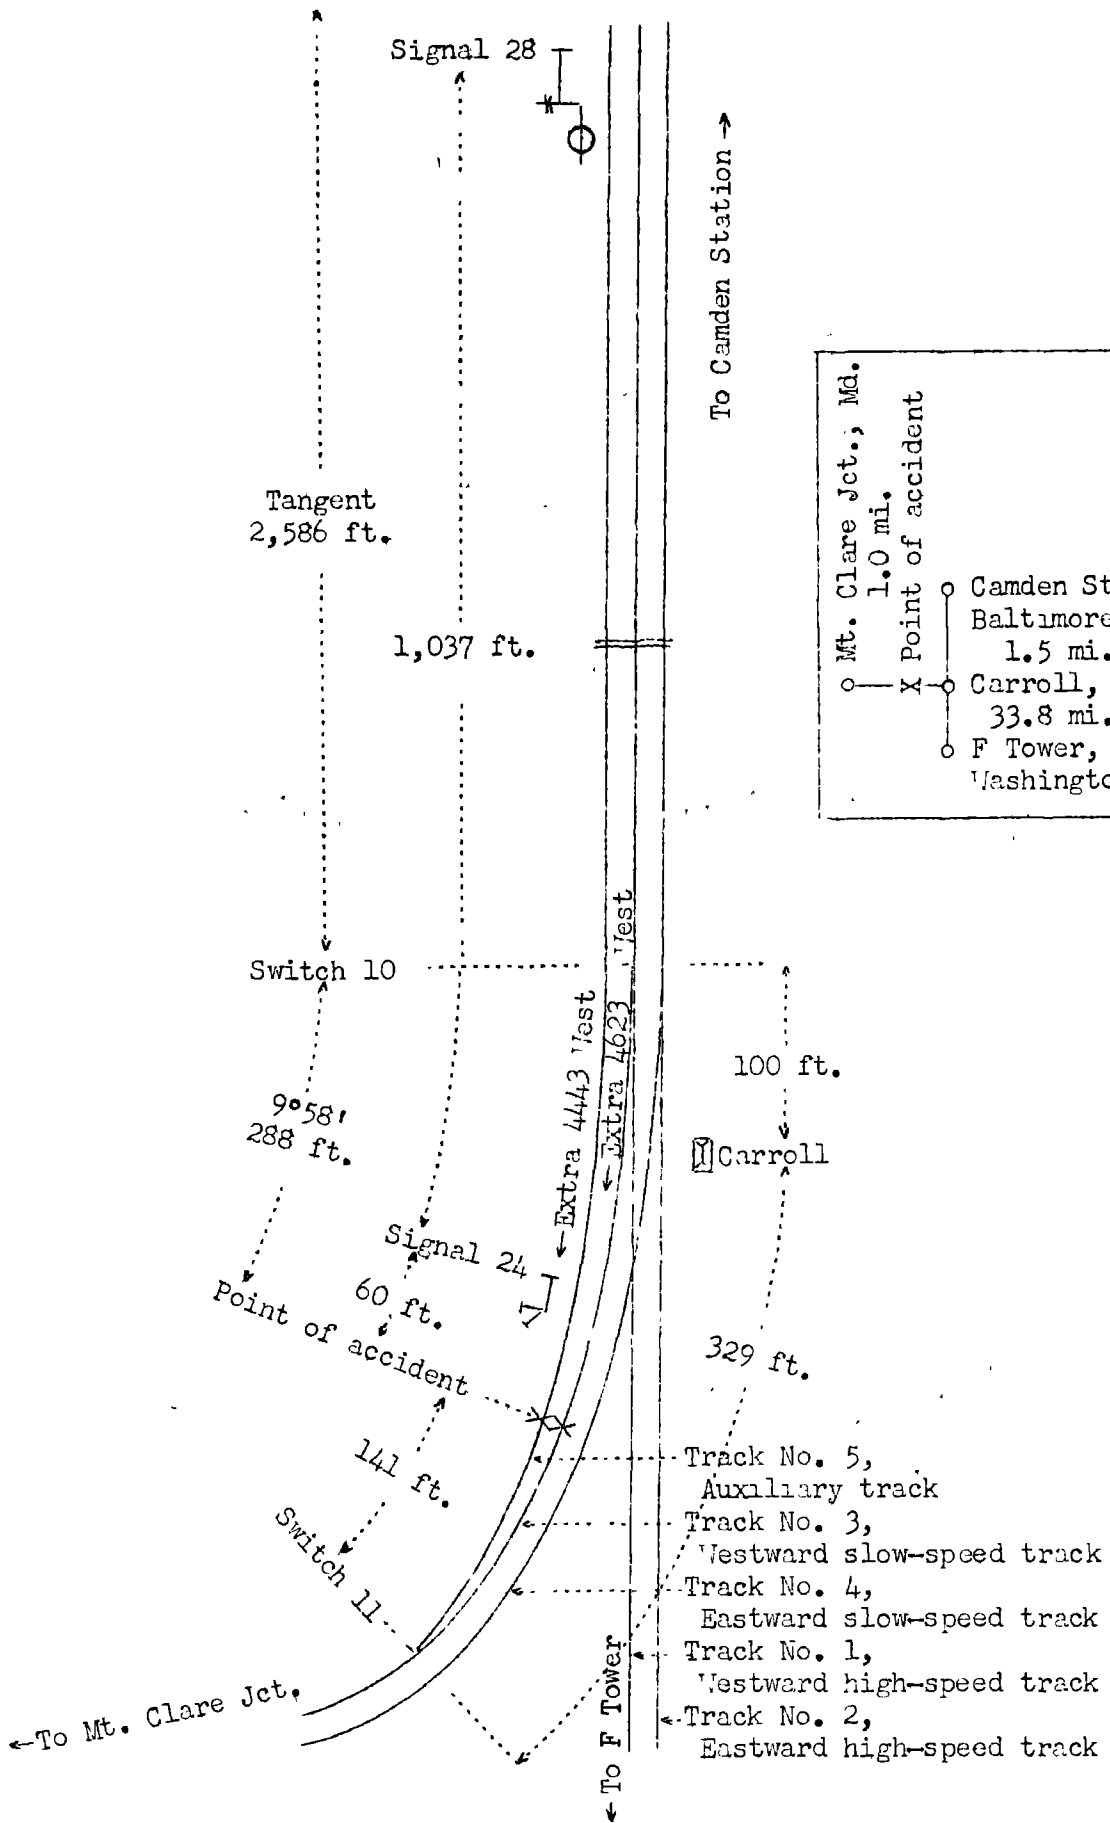
Mt. Clare Jct., Md.
 1.0 mi.
 X Point of accident
 Camden Station,
 Baltimore, Md.
 1.5 mi.
 Carroll, Md.
 33.8 mi.
 F Tower,
 Washington, D. C.

This accident occurred on that part of the Baltimore Terminal Division extending northward from Carroll to Mt. Clare Jct., Md., 1 mile. This was a double-track line. Within interlocking limits at Carroll this line converged with a double-track line extending westward from Camden Station, Baltimore, Md., to F Tower, near Washington, D. C., 35.3 miles. Time-table directions were eastward and westward for both lines. Hereinafter, time-table directions will be used in this report. The main tracks extending between Carroll and Mt. Clare Jct. were designated, from north to south, as track No. 3, westward slow-speed track, and track No. 4, eastward slow-speed track. The main tracks extending between Camden Station and F Tower were designated, from north to south, as track No. 1, westward high-speed track, and track No. 2, eastward high-speed track. In the vicinity of Carroll an auxiliary track, hereinafter referred to as track No. 5, paralleled track No. 3 on the north. Switch 10, which connected tracks No. 1 and No. 3, and switch 11, which connected tracks No. 3 and No. 5, were, respectively, 100 feet east and 329 feet west of the tower. The accident occurred at the fouling point of track No. 3 and the turnout of track No. 5, at a point 141 feet east of switch 11. From the east track No. 1 was tangent 2,586 feet to switch 10, and beyond this switch on track No. 3 there was a 9°58' curve to the right 288 feet to the point of accident. The grade was practically level.

Interlocking signal 28, governing west-bound movements from track No. 1 through switch 10 to track No. 3, and interlocking signal 24, governing movements from track No. 5 through switch 11 to track No. 3, were, respectively, 1,097 feet and 60 feet east of the point of accident. Signal 28 was of the color-position-light type, and signal 24 was a dwarf signal of the one-arm, upper-quadrant, semaphore type. The involved aspects and corresponding indications and names of these signals were as follows:
