INTERSTATE COMMERCE COMMISSION

ACCIDENT ON THE

BALTIMORE & OHIO RAILROAD

CLAY CITY, ILL.

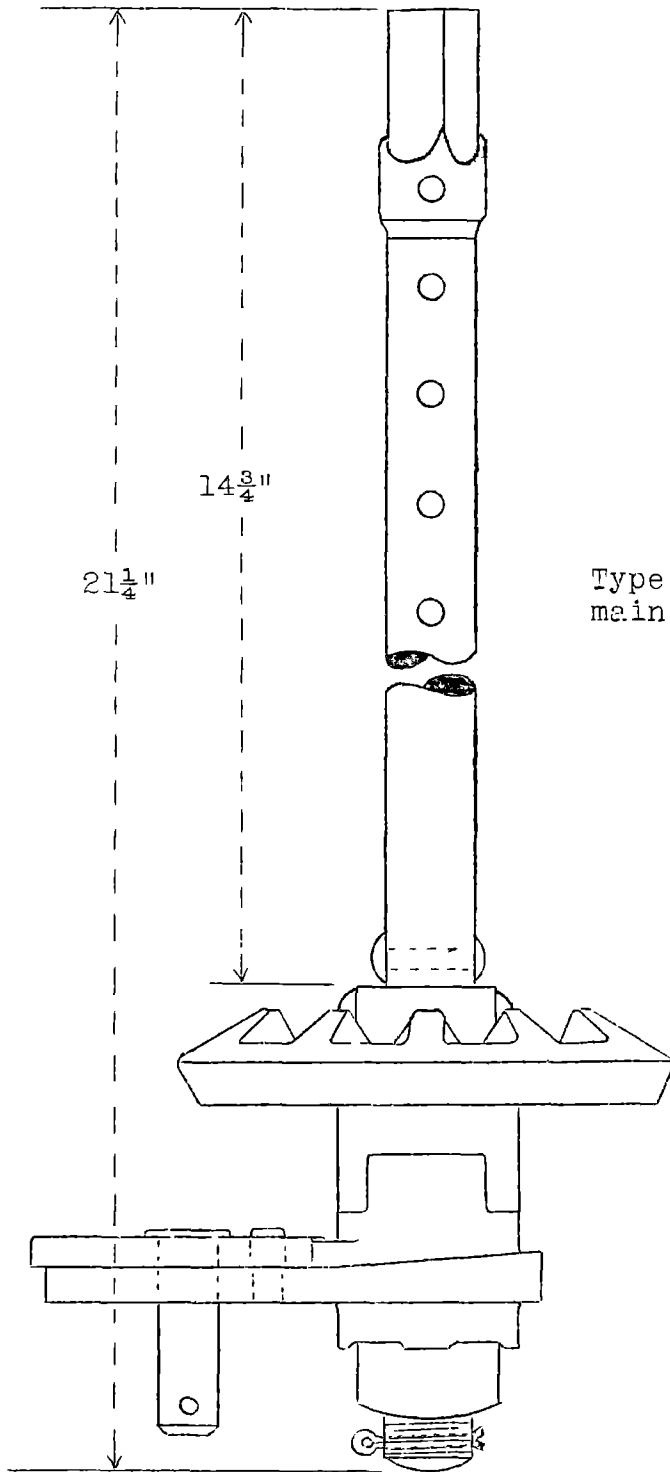
ECONOMY SWITCH STAND MECHANISM

Type of mechanism for
main line switches
