REPORT NO. 3335
THE BALTIMORE AND OHIO RAILROAD COMPANY
IN RE ACCIDENT
NEAR EATON, W. VA., ON
JUNE 30, 1950

Date: June 30, 1950

Kind of accident: Derailment

Accident near Eaton, W. Va., on June 30, 1950, caused by a
broken rail.

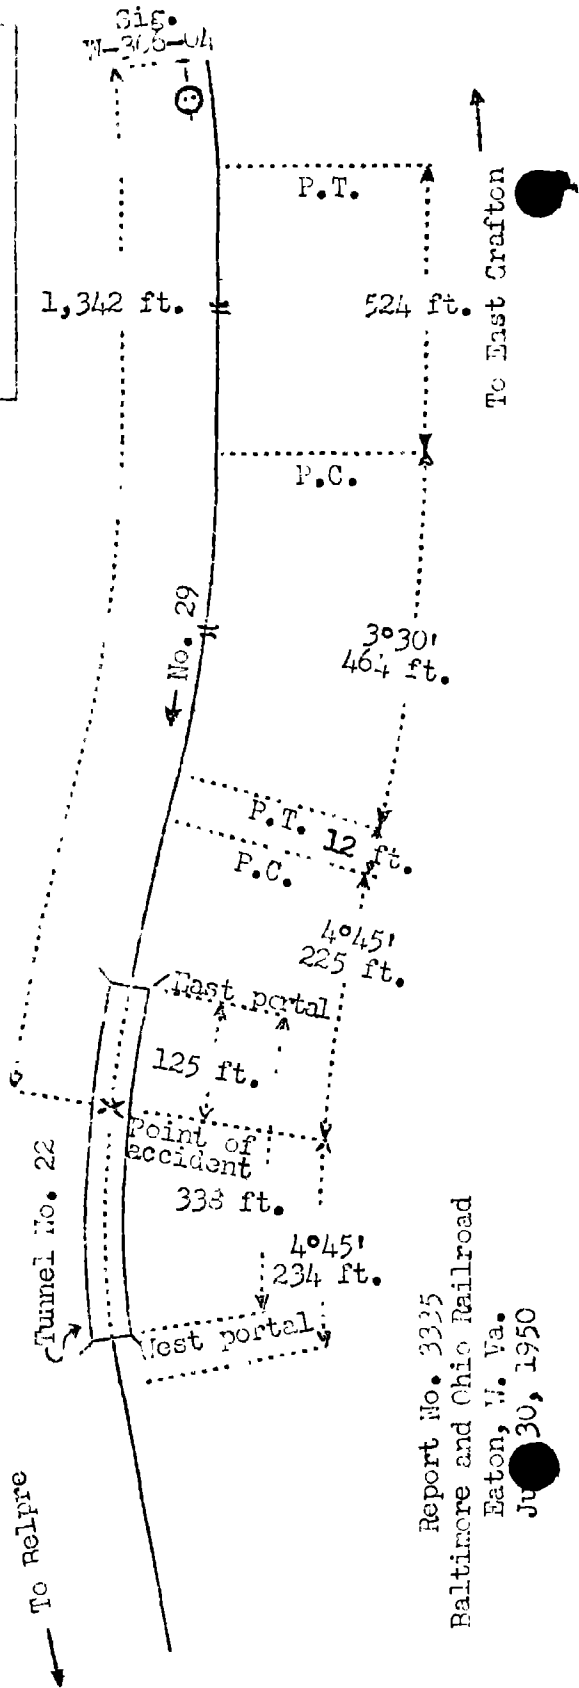
Additional pieces of rail found

After the accident occurred a broken rail was found on the north or high side of the curve. This rail was broken into many pieces, eleven of which, measuring from 9-7/8 inches to 53-1/4 inches in length, were recovered. The most easterly break occurred at a point 24 feet 2 inches west of the receiving end of the rail. Westward from this break, the rail was broken horizontally through the web a distance of 27-1/4 inches and then vertically through the head. Between points 12 inches and 20 inches west of the most easterly break, the adjacent surfaces of the horizontal break were worn smooth. This condition indicates that a break 8 inches long had existed for some time prior to the accident. All of the other breaks were new and apparently occurred as a result of the derailment. This rail was manufactured by the Illinois Steel Company in September, 1943, and was laid in the track the same year. The heat number was not legible.
