REPORT NO. 3461
THE BALTIMORE AND OHIO RAILROAD COMPANY
IN RE ACCIDENT
NEAR KINGMONT, W. VA., ON
APRIL 5, 1952

Date: April 5, 1952
Railroad: Baltimore and Ohio
Location: Kingmont, W. Va.
Kind of accident: Derailment
Train involved: Passenger
Train number: 66
Engine number: 5041
Consist: 3 cars
Speed: 33 m. p. h.
Operation: Signal indications
Track: Single; 5°40' curve; 0.17 percent
ascending grade eastward
Weather: Cloudy
Time: 2:20 p. m.
Casualties: 1 killed; 6 injured
Cause: Broken rail

Accident near Kingmont, W. Va., on April 5, 1952, caused
by a broken rail.

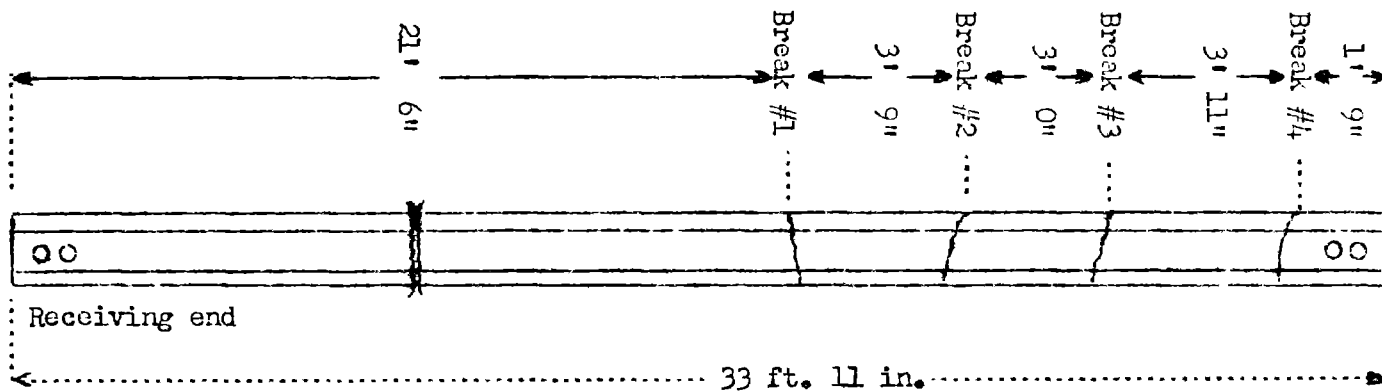
Sketch showing broken rail - south side of track

After the accident occurred, a broken rail was found on the south side of the track at the point of derailment. This rail originally was 39 feet long, but a piece 5 feet 1 inch long had been cut from one end and a piece of the same length cut from another rail had been substituted. The 33-foot 11-inch rail involved was broken into five pieces, all of which were recovered. Breaks occurred at points 21 feet 6 inches, 25 feet 3 inches, 28 feet 3 inches, and 32 feet 2 inches from

the receiving end of the rail. The first piece of rail remained in place and bolted to the adjoining rail west of the point of accident. The rail ends at the first and second breaks were slightly battered. Apparently the other breaks occurred during the derailment of No. 66. At the first break there was a driving-wheel burn on the top of the rail. Under this driving-wheel burn there was a progressive fracture which covered about 50 percent of the cross-sectional area of the head of the rail, and a portion of the head of the rail about 2-1/2 inches in length, 1-1/4 inches in width, and 3/4 inch in depth had shelled out on the gage side of the rail. There were no driving-wheel burns on the head of the rail at the other breaks or on the north rail opposite the first break. A split head was found at the west end of the fourth piece. This split had not progressed materially. There were no marks on the tires of the driving wheels of the engine to indicate that the engine had been derailed before it overturned. The flanges of the right front wheel of each truck of the first car and the front truck of the second car bore marks indicating that they had been in contact with the track structure after they were derailed. Apparently, the rail broke under the driving wheels of the engine and the wheels of the front truck of the tender dislodged the second piece of rail.

The rail involved was rolled by the Maryland Steel Company in June, 1930, and bore heat number 74304A24. This rail was in the medium range with a chemical composition of carbon, 0.84 percent; phosphorus, 0.013 percent; manganese, 0.59 percent; silicon, 0.26 percent; and sulphur, 0.030 percent. It originally was 39 feet in length, but because of a separation between the head and the web near a bolt hole, a piece 5 feet 1 inch in length had been cut from one end. A rail-defect detector car was last operated over this territory on November 6, 1951, at which time 10 defective rails were found within the mile of track on which this accident occurred.

The track supervisor last inspected the track in this vicinity 2 days before the accident occurred, and no defective condition was observed. This section of the track was last inspected by the section foreman the day before the accident occurred. He saw the engine burn and made a close inspection of the rail, but there was no evidence of the rail cracking out along the gage side of the head; he considered that it was only a minor burn and there was no visible evidence of impending trouble.
