INVESTIGATION NO. 3242
THE BALTIMORE AND OHIO RAILROAD COMPANY
REPORT IN RE ACCIDENT
NEAR LEBANON JCT., OHIO, ON
APRIL 6, 1949

Kind of accident: Collision

Accident near Lebanon Jct., Ohio, on April 6, 1949, caused
by a motor-truck occupying a rail-highway grade
crossing immediately in front of an approaching train.

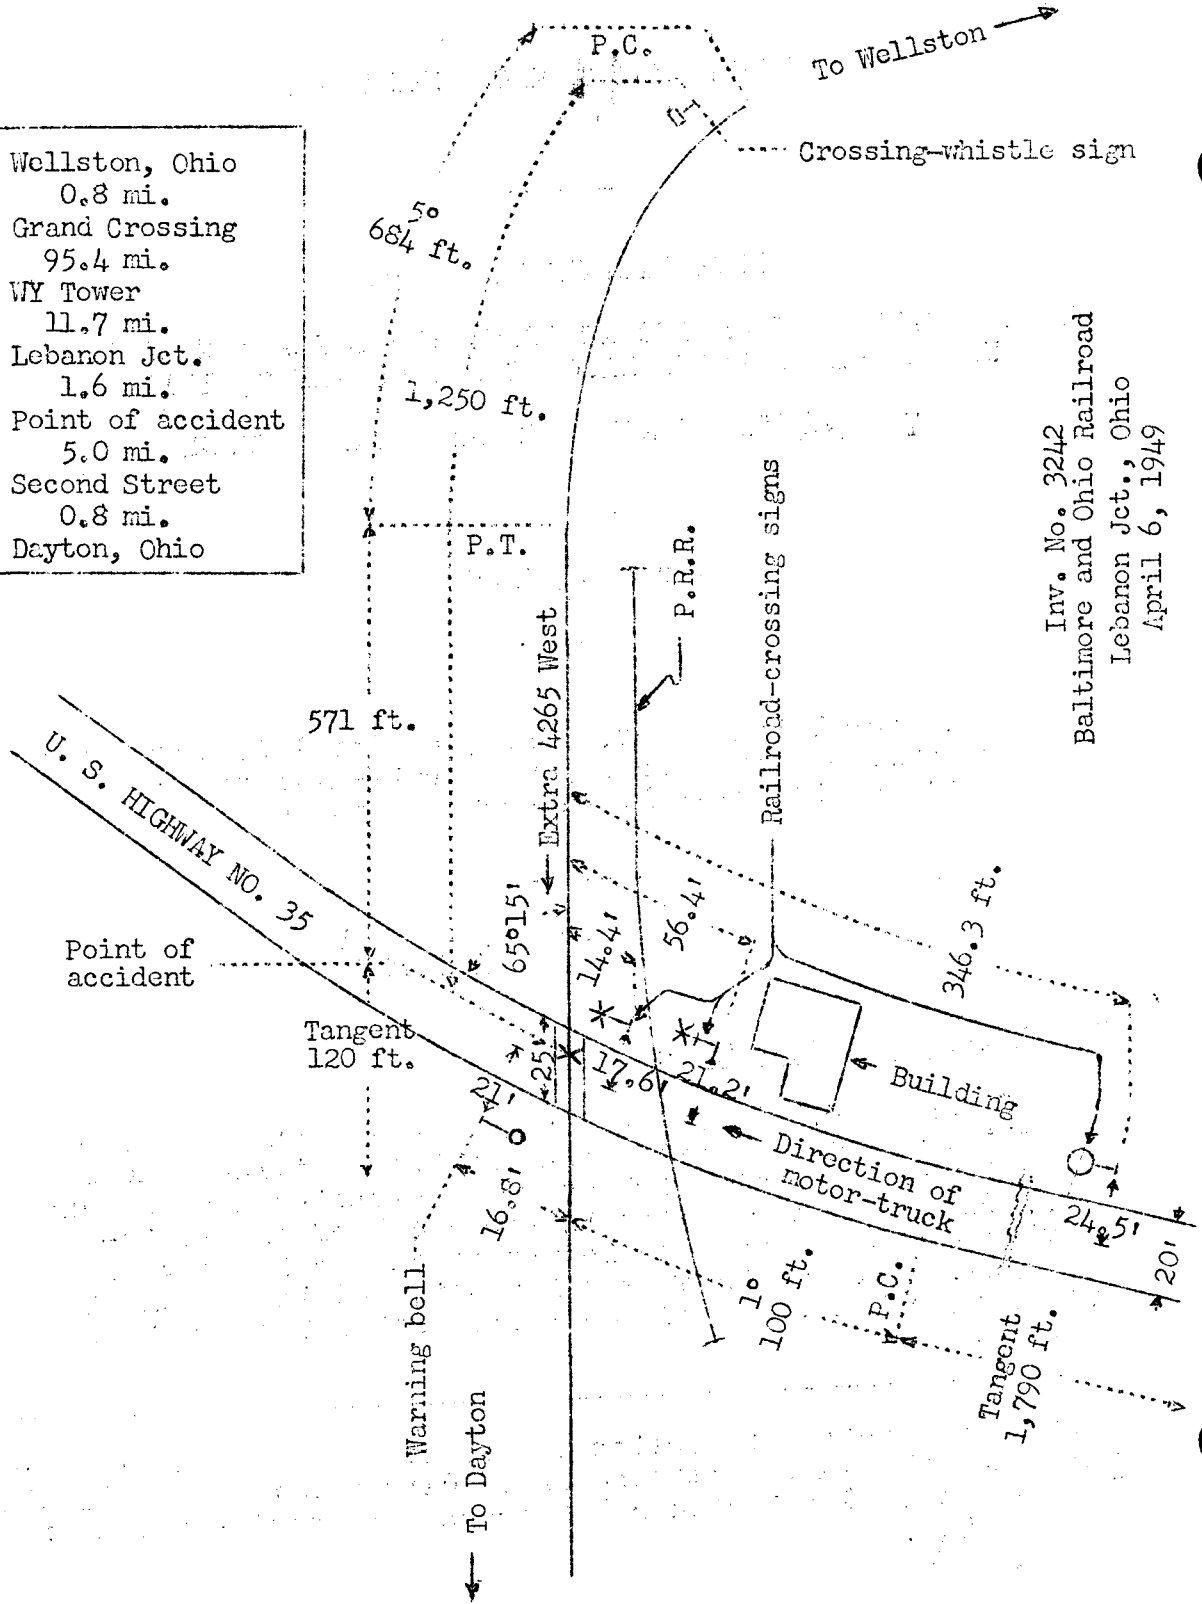
Inv. No. 3242
 Baltimore and Ohio Railroad
 Lebanon Jct., Ohio
 April 6, 1949

This accident occurred on that part of the Toledo Division extending between Grand Crossing, Wellston, and Second Street, Dayton, Ohio, 113.7 miles. In the vicinity of the point of accident this is a single-track line, over which trains are operated by timetable and train orders. There is no block system in use. The accident occurred on the main track at a point 108.7 miles west of Grand Crossing, Wellston, and 1.6 miles west of Lebanon Jct., where the railroad is crossed at grade by U. S. Highway No. 35. The track at this point extends practically north and south, and the highway practically east and west. Timetable directions on the railroad are east and west, and these directions will hereafter be used in this report. From the east on the railroad there is a 5° curve to the left 684 feet in length, and then a tangent 571 feet to the point of accident and 120 feet westward. The grade is 0.6 percent descending westward. In the vicinity of the point of accident a track of the P.R.R. parallels the B. & O. main track on the south at a distance of about 40 feet. U. S. Highway No. 35 intersects the railroad at an angle of 65°15'. This highway is 20 feet wide, and is surfaced with concrete. From the south the highway is practically tangent a distance of 1,790 feet, then there is a 1° curve to the right 100 feet to the point of accident. The grade for north-bound vehicles is, successively, 4.3 percent descending a distance of 900 feet, 2 percent descending 500 feet, and 0.6 percent descending 400 feet to the point of accident. The crossing is 25 feet wide. Timbers 4 inches thick and 10 inches wide are laid on the gage side of each rail throughout the width of the crossing. The remaining area of the crossing between the rails and a 3-foot section on the outside of each rail are surfaced with bituminous concrete. Flangeways 3 inches wide are provided. The surface of the crossing is practically level with the tops of the rails, and it is in good condition.

A circular railroad-crossing advance-warning sign, 2.35 feet in diameter, is located to the right of the direction of north-bound highway traffic, 24.5 feet east of the center-line of the highway and 346.3 feet south of the crossing. This sign is mounted on a mast 8.3 feet above the level of the highway, and bears two diagonal lines intersecting at right angles and the letters "RR" in black on a yellow background. The letters and the lines are outlined by colorless reflector buttons. A P.R.R. standard cross-buck railroad-crossing sign is located to the right of the direction of north-bound traffic, 21.2 feet east of the center-line of the highway, and 56.4 feet south of the center-line of the B. & O. track. This sign

is mounted on a mast 11.6 feet above the level of the highway and bears the words "RAILROAD CROSSING" in black on a white background. A sign 4 feet in width and 11 inches in height bearing the word "DANGER" in black on a white background is mounted on the same mast, 8.6 feet above the level of the highway. A B. & O. cross-buck railroad-crossing sign is located to the right of the direction of north-bound traffic, 17.6 feet east of the center-line of the highway, and 14.4 feet south of the center-line of the track. This sign is mounted on a mast 7.5 feet above the level of the highway and bears the words "RAILROAD CROSSING" in white reflectorized letters on a black background. Two sodium floodlights are suspended over the crossing, 25 feet above the level of the highway. A warning bell 1.5 feet in diameter is mounted on a mast 10 feet above the level of the highway, 21 feet west of the center-line of the highway, and 16.8 feet north of the center-line of the track. The control circuit of the bell is so arranged that this bell sounds when a west-bound train occupies any portion of the main track throughout a distance of 1,459 feet immediately east of the crossing. A crossing-whistle sign for west-bound trains is located 1,250 feet east of the crossing.

the cab of a west-bound engine, and to 547 feet from the right side. A vehicle approaching the crossing from the south is not visible from the cab of a west-bound engine until the vehicle passes a building which is in the southeast angle of the crossing, about 90 feet south of the track and 39 feet east of the highway. The fireman said that when the engine was approximately 130 feet east of the crossing he observed that the motor-truck was approaching from the south at a speed apparently too high for it to be stopped short of the crossing. He called a warning to the engineer, who moved the brake valve to position for emergency application. The collision occurred a few seconds later.
