INVESTIGATION NO. 3188
THE BALTIMORE AND OHIO RAILROAD COMPANY
REPORT IN RE ACCIDENT
NEAR LAUREL, MD., ON
JUNE 10, 1948

Accident near Laurel, Md., on June 10, 1948, caused by
insecure condition of the track.

Inv. No. 3138
 Baltimore and Ohio Railroad
 Laurel, Md.
 June 10, 1943

Location of Accident and Method of Operation

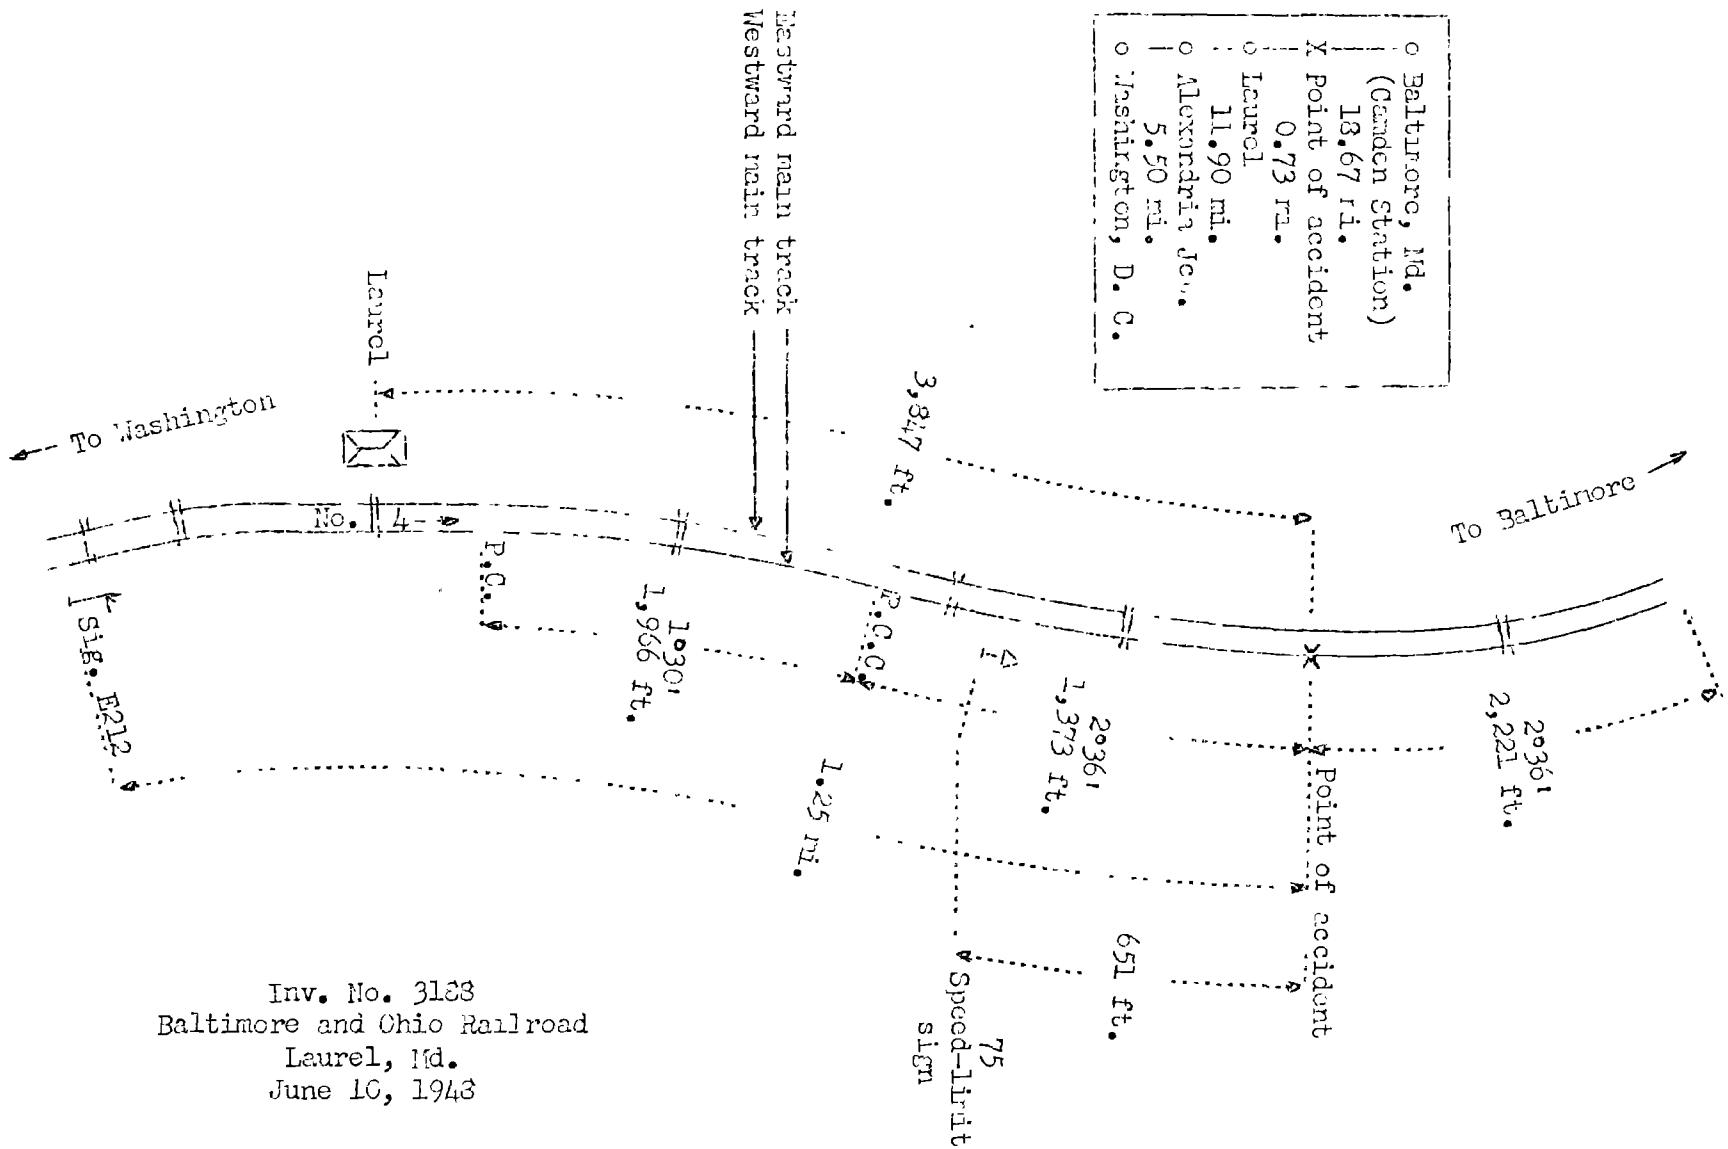
This accident occurred on that part of the Baltimore Division extending between Washington, D. C., and Baltimore, Md., 36.8 miles, a double-track line, over which trains moving with the current of traffic are operated by signal indications and an automatic train-stop system. The accident occurred on the eastward main track 18.15 miles east of Washington, at a point 3,647 feet east of the station at Laurel. From the west there is a 1°30' curve to the right 1,966 feet in length, then a compound curve to the left, having a maximum curvature of 2°36', 1,373 feet to the point of derailment and 2,221 feet eastward. The grade is 0.37 percent ascending eastward.
