INVESTIGATION NO. 2605

THE BALTIMORE & OHIO RAILROAD COMPANY

REPORT IN RE ACCIDENT

NEAR MT. AIRY JCT., MD., ON

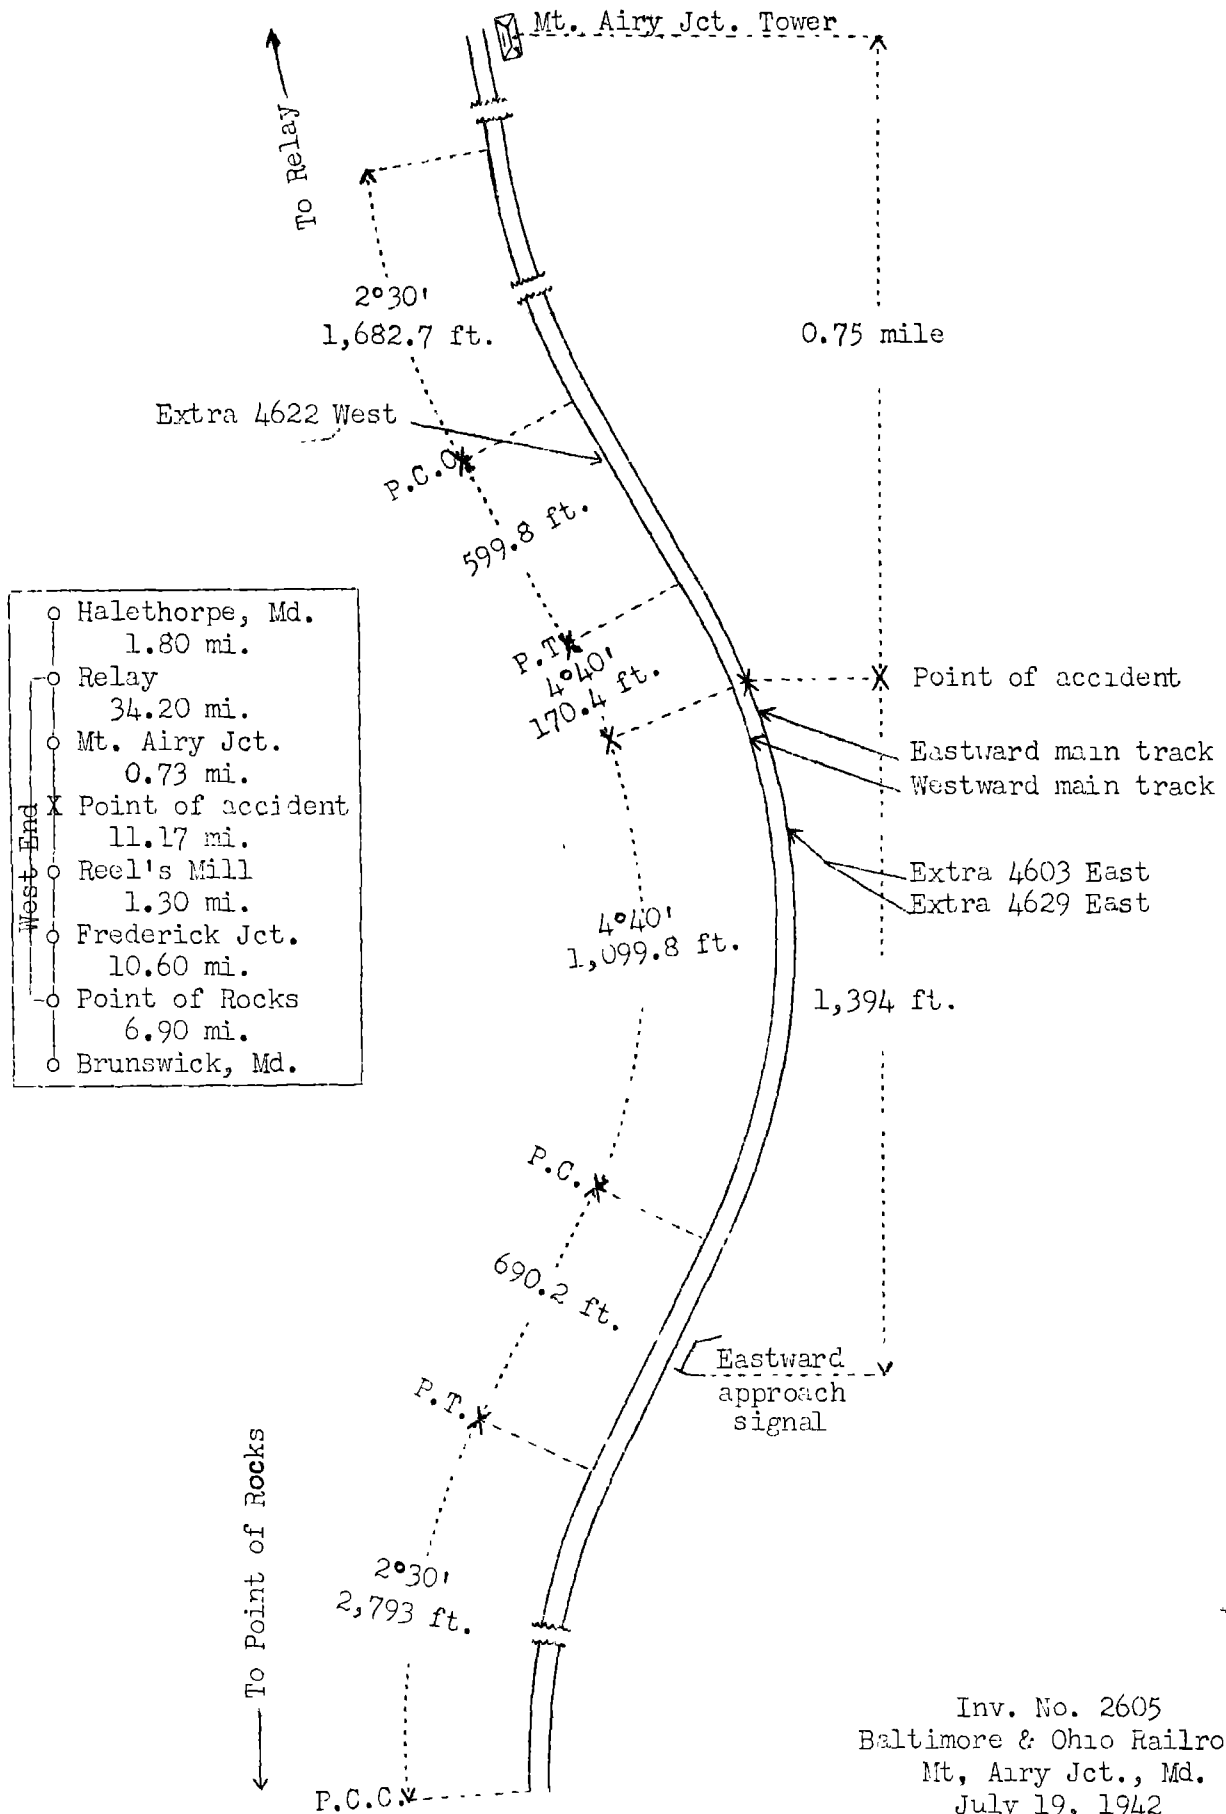
Inv. No. 2605
 Baltimore & Ohio Railroad
 Mt. Airy Jct., Md.
 July 19, 1942

From the right side of an east-bound engine the view of the point of accident is restricted to a few feet and from the left side to a distance of about 1,300 feet, because of track curvature and a rock cliff on the south side of the tracks. The wreckage which obstructed the westward main track could not be seen from a west-bound engine because of track curvature and the train on the eastward main track.
