INTERSTATE COMMERCE COMMISSION

ACCIDENT ON THE

BALTIMORE AND OHIO R. R.

FEBRUARY 16, 1937

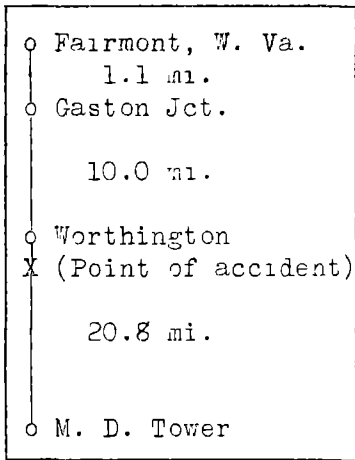
Inv. No. 2149
Baltimore & Ohio R.R.
Old Hutchinson Siding, W.Va.
Feb. 16, 1937

In the vicinity of the point of accident, two tracks parallel the main track on the north. The one nearest the main track, called Old Hutchinson Mine Siding, connects with the main track at both ends; this track is 2,155 feet long; the other track, called the Western Maryland main track, connects with Old Hutchinson Mine Track at both ends and is 1,298 feet long; in this report these tracks are referred to as "Old Hutchinson" and "Western Maryland" tracks, respectively. The main track switch at the west end of Old Hutchinson siding is located 2,475 feet west of Worthington, and the west switch connecting the Western Maryland track with Old Hutchinson siding is 107 feet east of the main track switch. The accident occurred at the fouling point between the main track and Old Hutchinson track, 77.5 feet east of the main track switch. Approaching the point of accident from the west there is a 6° curve to the right, 494.2 feet in length, followed by a tangent more than 1/2 mile in length; the accident occurred on this tangent at a point 590 feet from its western end. The grade, on the main track, is 0.09 per cent descending eastward to the point of accident while the grade on the Western Maryland track is 1 per cent descending westward to within a short distance of the point of accident, where it becomes level.

Point of accident

Direction of Runaway cars

-1.0%
