REPORT NO. 1978

REPORT OF THE DIRECTOR OF THE BUREAU OF SAFETY CONCERNING AN
ACCIDENT ON THE BALTIMORE & OHIO RAILROAD AT ROCKVILLE,
MD., ON APRIL 11, 1935.

May 21, 1935.

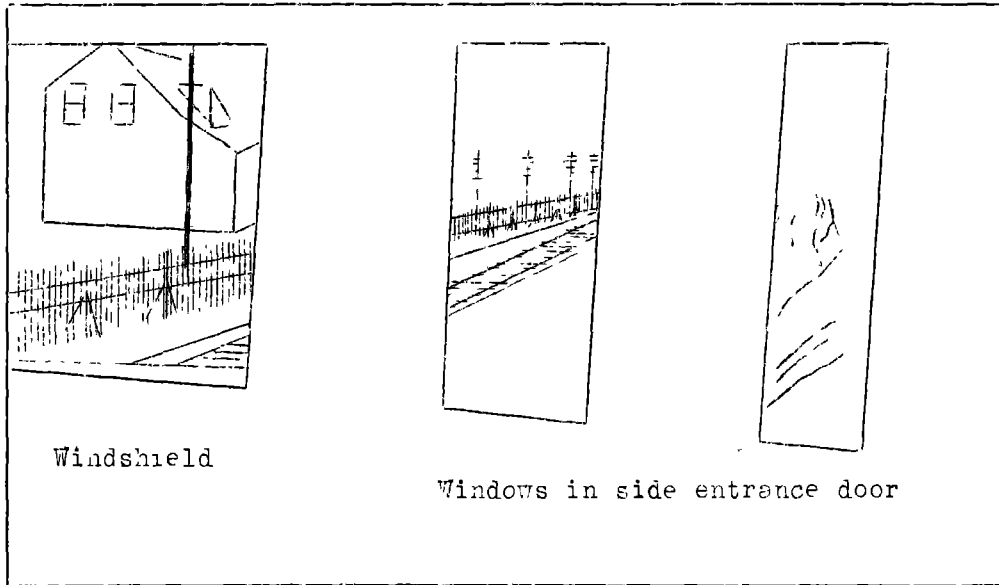
23 feet from eastward track

Operator's View of Tracks from Bus.

be seen when 1,486 feet from the crossing while the fireman could see automobile headlights located at the above-mentioned point on the highway when the engine was 920 feet from the crossing; at a point 39 feet from the eastward track the corresponding distances were 522 and 407 feet, respectively, and at a point 63 feet from the eastward track these distances were 300 and 242 feet, respectively. It also was noted that from the position on the highway 39 feet from the eastward track a brief view could be had back of the westward station shelter when the headlight was 1,545 feet distant. It was particularly noted that when closely approaching the 23-foot point, the sign under the cross-bar sign reading "NO WATCHMAN ON DUTY 10.00 P.M. TO 6.00 A.M." blended with the south side of the westward station shelter in such a way as to cut off practically all view of an approaching east-bound train; this condition, however, prevailed only for a fraction of a second when observed from a moving vehicle passing the sign. Attention also is called to the fact that observations made of the operation of school busses over this crossing during the period covered by the traffic check previously mentioned, and also at other times, showed that in several cases no material reduction in speed was made, even when loaded to capacity with school children; in fact, the only school bus which made a stop contained no passengers.

The view at this crossing is not good; in fact the conditions are such that for all practical purposes it is necessary for the driver of a south-bound vehicle to be beyond the cross-bar sign before he can obtain a good view of a train approaching from the west, and at that point the front end of his vehicle, especially in the case of a large truck or bus, would be dangerously close to the westward track. While the view is somewhat improved in the case of a north-bound vehicle, yet the need for better protection then obtained at the time of the accident is evident. The circumstances surrounding the occurrence of this accident, however, serve to emphasize the limitations of any system of grade-crossing protection which depends entirely upon audible signals. Not only was it impossible when close to the crossing involved in this

4. That front-end construction of motor vehicles should provide the driver with a full view to each side as well as to the front.
5. That, whenever practicable, busses should be routed so as to avoid grade crossings which are not protected by watchmen, or devices to give visual warning at all times when a train is approaching.

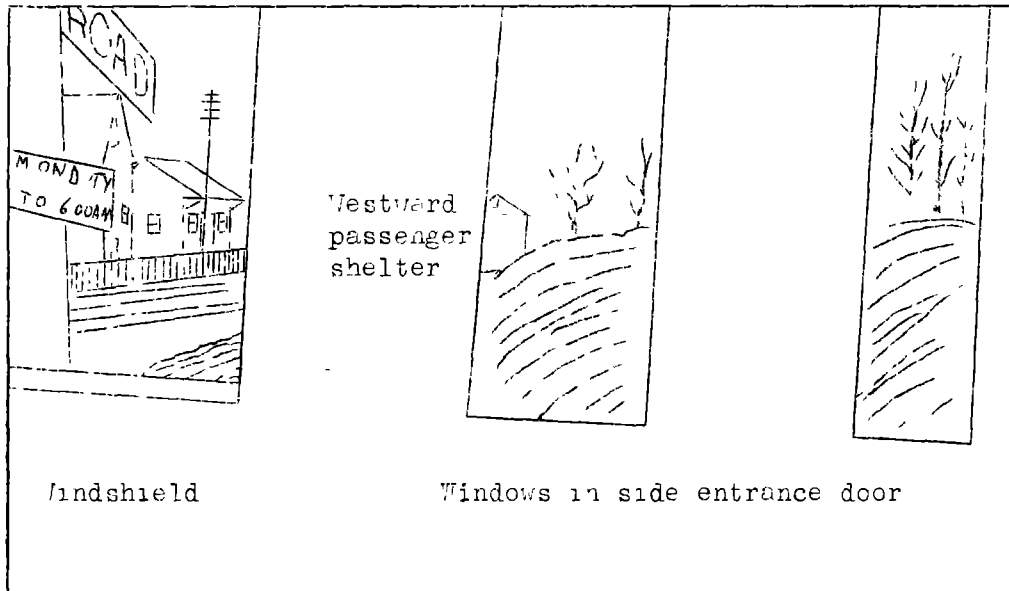
39 feet from eastward track

Driver Line said that the manner in which the side-door entrance to the bus was constructed did not interfere with his view; careful examination of this portion of the bus, however, did not support this statement, for measurements of the space between the right end of the windshield and the beginning of the first side window on that side of the bus showed that within this distance of approximately 40 inches there was only about $12\frac{1}{2}$ inches of glass through which a view to the right could be obtained from the driver's seat, this $12\frac{1}{2}$ inches consisting of one panel $7\frac{1}{2}$ inches wide and another panel $5\frac{1}{4}$ inches wide, with a dead space on either side of each glass which was considerably wider than the glass itself. The company which manufactured the body of this bus also equips bus bodies with a sedan-type entrance door, at extra cost, which furnishes practically the same vision as an ordinary window; had the bus involved in the accident been so equipped, it would have given Driver Line a much better opportunity of observing the headlight of the approaching engine.
