INTERSTATE COMMERCE COMMISSION

REPORT OF THE DIRECTOR OF THE BUREAU OF SAFETY CONCERNING AN
ACCIDENT ON THE BALTIMORE & OHIO RAILROAD AT SAND PATCH,
PA., ON FEBRUARY 28, 1934.

Inv. No. 1898
 Baltimore & Ohio R.R.
 Sand Patch, Pa.
 Feb. 28, 1934

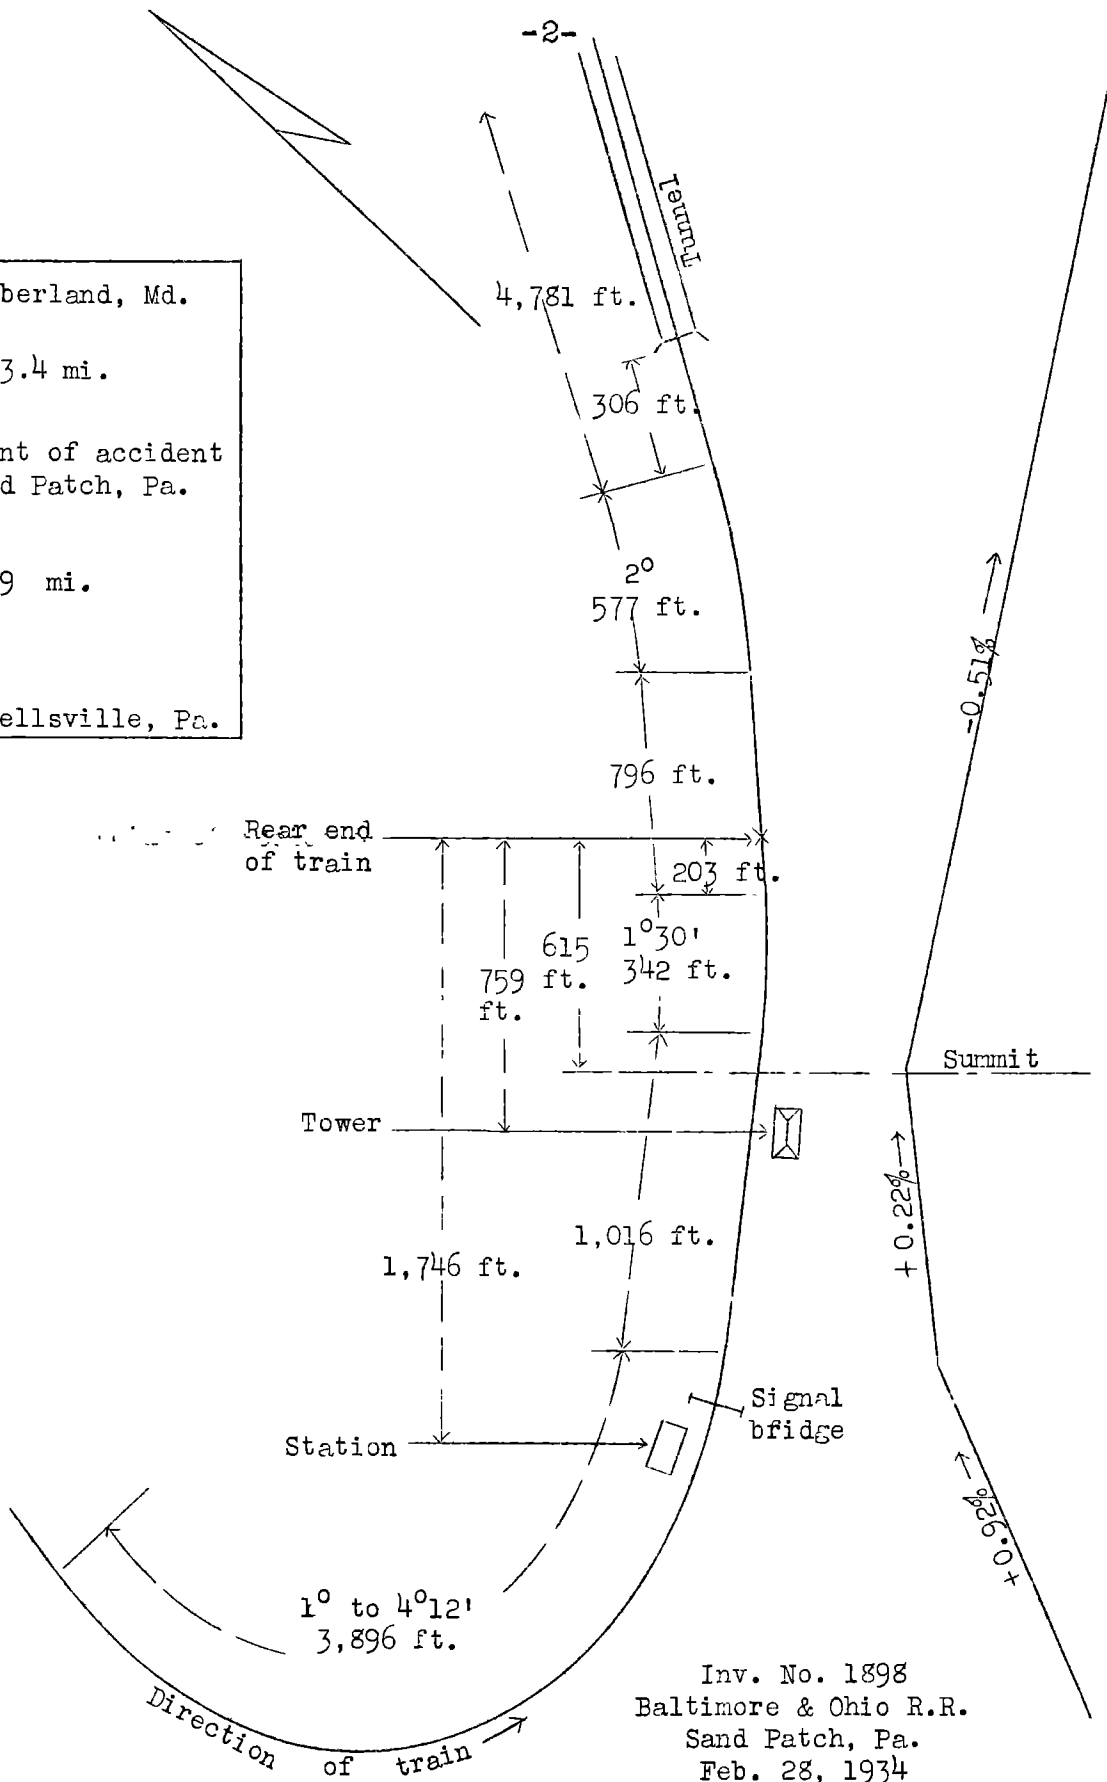
The south corner of the steel rear platform of the caboose was crushed, the rear end being forced over toward the west-bound track. The rear coupler was broken off and the left corner of the front platform was slightly crushed by the end of the car ahead of it. The rear truck of the caboose was derailed, and engine 6166 was slightly damaged. The coupler in the front end of the first car in the train was broken off, as was the rear portion of the coupler yoke in the front end of the nineteenth car. The employee killed was the helper flagman, who was crushed between the caboose platform and pilot of engine 6166.

This accident was caused by Train Second No. 94 breaking in two between the eighteenth and nineteenth cars.

The break-in-two which resulted in this accident probably was due to a combination of several factors. When Conductor Fair first made an attempt to cut off the helper engines the major portion of the train was on the descending grade and it is believed that with the helper engines being eased off and throttles finally closed preparatory to cutting off from the caboose, the train was stretched out and extra strain exerted on the defective coupler yoke on the nineteenth car, resulting in its failure. The temperature was reported to have been about 27° below zero and may have been a factor by reason of increasing the brittleness of the metal. The parting of the train in turn caused an emergency application of the air brakes, with the consequent derailment and damage to the caboose due to the force exerted by the two helper engines behind it. While the coupler on the first car in the train also was broken, there was no indication of an old defect, and it is believed that this break was a result of the accident.

Attention is called to the potential hazard involved in massing motive power against any caboose car or car used for similar purposes. The caboose involved in this accident was well constructed, but its strength was insufficient to withstand the crushing force exerted by the two heavy helper engines when the brakes on the train were applied in emergency after the angle cock at the rear of the caboose had been closed and when steam was being used on the helpers to provide
