INVESTIGATION NO. 3229  
THE BALTIMORE AND OHIO RAILROAD COMPANY  
REPORT IN RE ACCIDENT  
AT SYKESVILLE, MD., ON  
JANUARY 22, 1949

Accident at Sykesville, Md., on January 22, 1949, caused  
by the overturning of a rail.

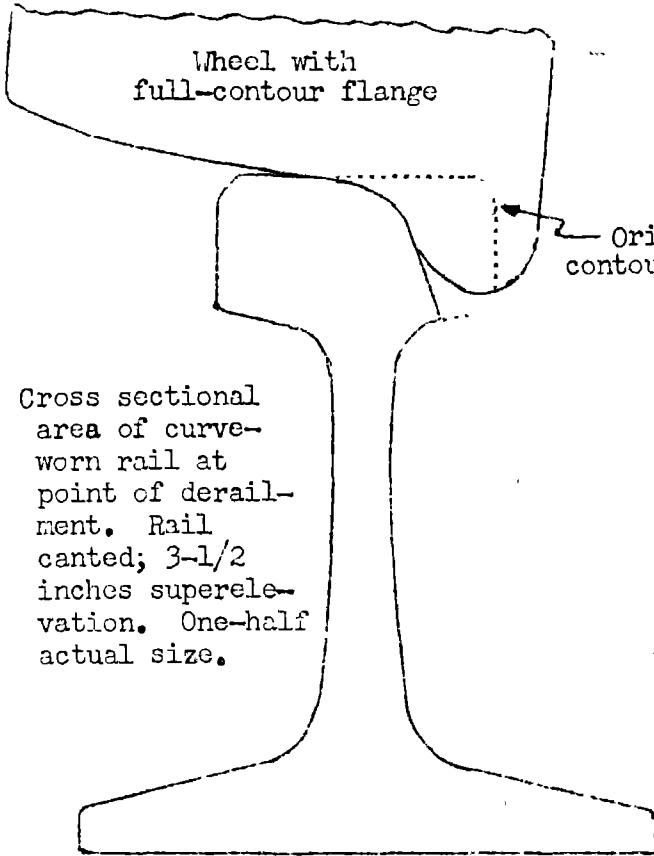
Cross sectional area of curve-worn rail at point of derailment. Rail canted; 3-1/2 inches superelevation. One-half actual size.

The derailment occurred near a joint between two rails on the north side of track No. 4. Of these rails, portions 13 feet 4 inches west of the joint and 25 feet 8 inches east of the joint were not recovered. The receiving portion of the rail west of the joint was broken into 2 pieces, one of which was 5 feet 7 inches long, and the other was 20 feet 1 inch long. The two recovered pieces of the east rail were gouged in the web and on the lower inside edge of the head and these marks extended throughout the entire length of both pieces. The inside joint bar and bolts at the receiving end were heavily battered. Both breaks were ragged and irregular in contour and the structure of the metal was sound. Apparently, the breaks occurred after the rail was overturned. The location of this rail in the track included a portion of the spiral and extended into the full curvature of  $9^{\circ}30'$ . At the east end of the second piece of rail, the gage side of the head was worn  $5/8$  inch at the lower edge and the curve-wear line sloped

diagonally upward and outward at an angle of 19 degrees a distance of 1-1/4 inches, then it rounded outward to a point on the original top surface 2-1/16 inches from the original gage side of the rail. Approximately 34 percent of the cross-sectional area of the head of the rail was worn away. Examination of all the recovered rails disclosed no mark which indicated that a wheel had crossed over the top surface of any of the rails.

The investigation of this accident disclosed no defective condition of the equipment of the train, and there was no indication of any obstruction having been on the track. The only indication of dragging equipment was identified as having been caused after the derailment occurred. The only mark on the flanges, treads or side surfaces of any wheel of the engine or of the tender was also identified as having been caused after the derailment occurred. There was no flange mark on the top surface of any of the recovered rails. The engine had an accumulated mileage of only 398 miles after having received class 3 repairs. The highest estimate of the speed of the train at the time of the accident was 11.4 miles per hour higher than the equilibrium speed on the curve in question. Considering that the speed was higher than equilibrium speed, that the engine was somewhat rigid, that the flanges of the wheels of the engine were of full contour, and that the high rail of the curve was considerably curve-worn, it is apparent that the flanges were in contact with the upper part of the inclined surface of the curve-worn area of the head of the rail. As a result, the forces were directed sufficiently outward and downward to cause the rail to overturn.
