REPORT OF THE DIRECTOR

ACCIDENT ON THE

BALTIMORE & OHIO RAILROAD

INVESTIGATION NO. 2099

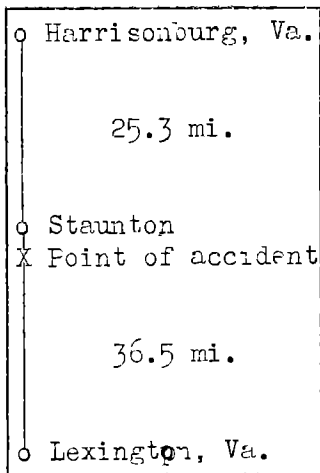
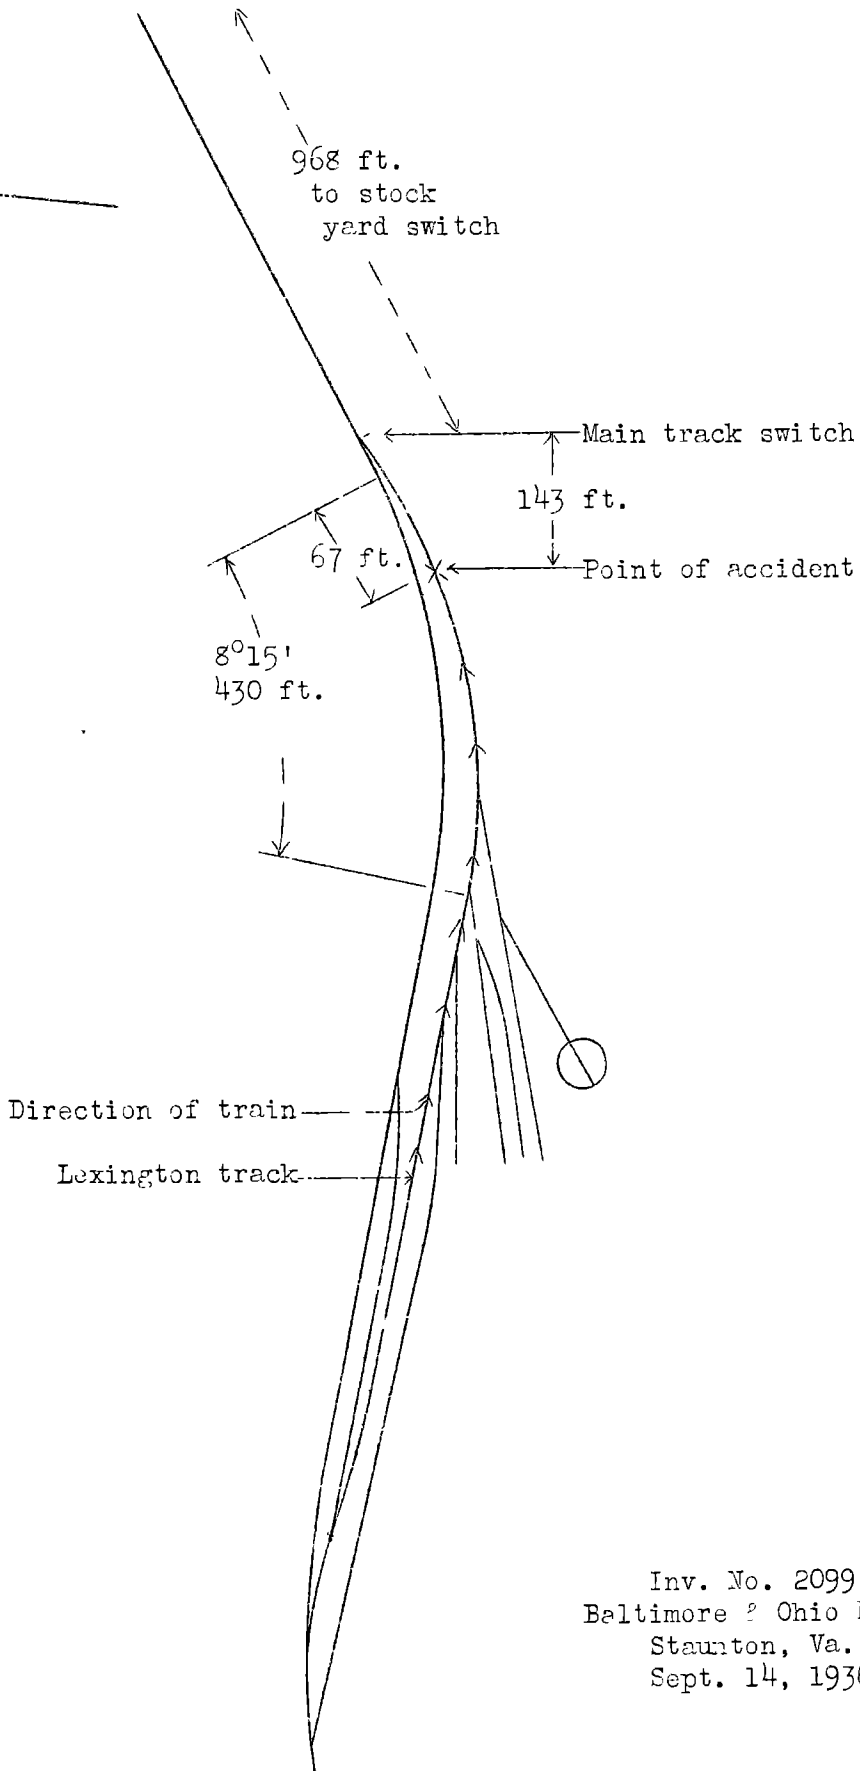
Inv. No. 2099
 Baltimore & Ohio R.R.
 Staunton, Va.
 Sept. 14, 1936

The front truck of the lead car was derailed to the right or south and on encountering the bank of a cut, the car was diverted to the left and stopped at a point 105 feet beyond, leaning at an angle of about 40° with the front end against the embankment on the left side of the track. The body of the car became detached from the trucks; the lead truck was crosswise of the track and against the rear truck which was not derailed.

The front wheels of the rear truck of the second car were also derailed. None of the remaining equipment was derailed. The employee killed was the flagman.
