REPORT NO. 3450
THE BALTIMORE AND OHIO RAILROAD COMPANY
AND
THE NEW YORK CENTRAL RAILROAD COMPANY
IN RE ACCIDENT
AT WALKERTON, IND., ON
FEBRUARY 7, 1952

Date: February 7, 1952

Location: Walkerton, Ind.

Kind of accident: Side collision

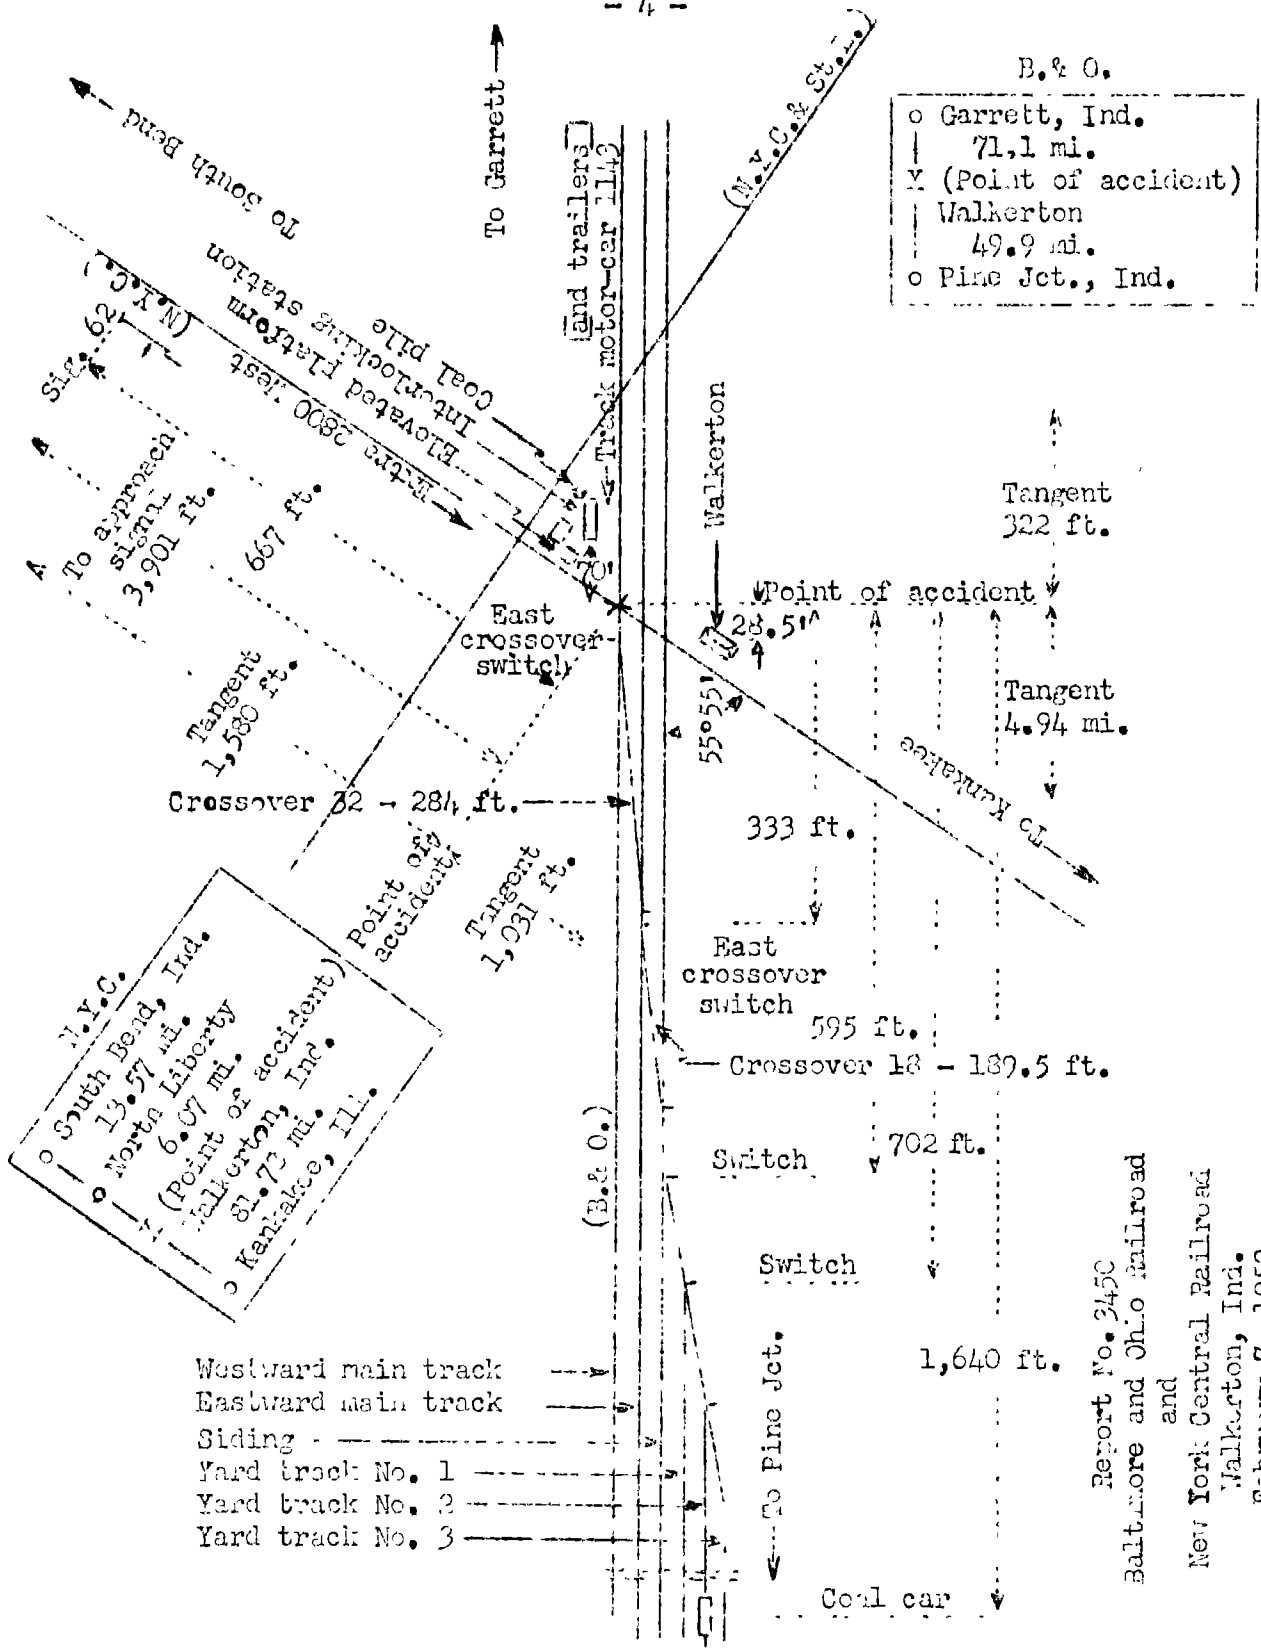
Location of Accident and Method of Operation

Point of accident

The track motor-car was demolished, and the wreckage stopped between the two main tracks of the B. & O. at a point about 20 feet west of the crossing. Engine 2800 stopped 2,530 feet west of the crossing.
