REPORT OF THE DIRECTOR OF THE BUREAU OF SAFETY CONCERNING AN ACCIDENT WHICH OCCURRED ON THE BALTIMORE & OHIO RAILROAD NEAR WARSAW, N. Y., ON MARCH 7, 1932

May 10, 1932

Inv. No. 1757
 Baltimore & Ohio R.R.
 Warsaw, N.Y.
 March 7, 1932.

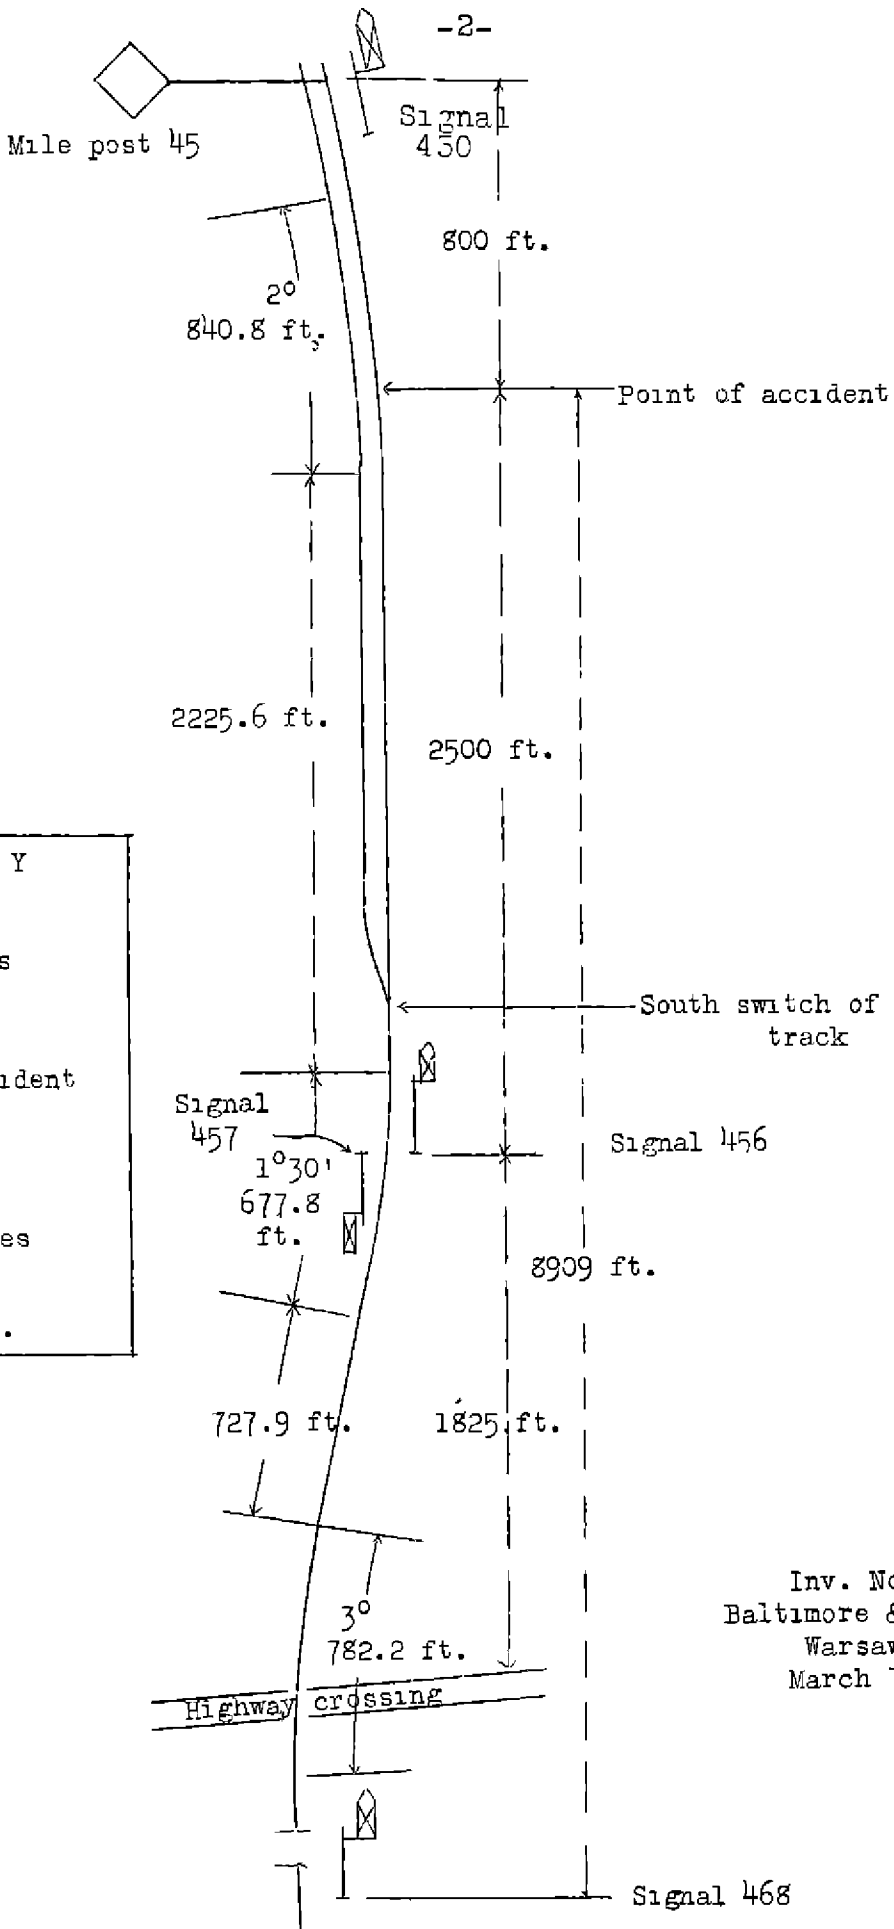
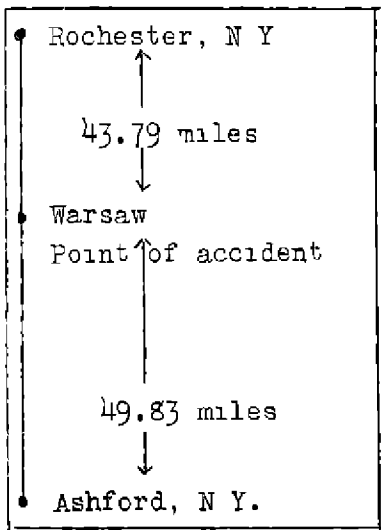
The signals involved in this accident are permissive signals 468 and 456, located 8,909 and 2,500 feet, respectively, south of the point of accident. These signals are of the three-position, upper-quadrant, semaphore type. A passing track, 6,900 feet in length, parallels the main track on the west and in the center of this passing track are two crossovers for entering the passing track from either direction. The south switch of the passing track is located about 200 feet north of signal 456.
