ACCIDENT ON THE
BALTIMORE AND OHIO RAILROAD

WHEATLAND, IND.

FEBRUARY 26, 1936

INVESTIGATION NO. 2048

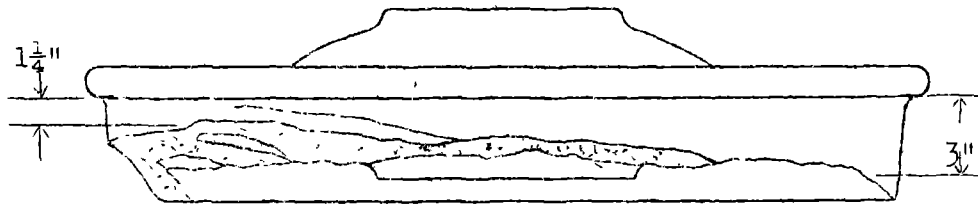
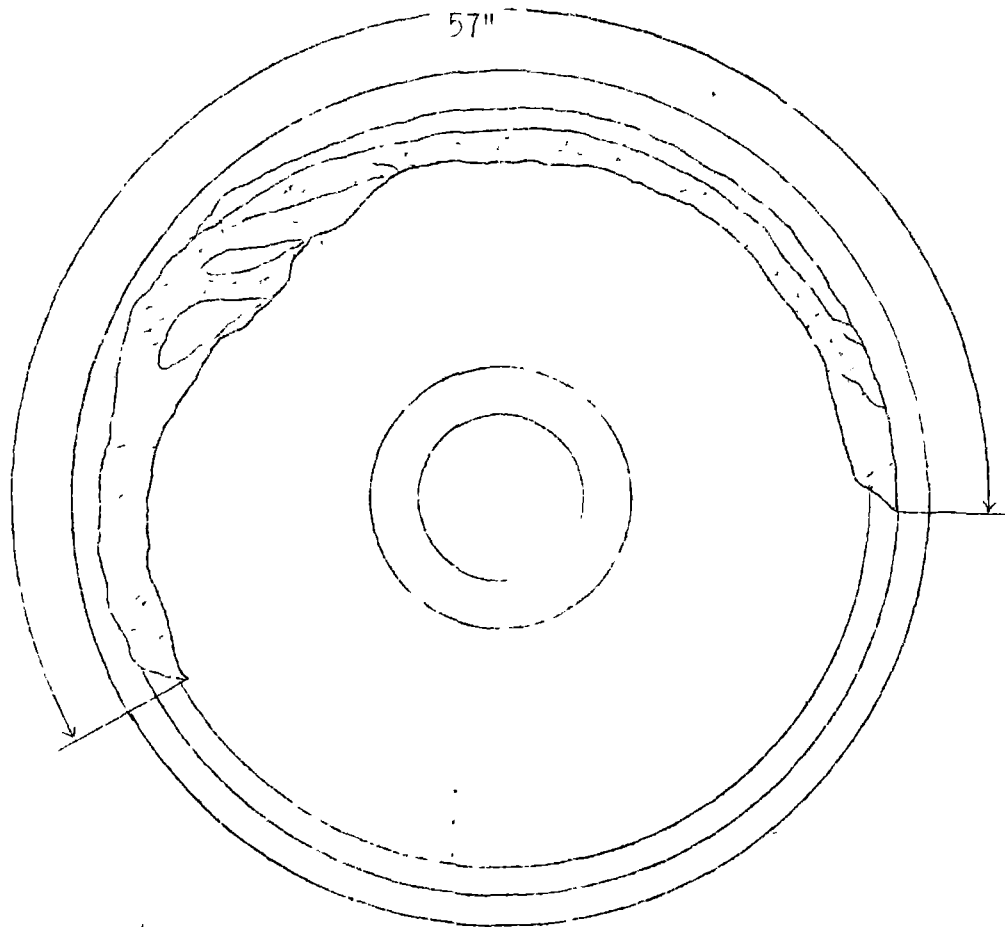
plate immediately under the tread section which measured about 2 by 5 inches. Inspection did not reveal any old flaws or any evidence that the wheel had been heated; the outer edge of the broken tread, however, was badly cut and ground off for about three-fourths of its circumferential length, and a large groove had been worn in it. That portion of the total tread which was left on the wheel showed no defects and the flange was not worn thin or vertical at any point, while the wheel was concentric with the journal and mounted to proper gauge on the axle. The flange of the mate wheel was broken for a distance of about 12 inches; this was a new, clean break, and evidently was the result rather than the cause of the derailment. The wheel involved was a double-plate, cast-iron wheel and was marked "Altoona- P.R.R. - ARA 1917" on the outside face and "78403-3-20-28-700" on the inside face, with an indicated 5 tape size. The mate to this wheel bore the same markings, except that the number was 78812 and the date cast was 3-25-28.

Examination of the broken wheel by Engineer of Tests Van Gundy, of the Baltimore and Ohio Railroad, disclosed that its failure was due to the absence of chill in the tread; a number of circumferential interwoven cracks also were found in the rim and tread, but there were no indications of overheating at any place. Chemical analysis was made of metal taken from a point at the junction of the front and back plates and also from a point one-fourth inch below the tread surface and $1\frac{1}{2}$ inches from the throat of the flange, with the following results:

Engineer Van Gundy said this analysis indicated a very unusual condition, the combined carbon being very low, and it was lower in the tread section than in the plate. The total carbon and other constituents were approximately normal, but there was not a good balance between the manganese and silicon. The main weakness in the wheel was stated to have been due to faulty foundry practice which failed to develop chill and mottled iron; the low combined carbon content confirmed the low chill on the wheel at the time of manufacture.

Sketch showing extent of broken rim on chilled tread wheel.

It is recommended that careful consideration be given to the question of whether some degree of variation, and some consideration for the date of manufacture, is justified in the condemning rules governing wheels manufactured many years ago as compared with wheels of more recent design and manufacture.
