**RAILROAD ACCIDENT INVESTIGATION**

**Report No 3870**

THE BALTIMORE AND OHIO RAILROAD COMPANY

DECEMBER 27, 1959

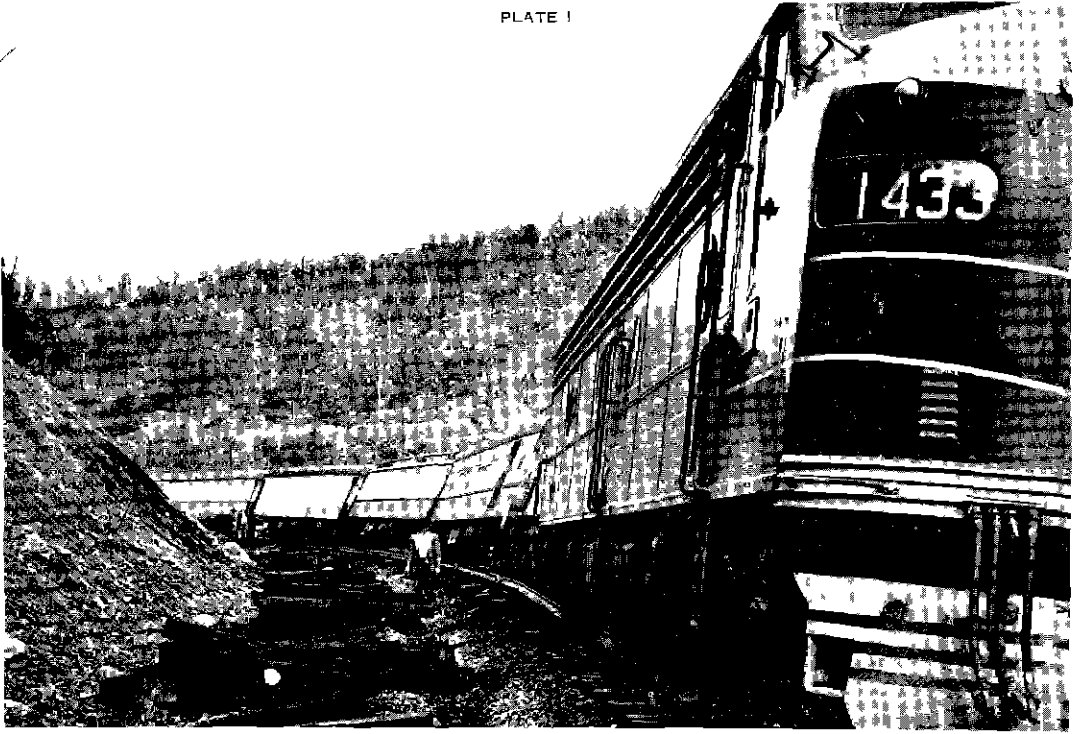
PLATE 1

separations between units of the train. The diesel-electric units stopped upright on the structure of track No. 2 and in line with the rails. All the derailed cars stopped upright on the track structure in positions similar to those of the cars shown in PLATE 1. All the diesel-electric units, and the 2nd, 6th and 7th cars were slightly damaged. The 1st, 3rd, 4th, and 5th cars were somewhat damaged.

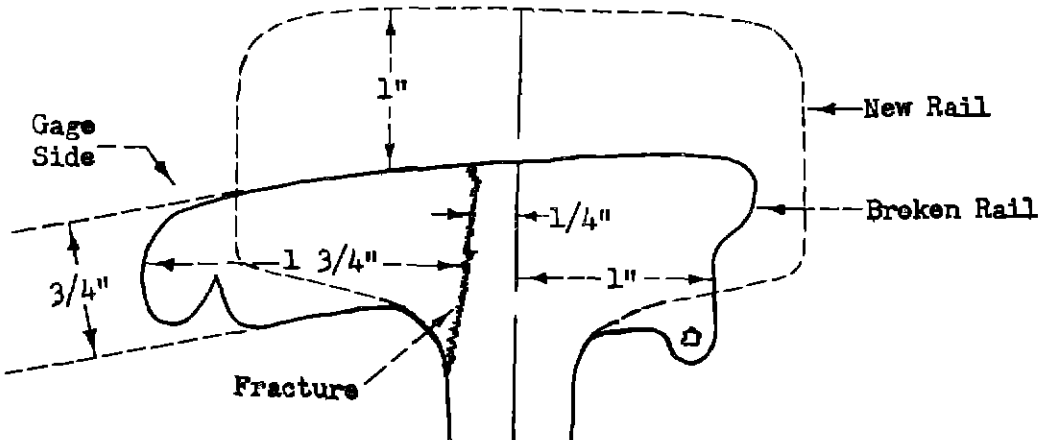
PLATE 3

Cross section of broken 131-pound rail with cross section of new 131-pound rail superimposed

The investigation disclosed that the failed rail had been curve-worn before it was laid on the south side of track No. 2 at the point where the accident occurred. In the normal contour of a new 131-pound rail section the width of the head is 3 inches and the depth of the head is 1¾ inches. The head of the rail involved had been reduced from its normal contour by wear, and distortion resulting from metal flow, to a thickness of ¾-inch on the gage side in the cross-sectional area of the head at the point where the failure occurred, and at this point the field side of the rail also was considerably worn and distorted. In addition to the worn condition of the rails, the gage was wide throughout the curve. It is apparent that as the locomotive of No. 2 was moving on this curve at a speed of about 30 miles per hour with the wheels on the north side of the locomotive crowding the high rail, only the outer portion of the treads of the wheels on the south side of the locomotive were bearing on the rails in the south side of the curve. It is evident, under these circumstances, that at the point of accident the gage was sufficiently wide so that the outer portion of the treads of the wheels were in contact with only that portion of the head of the rail projecting inward on the gage side which was worn and distorted and which was not supported by the girder strength of the web section of the rail. As a result, a portion of the head broke off on the gage side of this rail, permitting wheels on the south side of the rear truck of the first diesel-electric unit to drop inside the south rail and the general derailment then occurred. The pieces which broke off the head of this rail were 1¾ inches wide and ¾-inch thick at the point of initial failure and their combined length was 29 inches. Laboratory analysis of the failed rail disclosed that the fracture, which was 29 inches long, showed all new break and resulted from service stresses after being worn to a ¾-inch head thickness.

as a result of a combination of wide gage and the excessively worn condition of the head of the low rail, a portion of which broke off under the stresses which were then imposed on it

It is recommended that the carrier review its policy as to permissible limits of rail wear and immediately remove from main track service all rails which are excessively worn
