RAILROAD ACCIDENT INVESTIGATION

REPORT NO. 4151

BESSEMER AND LAKE ERIE RAILROAD COMPANY

OCTOBER 12, 1969

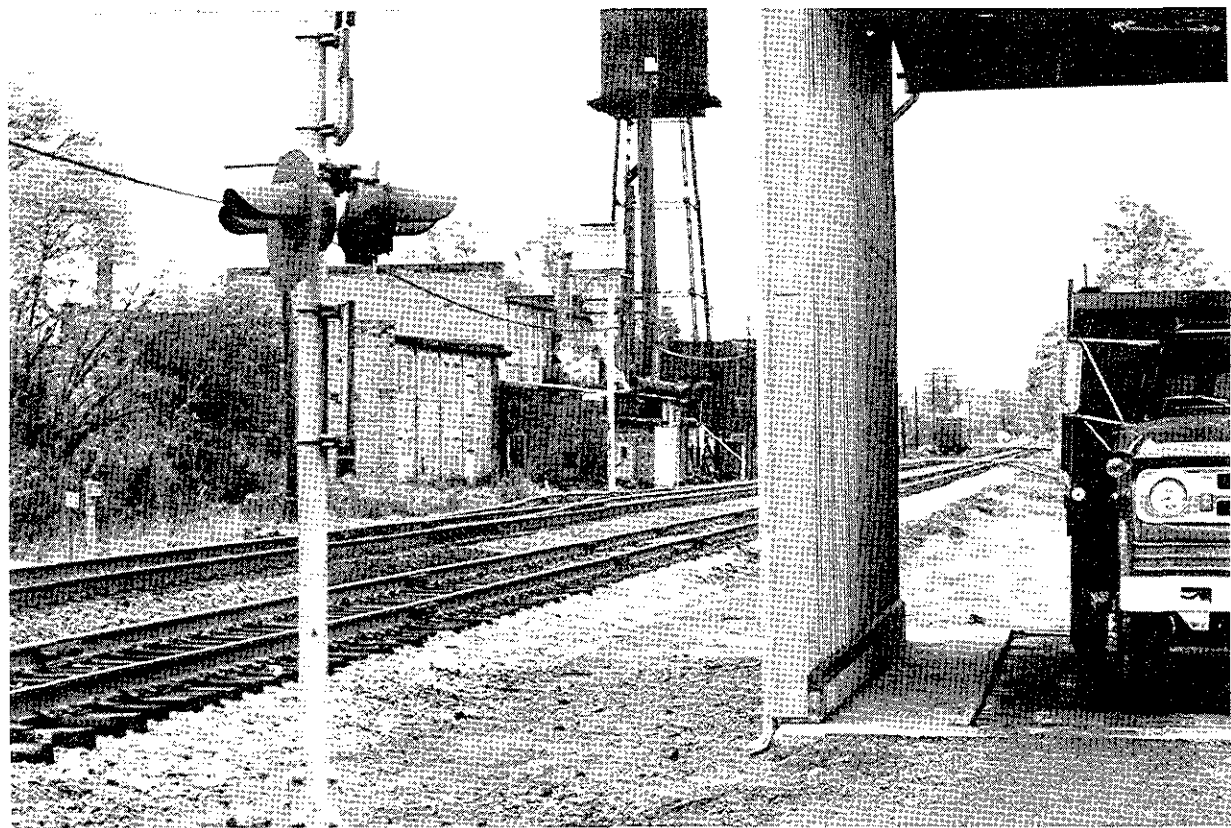
Structures of a feed-mill plant are along the south side of Mulberry Street, a short distance west of the railroad, as indicated in the sketch appended to this report. A shed, covering a truck scale, is the easternmost structure of the feed-mill. Because of the feed-mill structures, the driver of an eastbound vehicle approaching the railroad via Mulberry Street cannot see an approaching northbound train until his vehicle is about 40 feet from the crossing. Between this point and the nearest track, the driver may look through the shed or along its outside wall and see a northbound train approaching throughout a distance of about 1000 feet. His view southward along the railroad would be impeded,
