Report No. 82-1
Bessemer and Lake Erie
Railroad Company
Sherwin, Pennsylvania
January 16, 1982

Report No. 82-2
Louisville and Nashville Railroad Company
Dudley, Alabama
February 3, 1982

RAILROAD ACCIDENT INVESTIGATION
ACCIDENT REPORT NO. 82-1

BESSEMER AND LAKE ERIE RAILROAD COMPANY
SHERWIN, PENNSYLVANIA
JANUARY 16, 1982

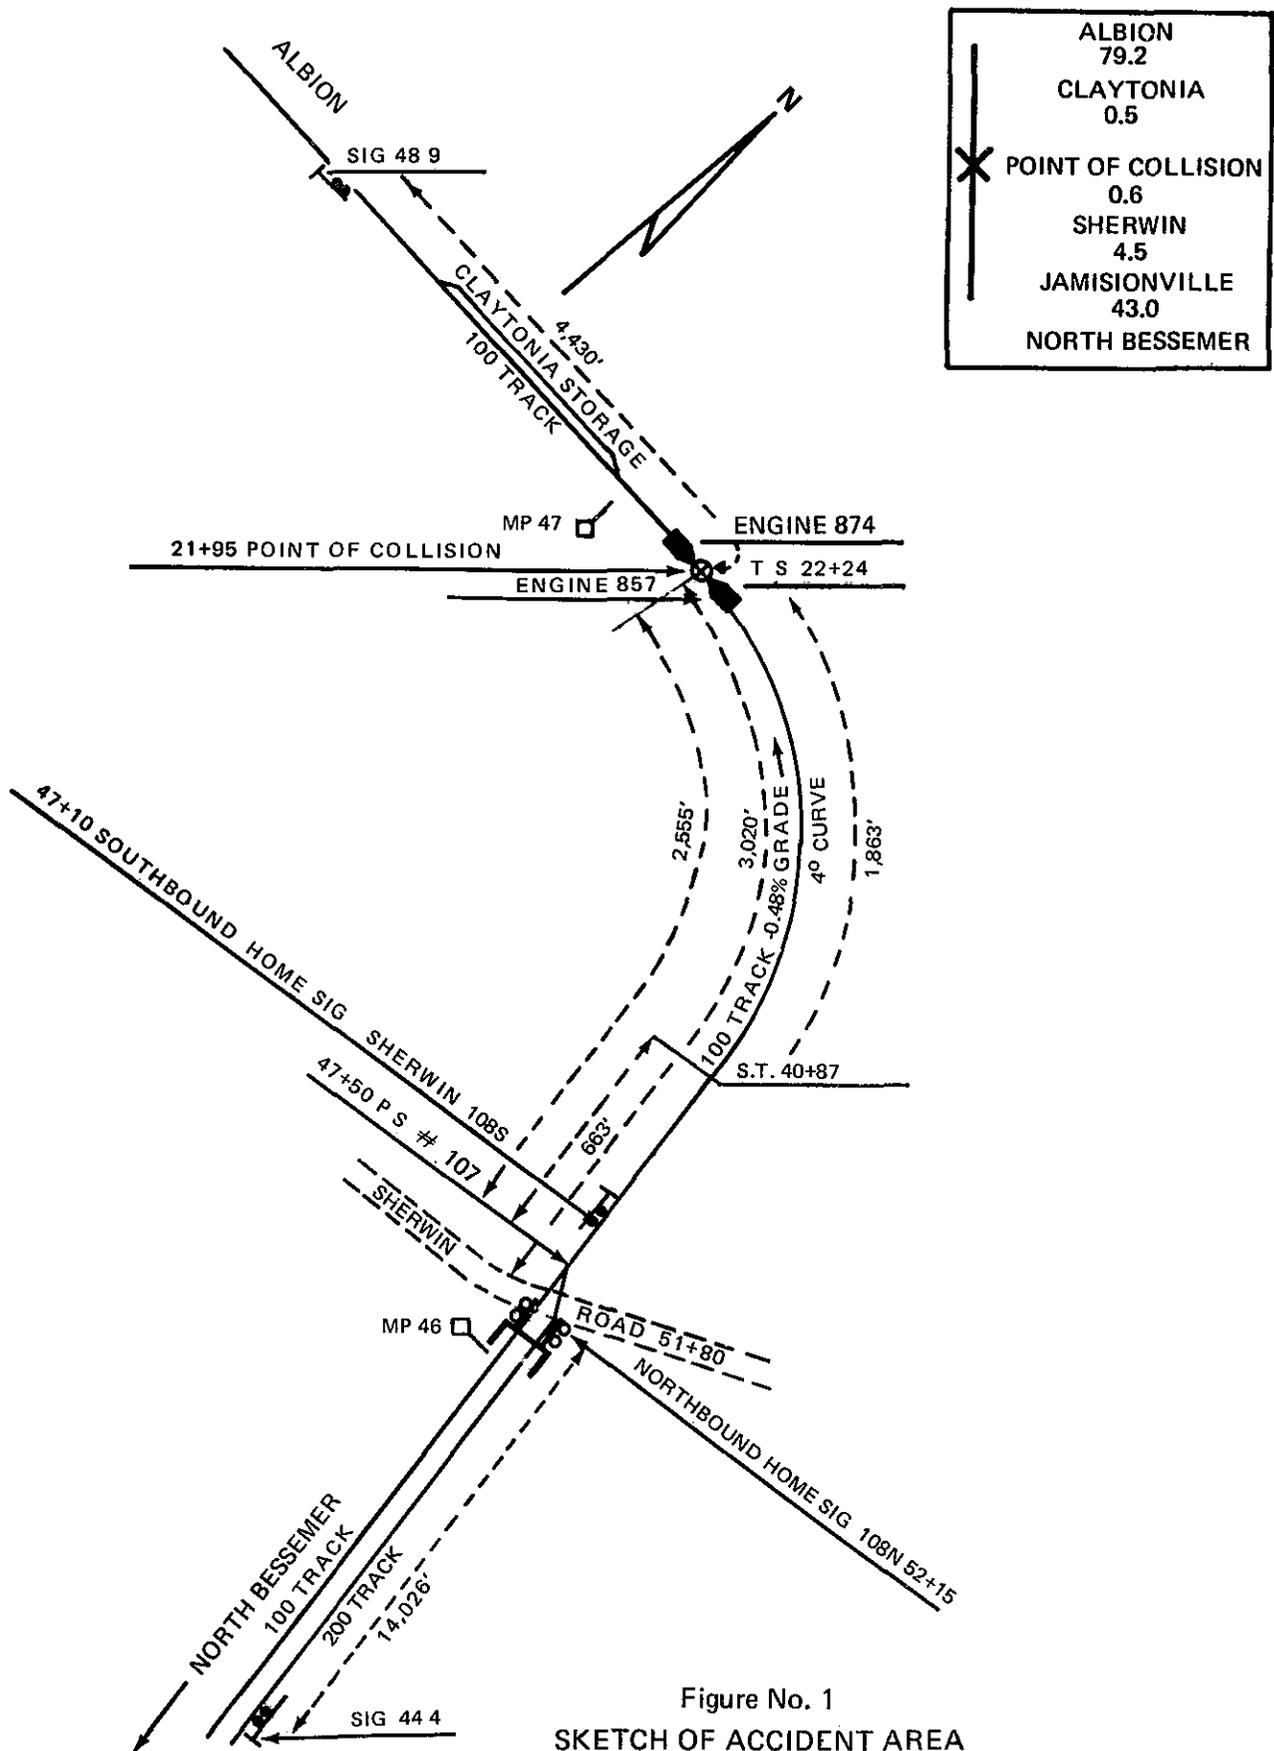
Figure No. 1
 SKETCH OF ACCIDENT AREA
 (Not to Scale)

From the south, on the main track, there is a tangent of 663 feet, a 4-degree curve to the left 1,863 feet to a tangent of 29 feet to the point of collision and a considerable distance beyond. (See figure 1.)

ALBION	79.2
CLAYTONIA	0.5
POINT OF COLLISION	0.6
SHERWIN	4.5
JAMISIONVILLE	43.0
NORTH BESEMER

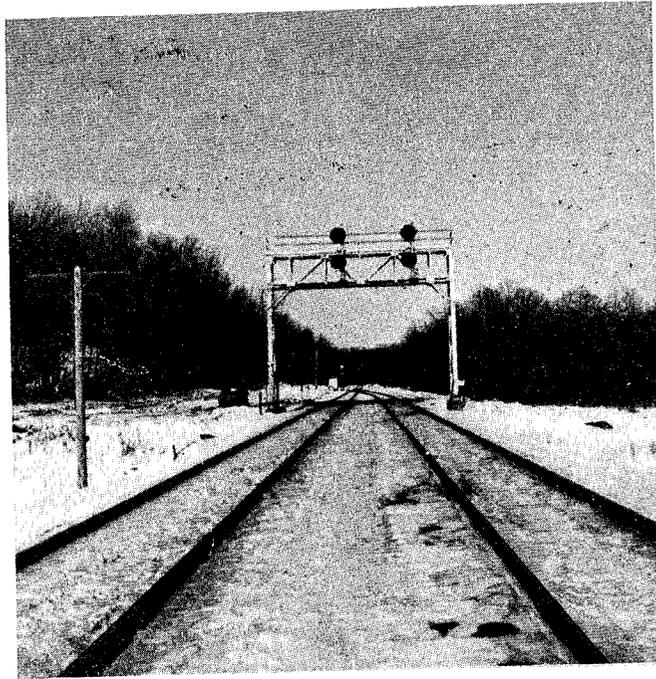
Extra 857 North proceeded north on track No. 200 from Jamisonville to Sherwin. The train continued north past Signal 108N, which displayed a stop indication, and onto track No. 100. (See figures 2 and 3.) It traveled approximately 3,020 feet from Signal 108N on a 0.48-percent descending

Figure 2. View of signal 108-N, and Sherwin Road Crossing.

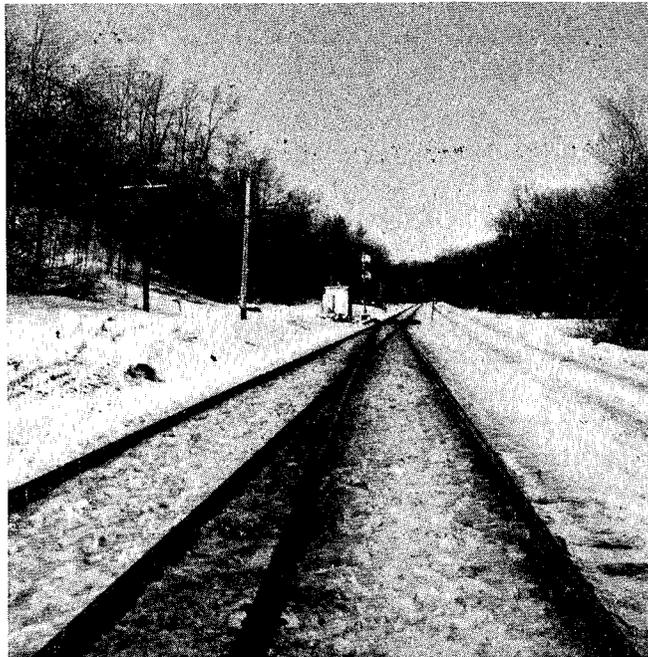
Figure 3. View of switch at Sherwin.
