INTERSTATE COMMERCE COMMISSION

REPORT OF THE DIRECTOR OF THE BUREAU OF SAFETY CONCERNING
AN ACCIDENT ON THE BOSTON & ALBANY RAILROAD AT
BOSTON, MASS., ON OCTOBER 13, 1932

December 12, 1932.

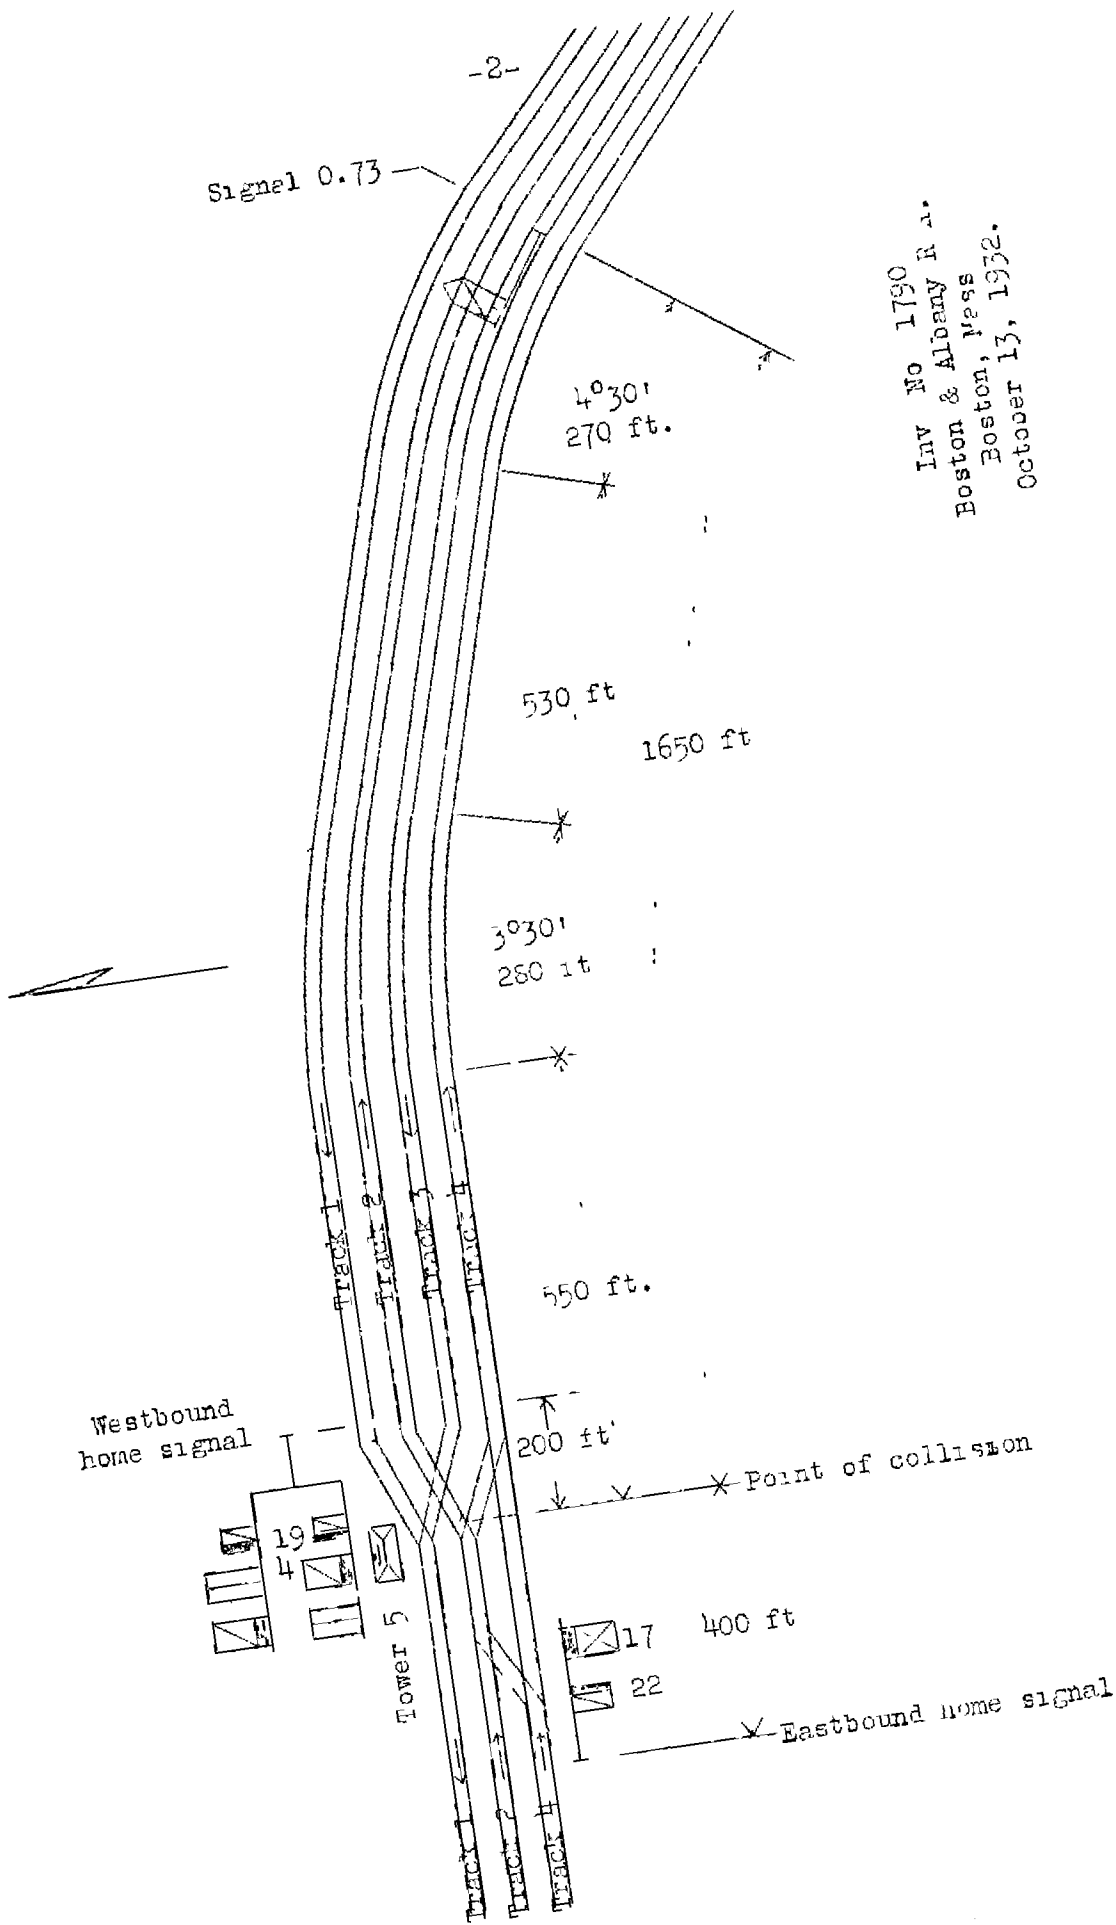
Inv No 1790
 Boston & Albany R.R.
 Boston, Mass
 October 13, 1932.

The lead end of the first coach struck the rear end of the tender of the switch engine approximately 75 feet west of the frog, resulting in the car being tipped on its right side on track 1. The tender of the switch engine telescoped the cab, the frame of the tender being swung around at right angles to the track. The lead end of the second car was derailed. None of the remaining equipment in either train was derailed. The employees injured were the engineman and fireman of the switch engine.

This accident was caused by the failure of Trainmen Kearns and Curry, of the equipment train, properly to observe and obey signal indications.

Under these provisions the speed of the equipment train should have been reduced to not more than $12\frac{1}{2}$ miles per hour at signal O.73, instead of doing so, however, Trainmen Kearns and Curry called the approach indication, failed to reduce speed, and then became engrossed in conversation and failed to observe the stop indication at the home signal until they had nearly reached it. It was then too late to avert the accident.

Attention has been called often to the necessity for taking positive action at the distant or caution signal location with a view to bringing the speed of a train under control and the rules of many railroads, including the Boston & Albany, now provide for the taking of such action. Rigid enforcement of a rule of this character would nearly eliminate the possibility of the occurrence of accidents of the kind involved in this case.
