REPORT NO. 3580
BOSTON AND ALBANY RAILROAD COMPANY
IN RE ACCIDENT
NEAR EAST CHATHAM, N. Y., ON
MAY 30, 1954

Date: May 30, 1954
Railroad: Boston and Albany
Location: East Chatham, N. Y.
Kind of accident: Derailment
Train involved: Passenger
Train number: 11
Engine number: Diesel-electric units 8220 and 8215
Consist: 6 cars
Speed: 49 m. p. h.
Operation: Signal indications
Tracks: Double; tangent; 0.79 percent
descending grade westward
Weather: Clear
Time: 8:50 p. m.
Casualties: 19 injured
Cause: Broken rail

Accident near East Chatham, N. Y., on May 30, 1954, caused
by a broken rail.

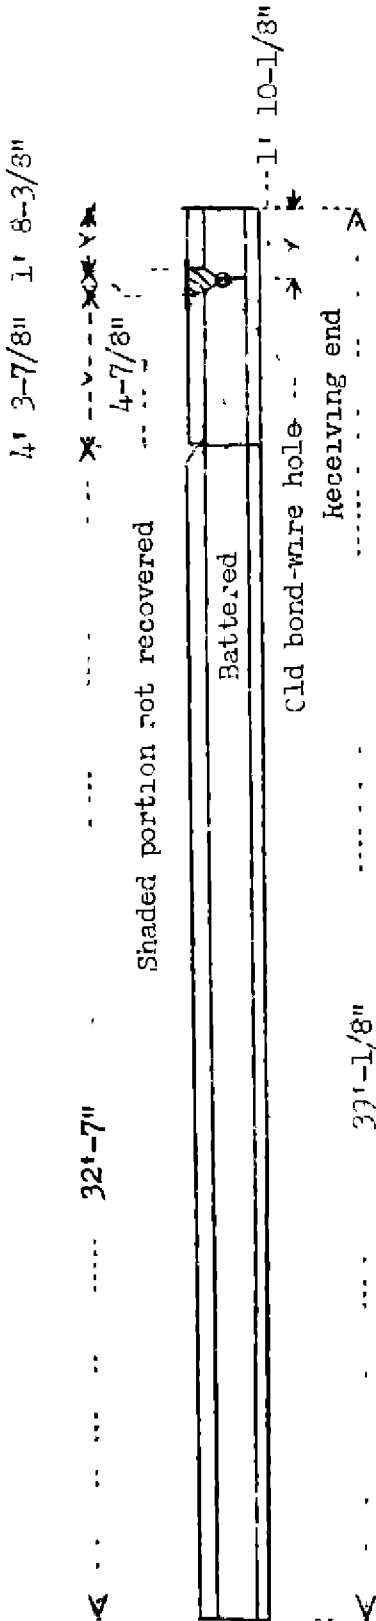
Sketch showing broken rail-north side of track

After the accident occurred a broken rail was found in the north side of track No. 1. This rail, which bore heat number PW-4365-A, was manufactured by the Bethlehem Steel Company, Lackawanna Plant, in June 1934. It was broken into several pieces, three of which were recovered. Fractures occurred at points, respectively, 1 foot 8-3/8 inches, 2 feet 1-1/4 inches, and 6 feet 5-1/8 inches west of the receiving end of the rail. The first fracture occurred between tie locations. It extended downward through the base of the rail from an old bond-wire hole in the web 1 foot 10-1/8 inches west of the receiving end of the rail, and diagonally upward from the bond-wire hole and through the head at a point 1 foot 8-3/8 inches from the end of the rail. The second fracture extended diagonally upward from the bond-wire hole and through the head of the rail at a point 4-7/8 inches west of the first fracture. The third fracture was a vertical break which extended through the head, web, and base of the rail. Examination of the rail disclosed that prior to the time of the accident transverse fissures had existed at the points where the first and third breaks occurred. These fissures, which did not extend to the surface, covered 60 percent and 10 percent, respectively, of the cross-sectional area of the head. The triangular portion of the rail between the first and second fractures was not recovered. The portion of rail between the second and third fractures was dislodged from the track and was found approximately 200 feet west of its original location. The east ends of both this portion of rail and the portion immediately west of it were battered. Apparently after the first break occurred the broken end was struck by the wheels of a west-bound train with sufficient force to cause the other breaks. The derailment occurred after a section of the rail was dislodged as the forward portion of No. 11 was passing over it.
