NATIONAL TRANSPORTATION SAFETY BOARD

RAILROAD ACCIDENT REPORT

HEAD-ON COLLISION OF
BOSTON & MAINE CORPORATION
EXTRA 1731 EAST AND
MASSACHUSETTS BAY TRANSPORTATION AUTHORITY
TRAIN NO. 570
ON FORMER BOSTON & MAINE CORPORATION TRACKS
BEVERLY, MASSACHUSETTS
AUGUST 11, 1981

NTSB-RAR-82-1

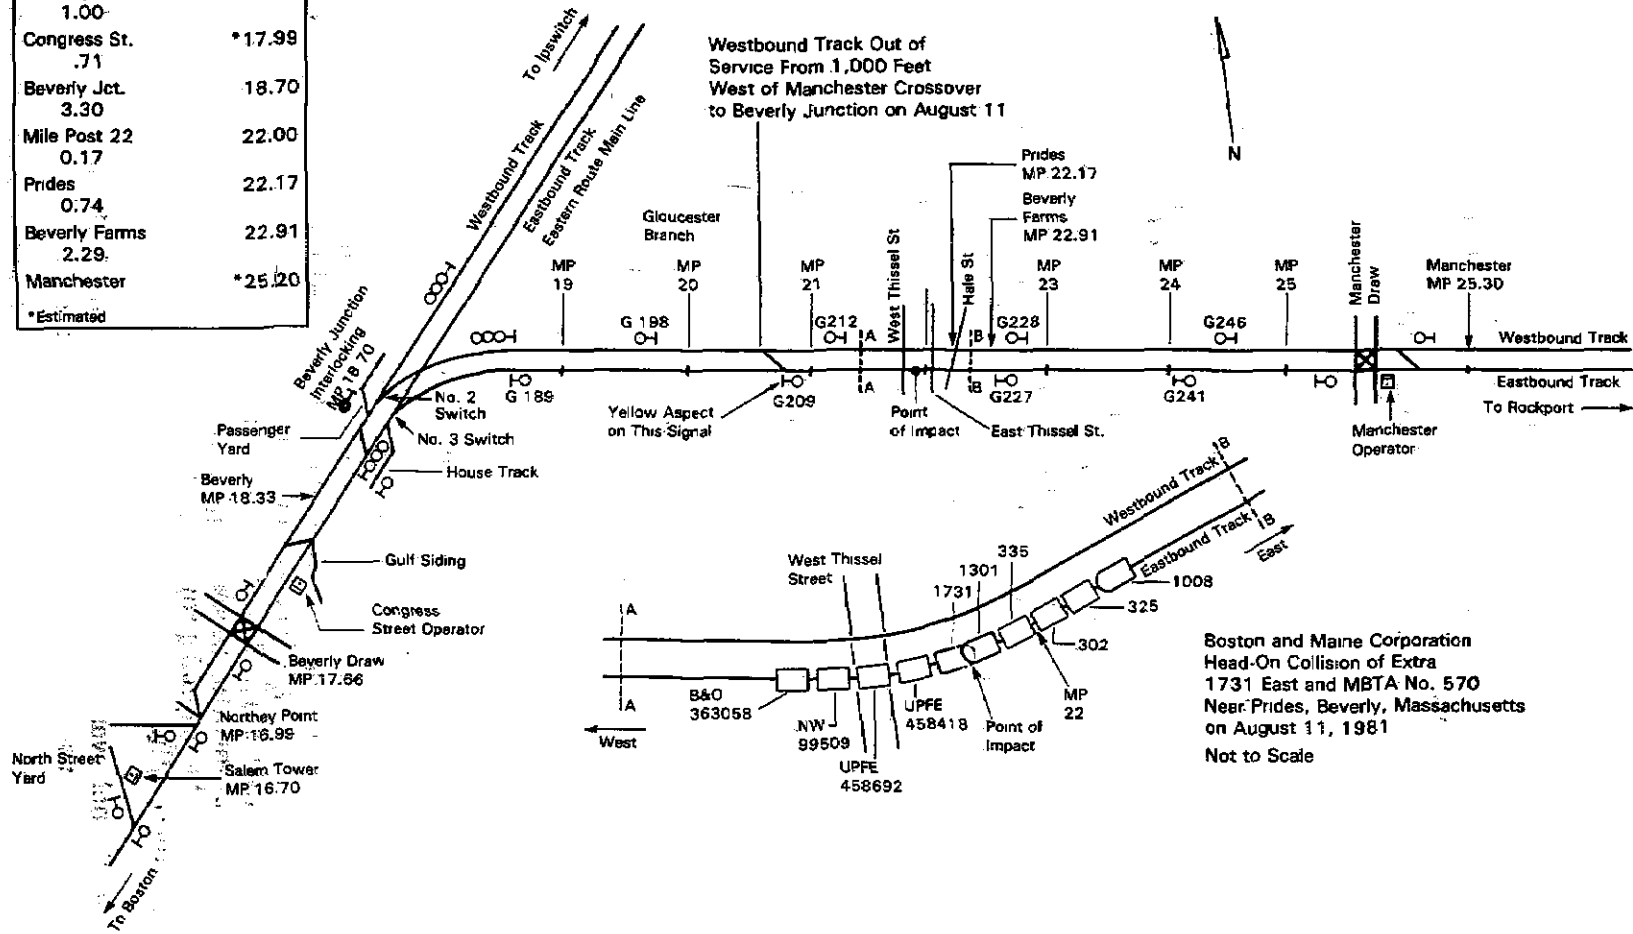
Figure 1.—Plan view of accident site.

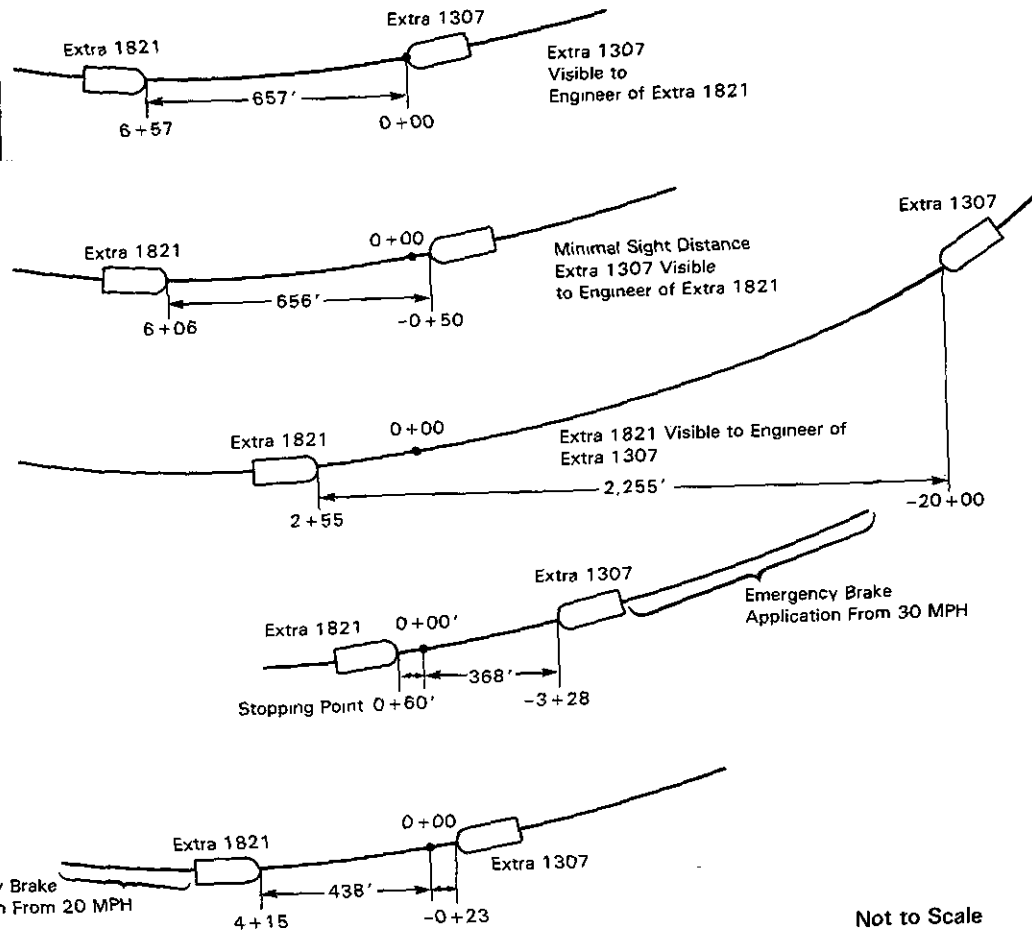
Figure 3.—Summary of data from sight distance tests.

The sight distance and stopping tests indicated that the engineers of the two trains saw each other at about the maximum available sight distance. The points at which sand was first observed on the rails placed the two trains about 750 feet apart when the brakes were applied, and the sand on the rails is an indication that the brakes of each train were applied in emergency. Also, the conductor of No. 570 said he felt the brakes applying, and the speed indications shown on the speed tapes indicated that the speed of the two trains had reduced. The sight distance was limited because Extra 1731 East was in the 2° curve and the trains were out of sight of each other. Whether or not the brakes functioned effectively, the trains could not have stopped in the distance available to them. Each engineer made an effort to stop as evidenced by the emergency brake application. It is questionable whether either engineer heard the whistle from the other train.
