REPORT NO. 1943

Railroad: Boston and Maine
Date: November 9, 1954.
Location: Ayer, Mass.
Kind of accident: Head-end collision
Trains involved: Passenger and passenger
Casualties: 1 killed; 15 injured
Summary of facts: Train overran stop signal and col-
lided with another train making
cross-over movement.
Cause of accident: Failure of engineman to obey signal
indications.

INTERSTATE COMMERCE COMMISSION

REPORT OF THE DIRECTOR OF THE BUREAU OF SAFETY CONCERNING
AN ACCIDENT ON THE BOSTON AND MAINE RAILROAD AT AYER,
MASS., ON NOVEMBER 9, 1934.

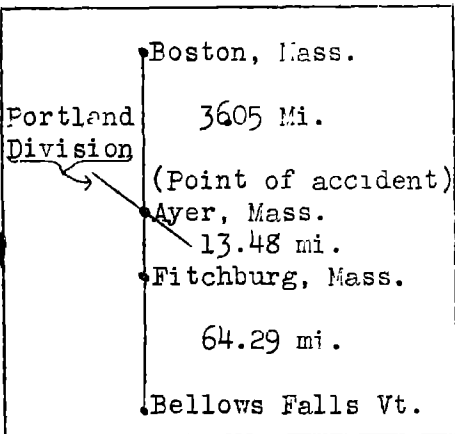
Inv. No. 1943
Boston & Maine R.R.
Ayer, Mass.
Nov. 9, 1934

This accident occurred on that part of the Fitchburg Division extending between Bellows Falls, Vt., and Ayer, Mass., a distance of 77.77 miles; in the vicinity of the point of accident this is a double-track line over which trains are operated by time table, train orders, an automatic block-signal system, and an automatic train-stop system with 2-indication cab signals, the latter being of the continuous-inductive type. At Ayer the Portland Division intersects the Fitchburg Division and trains from the former division cross the Fitchburg Division tracks through a series of cross-overs and wye tracks. The accident occurred within interlocking limits on the west-bound main track of the Fitchburg Division, at a point 845 feet east of the east end of the station. Approaching this point from the west on the Fitchburg Division, there is a $2^{\circ}30'$ curve to the right 1,130 feet in length and tangent track for a distance of 1,720 feet, followed by a $2^{\circ}04'$ curve to the right 1,215 feet in length, the accident occurring on this latter curve at a point 507 feet from its western end. The grade is level at the point of accident.

The interlocking plant is of the electro-pneumatic type; the signals involved are automatic signal 370 and interlocking signals R-10 and R-30, located on the Fitchburg Division at points 6,380 feet, 1,987 feet and 424 feet, respectively, west of the point of accident, and interlocking signal L-40 located on the Stony Brook Branch of the Portland Division 606 feet east of the point of accident. Signal 370 is of the 2-arm, 2-position, lower-quadrant type, and operating in conjunction
