INTERSTATE COMMERCE COMMISSION,  
WASHINGTON

-----  
ACCIDENT ON THE  
BOSTON & MAINE RAILROAD

-----  
CLAREMONT JUNCTION, N.H.

-----  
INVESTIGATION NO. 2051

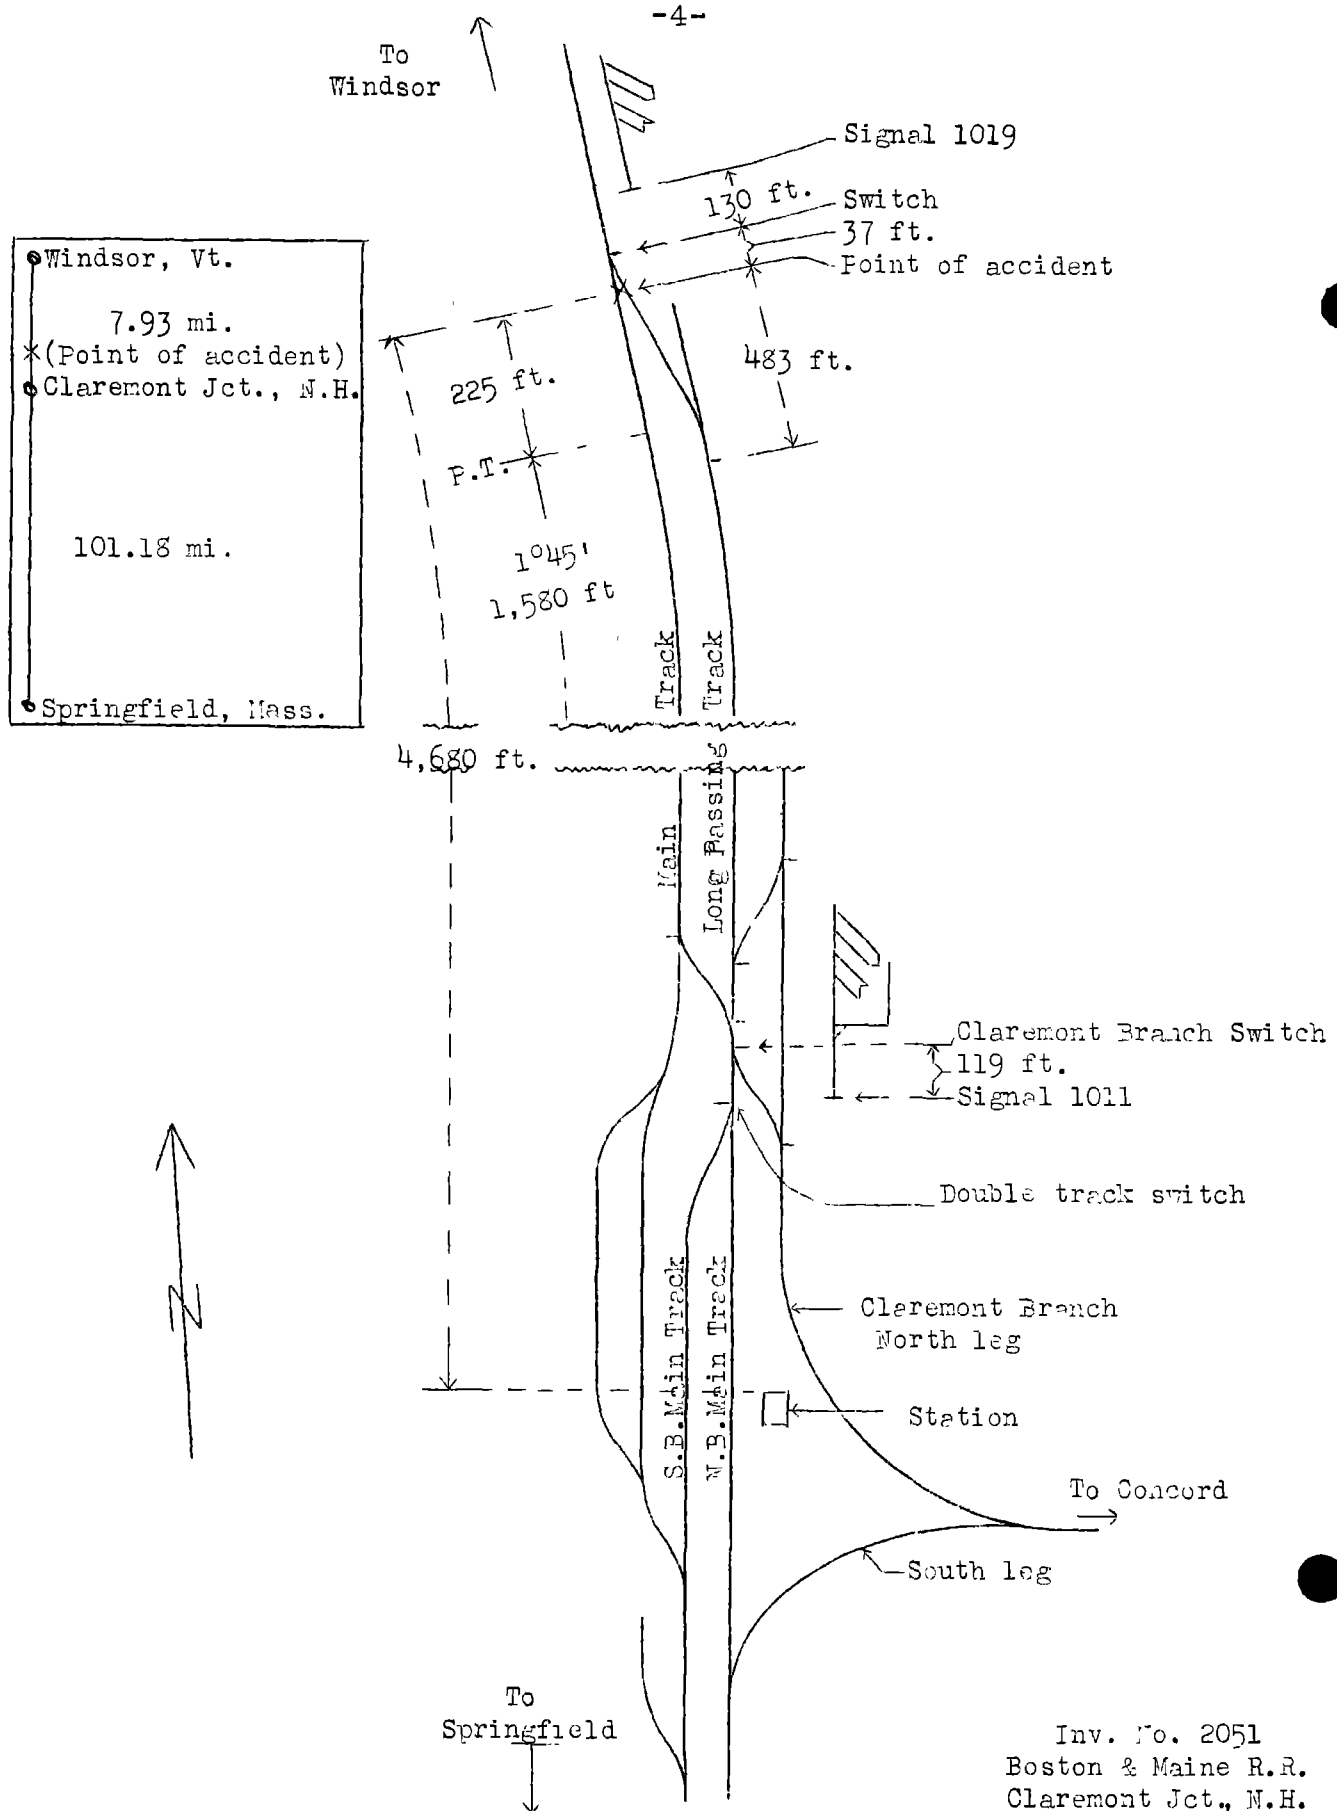
Inv. No. 2051  
Boston & Maine R.R.  
Claremont Jct., N.H.  
March 12, 1936.

The station at Claremont Junction is located in the north angle of a wye east of the main track. A passing track about 4,000 feet long parallels the main track on the east, the south switch of which is located approximately 900 feet north of the station; due to an extension on the north end of the passing siding, the connection with the main track at this point is made through a cross-over. The north leg of the wye connects with the main track through a cross-over located about 650 feet north of the station; northbound automatic block-signal 1011, governing main track movements, is located on the east side of the tracks 119 feet south of the north switch of this cross-over and between its switches; automatic block-signal 1019 is located 4,300 feet north of signal 1011 and 130 feet north of the main line switch at the north end of the passing track.
