INTERSTATE COMMERCE COMMISSION

REPORT OF THE DIRECTOR

ACCIDENT ON THE
BOSTON & MAINE RAILROAD

EAST SOMERVILLE, MASS.

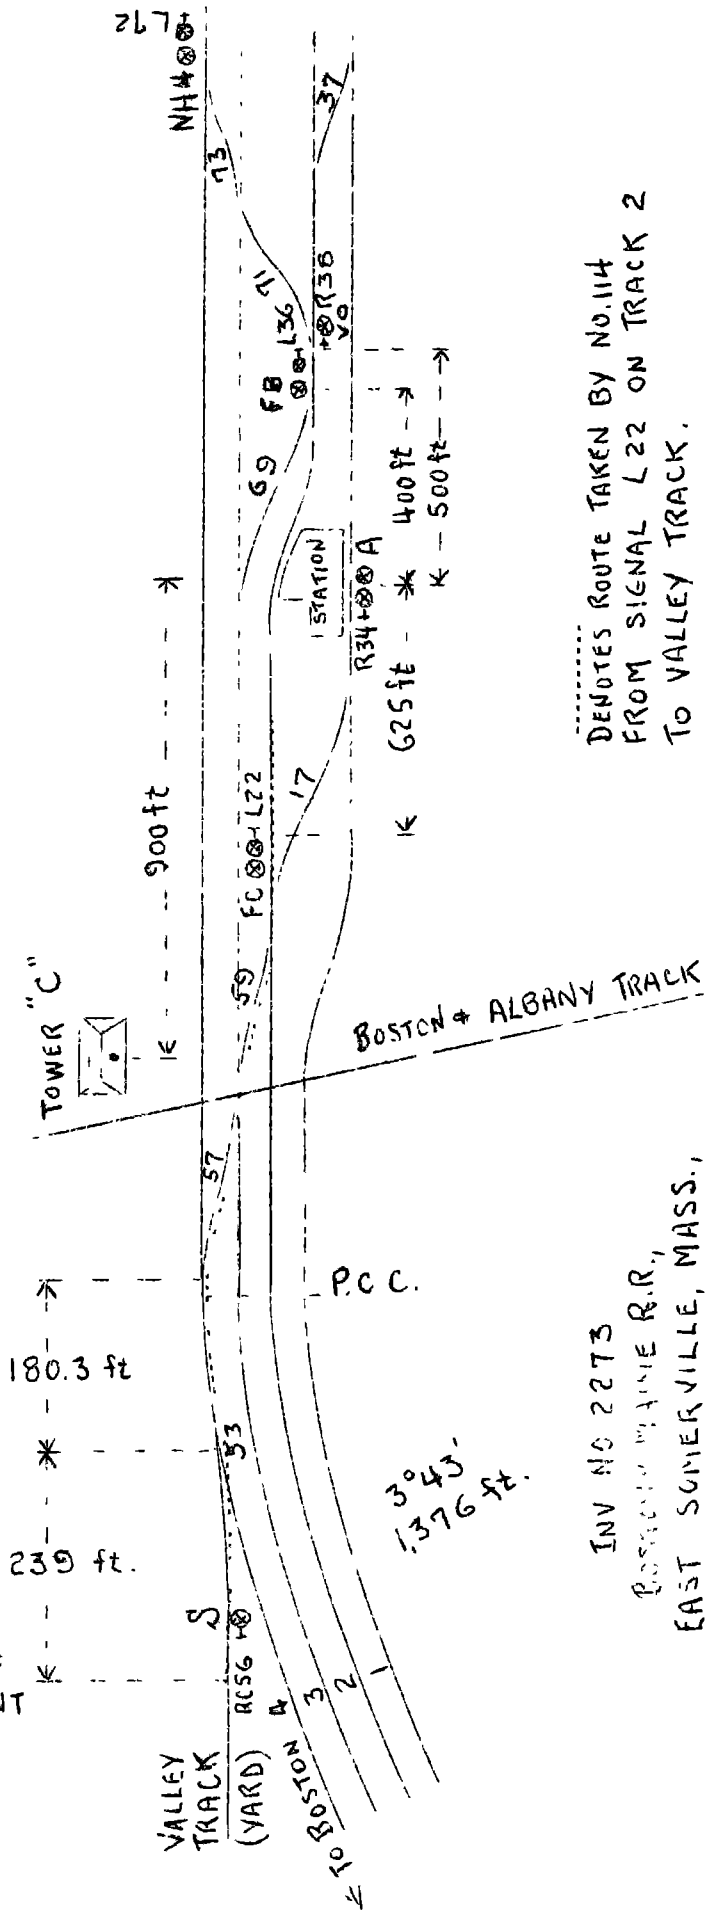
INV NO 2273
BOSTON & ALBANY R.R.,
EAST SOMERVILLE, MASS.,
MAY 31, 1938.

POINT OF
ACCIDENT

DENOTES ROUTE TAKEN BY NO. 114
FROM SIGNAL L22 ON TRACK 2
TO VALLEY TRACK.
