INVESTIGATION NO. 2876  
BOSTON AND MAINE RAILROAD  
REPORT IN RE ACCIDENT  
NEAR EAST PORTAL, MASS., ON  
MARCH 17, 1945

April 28, 1945.

Accident near East Portal, Mass., on March 17, 1945, caused  
by a false clear signal indication, as a result of  
sand on rails.

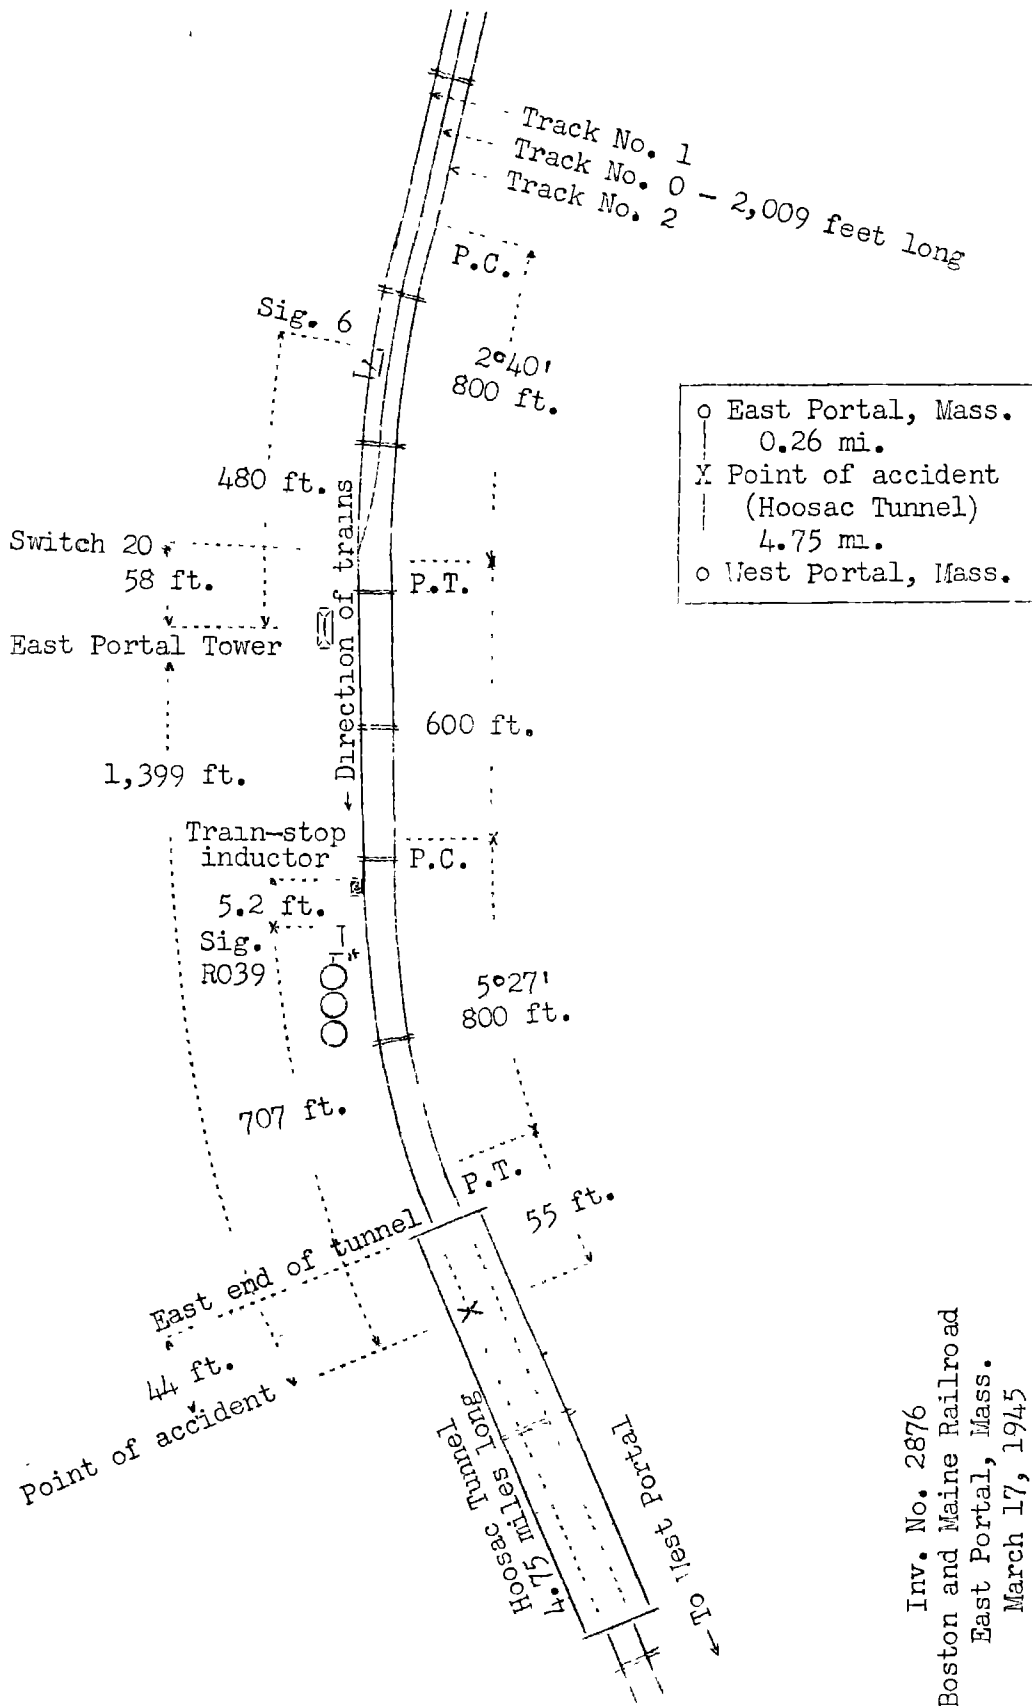
Inv. No. 2876  
Boston and Maine Railroad  
East Portal, Mass.  
March 17, 1945

This accident occurred on that part of the Fitchburg Division extending westward from East Portal to West Portal, Mass., 5.01 miles, a double-track line equipped with an overhead catenary system for the electric propulsion of trains and extending through Hoosac Tunnel, 4.75 miles in length. The tracks are designated, from north to south, as track No. 1 and track No. 2. Trains are operated in either direction on these tracks by signal indications and an automatic train-stop system. The accident occurred on track No. 1 at a point 44 feet west of the eastern end of Hoosac Tunnel and 1,399 feet west of the tower at East Portal. From the east on track No. 1 there are, in succession, a 2°40' curve to the left 800 feet in length, a tangent 600 feet, a 5°27' curve to the left 300 feet and a tangent 55 feet to the point of accident and a considerable distance westward. The grade is 0.43 percent ascending westward.

Within interlocking limits at East Portal an auxiliary track 2,009 feet long and designated as track No. 0, is between track No. 1 and track No. 2 and parallel to them. Switch 20, which connects the west end of track No. 0 and track No. 1, is 58 feet east of the tower.

Interlocking signal 6, governing west-bound movements from track No. 0 through switch 20 to track No. 1, and interlocking signal 39, governing west-bound movements entering Hoosac Tunnel on track No. 1, are, respectively, 1,879 feet and 707 feet east of the point of accident. Signal 6 is a dwarf signal of the one-arm, lower-quadrant, semaphore type, and signal RO 39 is of the color-light type. The involved night aspects, and corresponding indications and names of these signals are as follows:
