INTERSTATE COMMERCE COMMISSION

ACCIDENT ON THE

BOSTON AND MAINE RAILROAD

INVESTIGATION NO. 2098

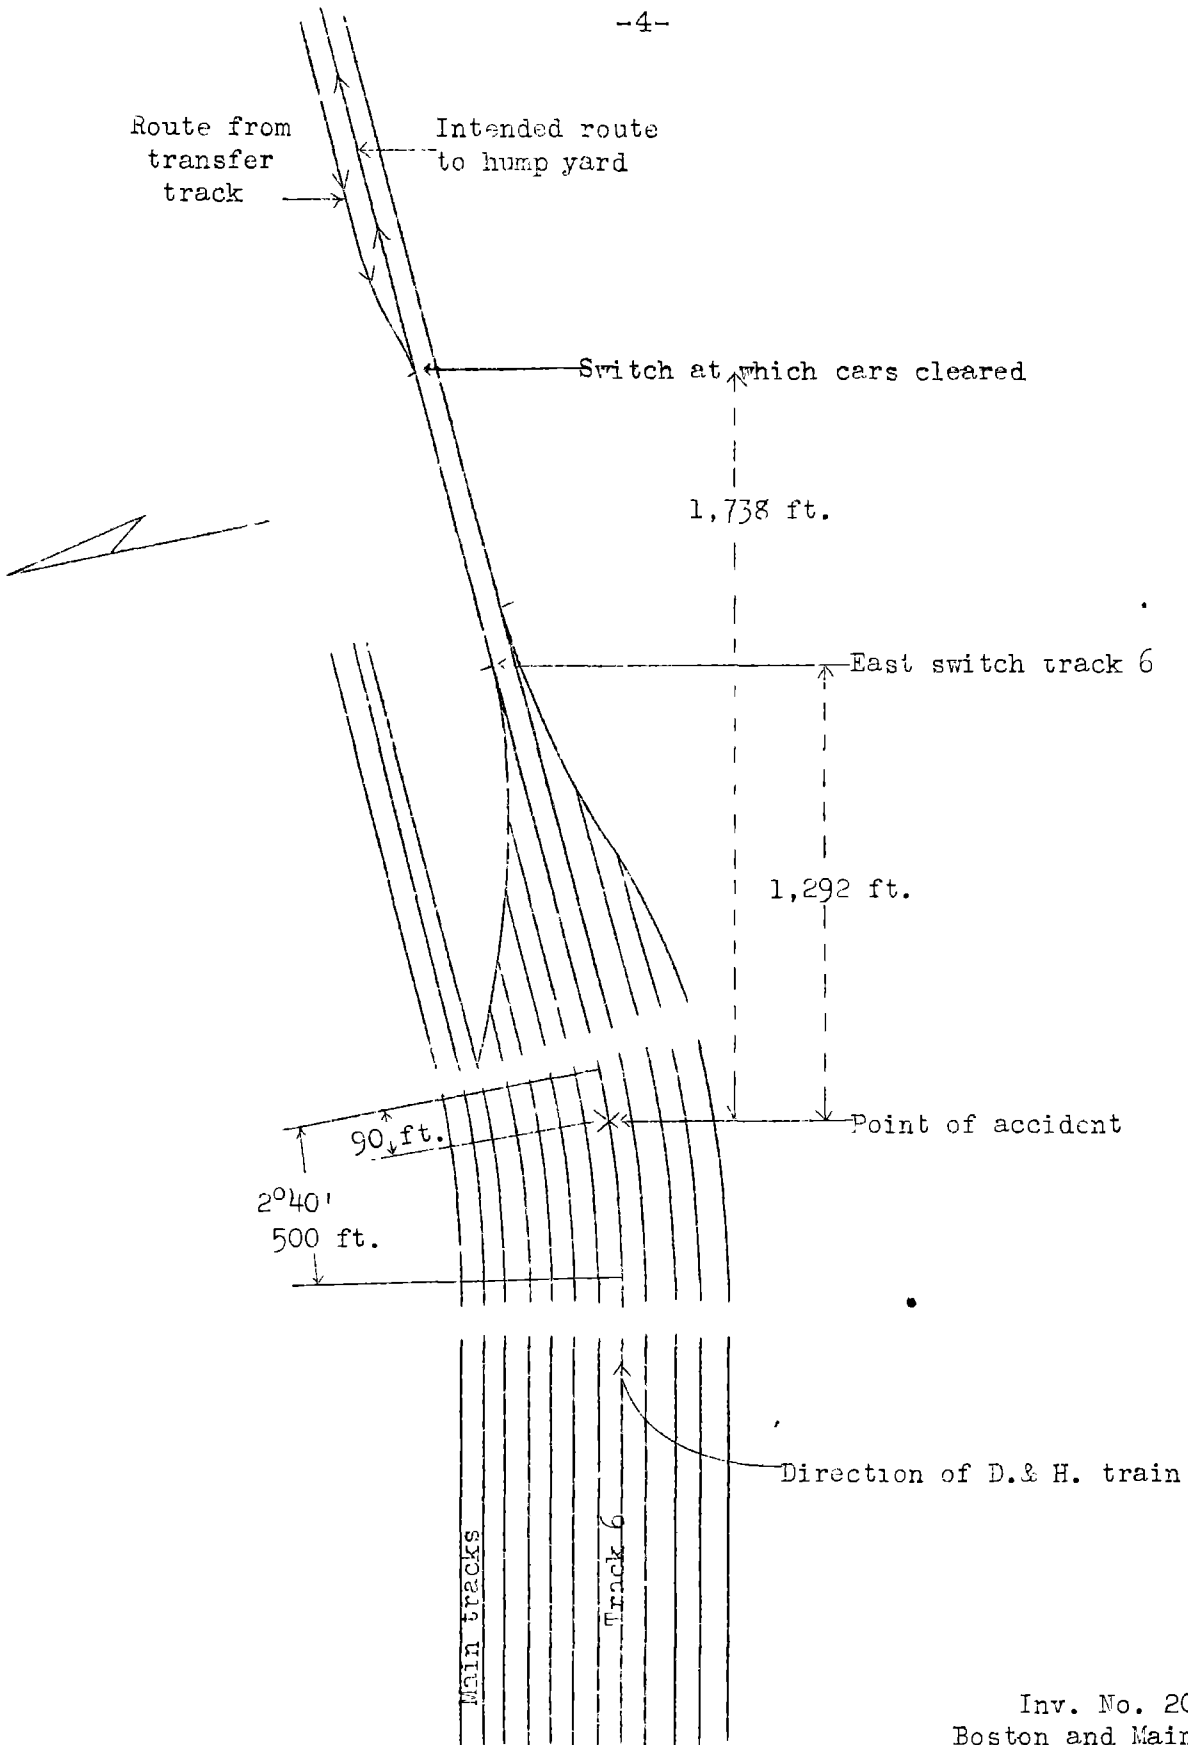
Inv. No. 2098
Boston and Maine R.R.
Mechanicville, N. Y.
September 14, 1936.

10 tracks numbered consecutively from north to south. The accident occurred on track 6, which is 3,570 feet in length, at a point 1,292 feet from its eastern end. Approaching from the west this track is tangent for a distance of 1,362 feet, followed by a 2°40' curve to the left 500 feet in length, the accident occurring on this curve at a point 92 feet from its eastern end. The grade is 0.52 percent descending east-bound.
