ACCIDENT ON THE
BOSTON & MAINE RAILROAD

SOMERVILLE, MASS.

JUNE 9, 1937

INVESTIGATION NO. 2179

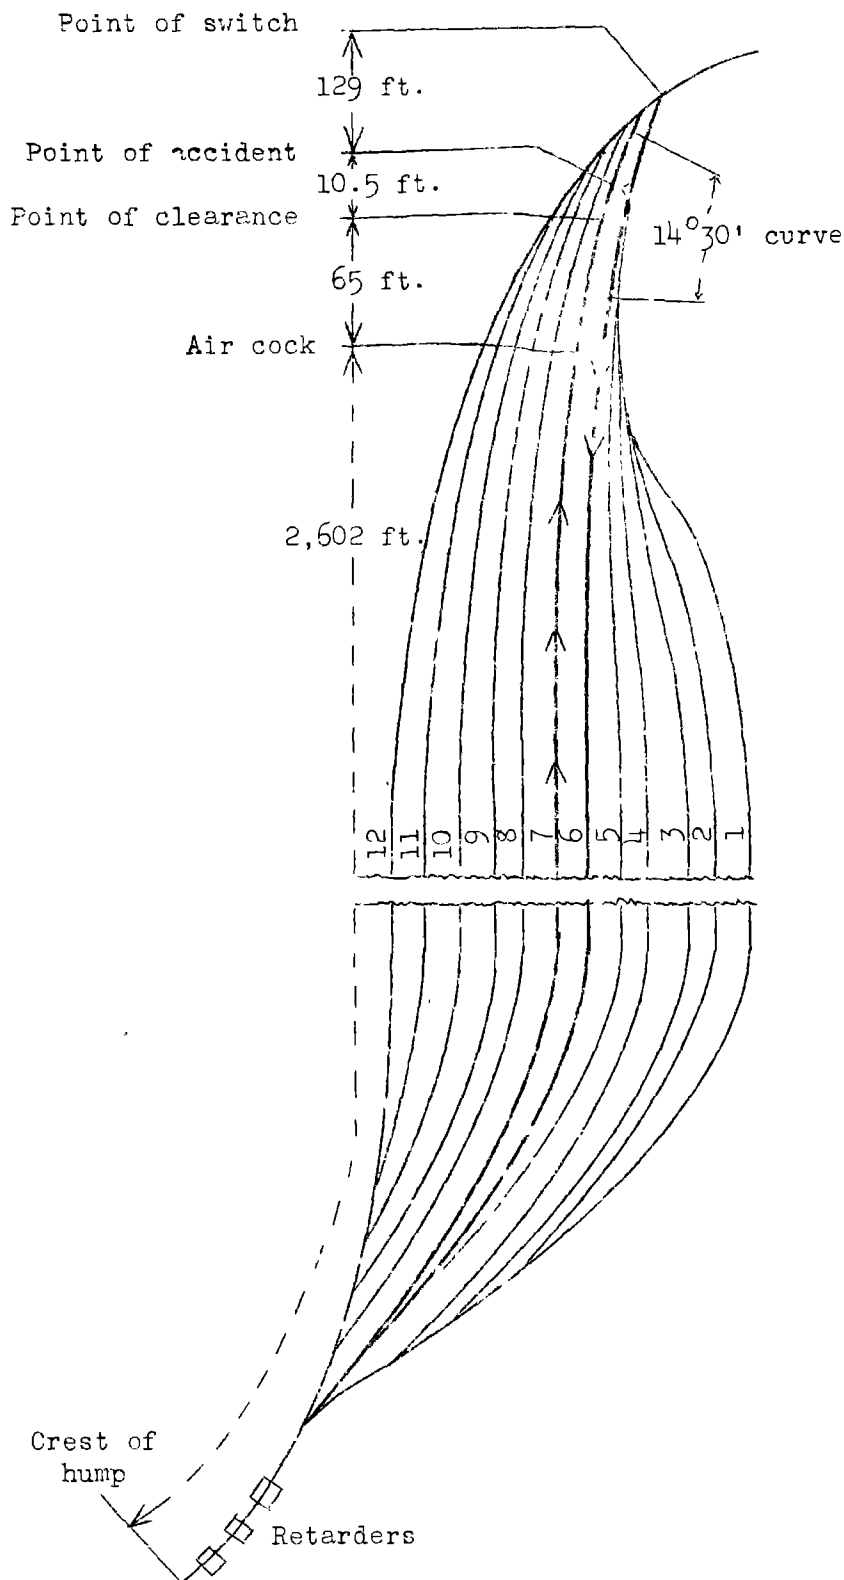
Inv. No. 2179
Boston & Maine R.R.
Somerville, Mass.
June 9, 1937

Switch engine 647, headed east, in charge of Yard Foreman O'Riordan and Engineman Fletcher, moving at a speed of about 6 miles per hour, was engaged in shoving 14 cars into the east end of track 6 when it was struck on the left side by a cut of cars which had been standing at the east end of track 7, but which were moved beyond the clearance point by the impact of another cut of cars striking against them from the west.

Two pairs of driving wheels of the locomotive were derailed, and the first car on track 7 was raised off the rails, and slightly damaged. The left side of the tender was lightly scored and the left side of the engine cab was torn off.
