INVESTIGATION NO. 3084
BOSTON AND MAINE RAILROAD
REPORT IN RE ACCIDENT
AT SPRINGFIELD, MASS., ON
MARCH 15, 1947

BOSTON AND MAINE RAILROAD

April 25, 1947

Accident at Springfield, Mass., on March 15, 1947, caused
by failure properly to control the speed of the
following train in accordance with signal indication.

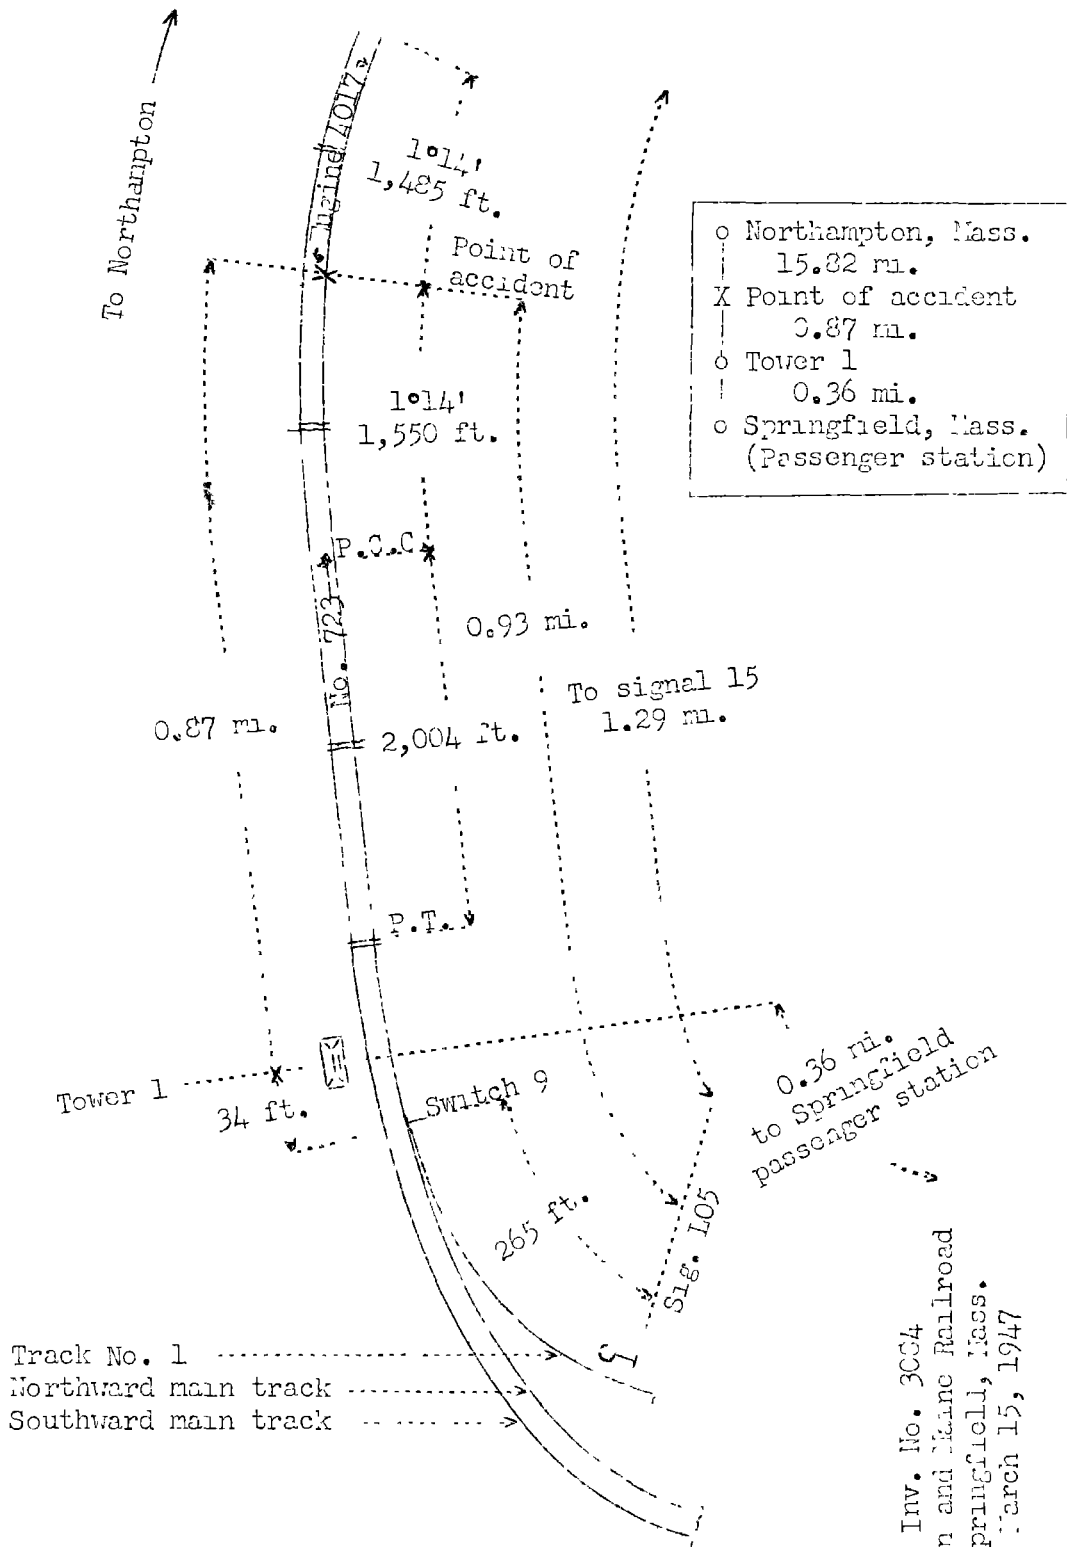
Inv. No. 3084
 Boston and Maine Railroad
 Springfield, Mass.
 March 15, 1947

This accident occurred on that part of the Fitchburg Division extending between Springfield and Northhampton Mass., 17.05 miles, a double-track line over which trains moving with the current of traffic are operated by timetable, train orders and an automatic block-signal system. Within interlocking limits at Springfield a connecting track, extending from the southeast and designated as track No. 1, connects the B. & M. northward main track and an auxiliary track of the New York, New Haven and Hartford Railroad. This track is used by B. & M. trains and engines en route northward from the passenger station or the engine house at Springfield to the B. & M. main tracks. The connecting switch of the northward main track and track No. 1 is designated as switch 9 and is 34 feet south of Lobby 1, hereinafter referred to as Tower 1. Tower 1 is 0.36 mile north of the passenger station. The accident occurred on the northward main track within yard limits at Springfield, at a point 0.87 mile north of Tower 1. From the south on the northward main track there is a tangent 2,004 feet in length, then a compound curve to the right, the maximum curvature of which is 1°14', 1,550 feet to the point of accident and 1,485 feet northward. At the point of accident the curvature is 1°02'. The grade is practically level.

Semi-automatic signal L05 governs north-bound movements from track No. 1, through switch 9 to the northward main track, thence on the northward main track to automatic signal 15, 1.29 miles northward. It is 265 feet south of switch 9 and 0.93 mile south of the point of accident, and is of the single-unit, 4-indication, color-light type. The involved aspects and corresponding indications and names are as follows:
