**RAILROAD ACCIDENT INVESTIGATION**

**Report No 3779**

BOSTON AND MAINE RAILROAD

MEDFORD, MASS

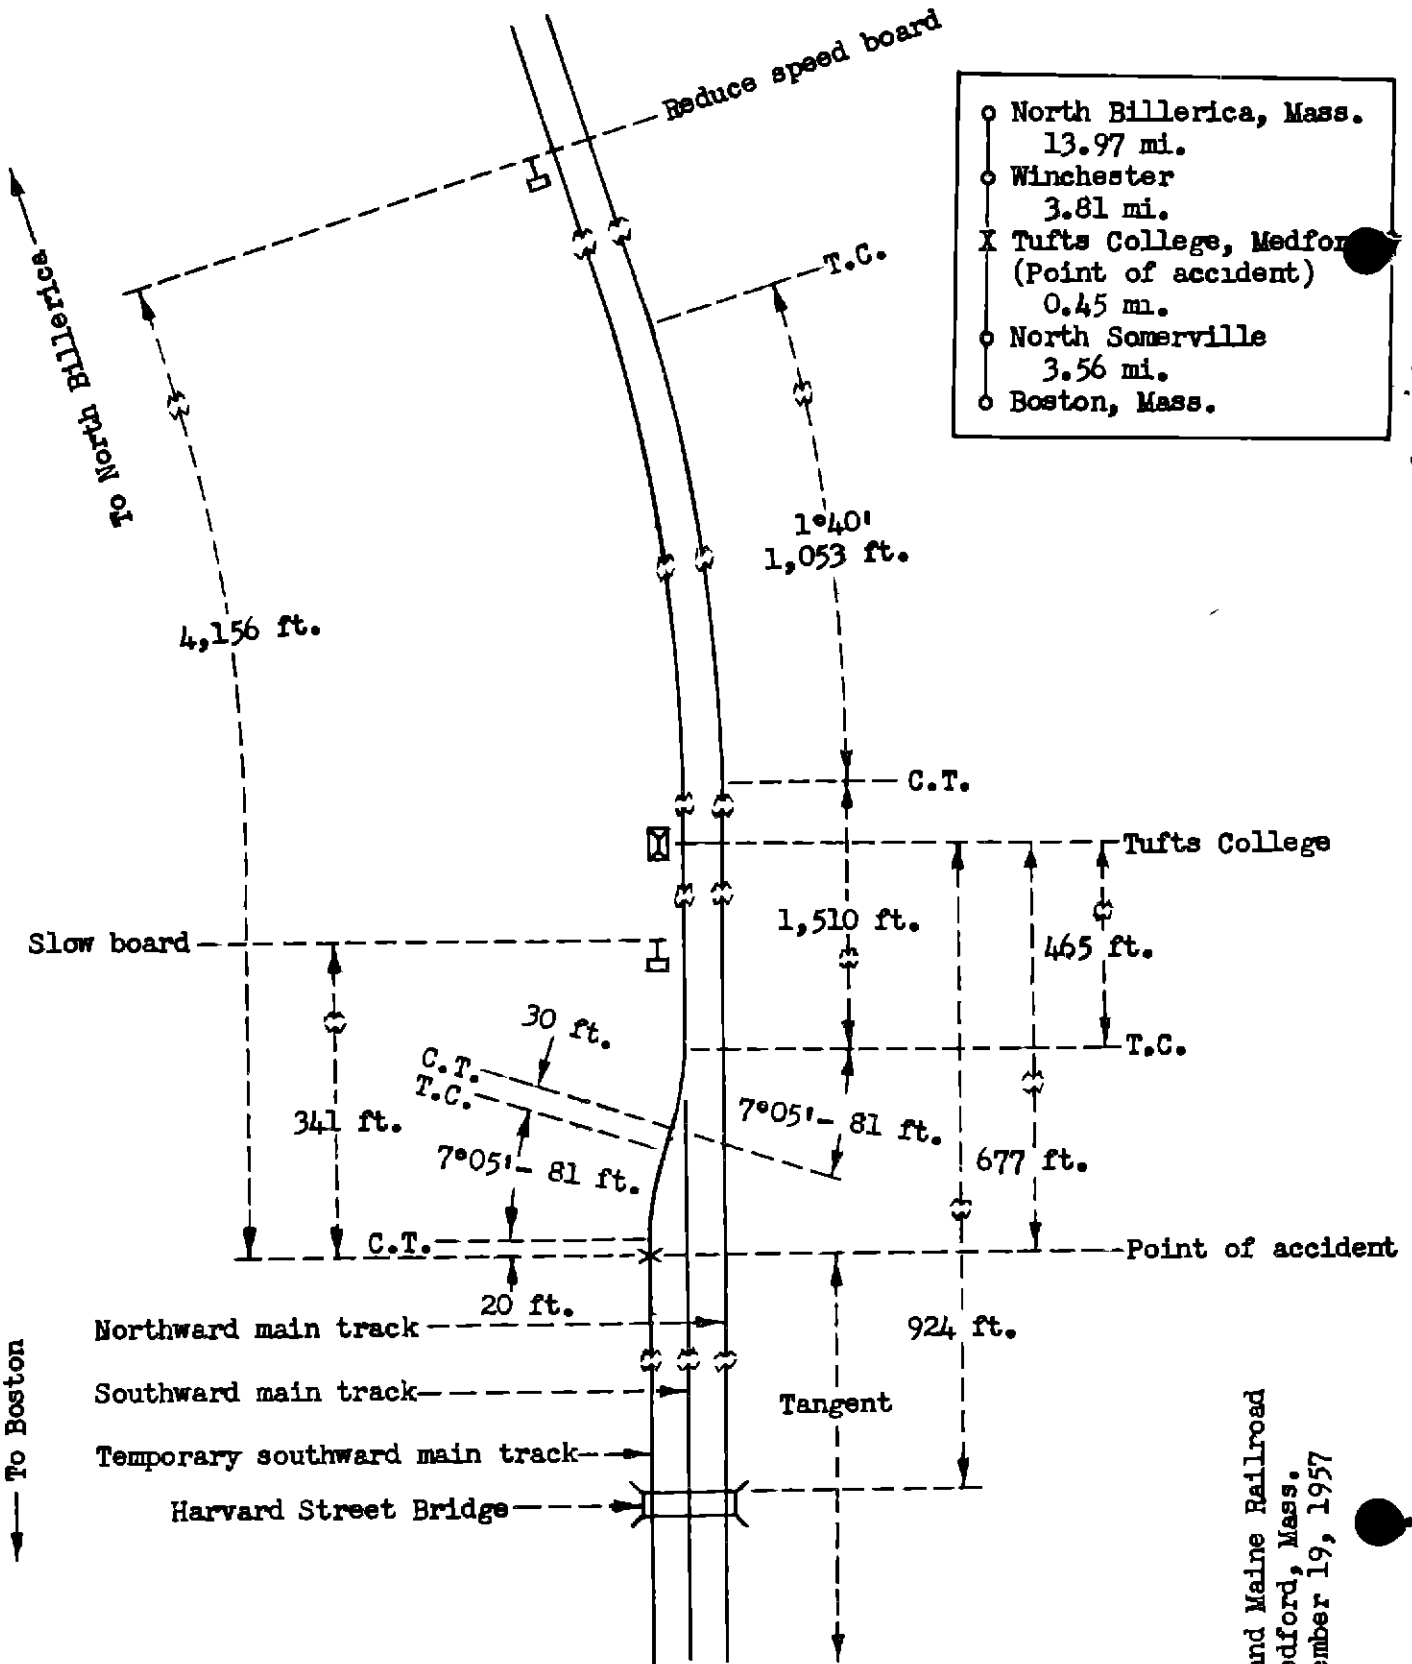
Boston and Maine Railroad  
 Medford, Mass.  
 November 19, 1957

at a speed of 57 miles per hour as indicated by the tape of the speed-recording device, the locomotive, the first six cars, and the front truck of the seventh car were derailed immediately after entering the temporary southward main track at a point 677 feet south of Tufts College Station.

Separations occurred between the diesel-electric units, and at both ends of the second to the sixth cars, inclusive. The first diesel-electric unit stopped on its right side with the front end on top of the south abutment of the bridge and the rear end on Harvard Street. The second diesel-electric unit and the first car struck and demolished a portion of a brick building adjacent to the track. The second diesel-electric unit and the first car stopped parallel to and about 25 feet west of the siding with the front end of the unit about 230 feet south of the point of derailment. The second and third cars stopped across the tracks. The other derailed cars stopped on or near the track structure. The first to the third cars, inclusive, were destroyed. The diesel-electric units and the fourth to the sixth cars, inclusive, were heavily damaged. The seventh car was slightly damaged.

The track structure of the temporary southward main track was destroyed throughout the distance extending from the south end of the connection to Harvard Street Bridge. Examination of the rails recovered after the accident occurred disclosed that the west rail of the temporary southward main track immediately south of the south compromise joint was bowed outward at the north end throughout a distance of 8 feet. Marks on the track structure indicated that the derailment occurred at that location.
