REPORT NO. 3600
BOSTON AND MAINE RAILROAD
IN RE ACCIDENT
AT NASHUA, N. H., ON
NOVEMBER 12, 1964

Accident at Nashua, N. H., on November 12, 1954, caused by
excessive speed on a curve.

Report No. 3600
Boston and Maine Railroad
Nashua, N.H.
November 12, 1954

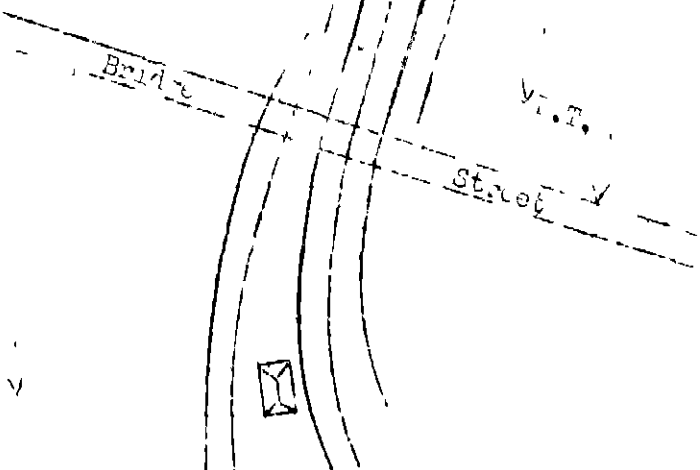
Location of Accident and Method of Operation

Point of accident

This accident occurred on that part of the New Hampshire Division extending between Concord, N. H., and South Lowell, Mass., 50.0 miles. In the vicinity of the point of accident this is a double-track line, over which trains moving with the current of traffic are operated by timetable, train orders, and an automatic block-signal system. The main tracks from west to east are designated as southward main track and northward main track. At Nashua Union Station, 34.36 miles south of Concord, auxiliary tracks parallel the southward main track on the west, and a siding and an auxiliary track, from west to east in the order named, parallel the northward main track on the east. A three-track through-truss bridge, 117 feet in length, spans the Nashua River at a point 1,279 feet north of the station. The accident occurred on the southward main track at a point 281 feet south of the south end of the bridge. From the north on the southward main track there are, in succession, a tangent 2,050 feet, a 1° curve to the left 345 feet, a tangent 429 feet, a 3°08' curve to the right 309 feet, a tangent 117 feet over the bridge, and a compound curve to the right, having a maximum curvature of 6°35', 281 feet to the point of accident and 423 feet southward. The grade in the vicinity of the point of accident is practically level.

A diamond-shape speed restriction sign 26 inches long and 20 inches high, which bears the numerals "30" in 8-inch black figures on a yellow background, is located 3,040 feet north of the point of accident. Reflector buttons are provided in the numerals. This sign is approximately 7 feet above ground level and is mounted on a post about 25 feet west of the center-line of the southward main track.

Examination of the track after the accident disclosed that the first mark on the track structure was a flange mark inside the east rail 281 feet south of the south end of the bridge. The east rail on the curve was canted outward beginning at a point about 320 feet south of the bridge. The rail at this point was bent, and the general derailment occurred approximately 75 feet southward. Apparently the train entered the curve at approximately overturning speed, and the sequence in which the equipment became derailed could not be determined. The southward main track was destroyed throughout a distance of approximately 490 feet, and the northward main track and adjacent auxiliary tracks in the immediate vicinity were damaged. The marks on the track structure north of the point of general derailment apparently were made by following car equipment.
