INVESTIGATION NO. 2948
THE BOSTON TERMINAL COMPANY
REPORT IN RE ACCIDENT
NEAR SOUTH STATION, BOSTON, MASS., ON
NOVEMBER 17, 1945

Accident near South Station, Boston, Mass., on November
17, 1945, caused by failure to obey an interlocking
signal indication.

Inv. No. 2948
Boston Terminal Company
South Station, Boston, Mass.
November 17, 1945

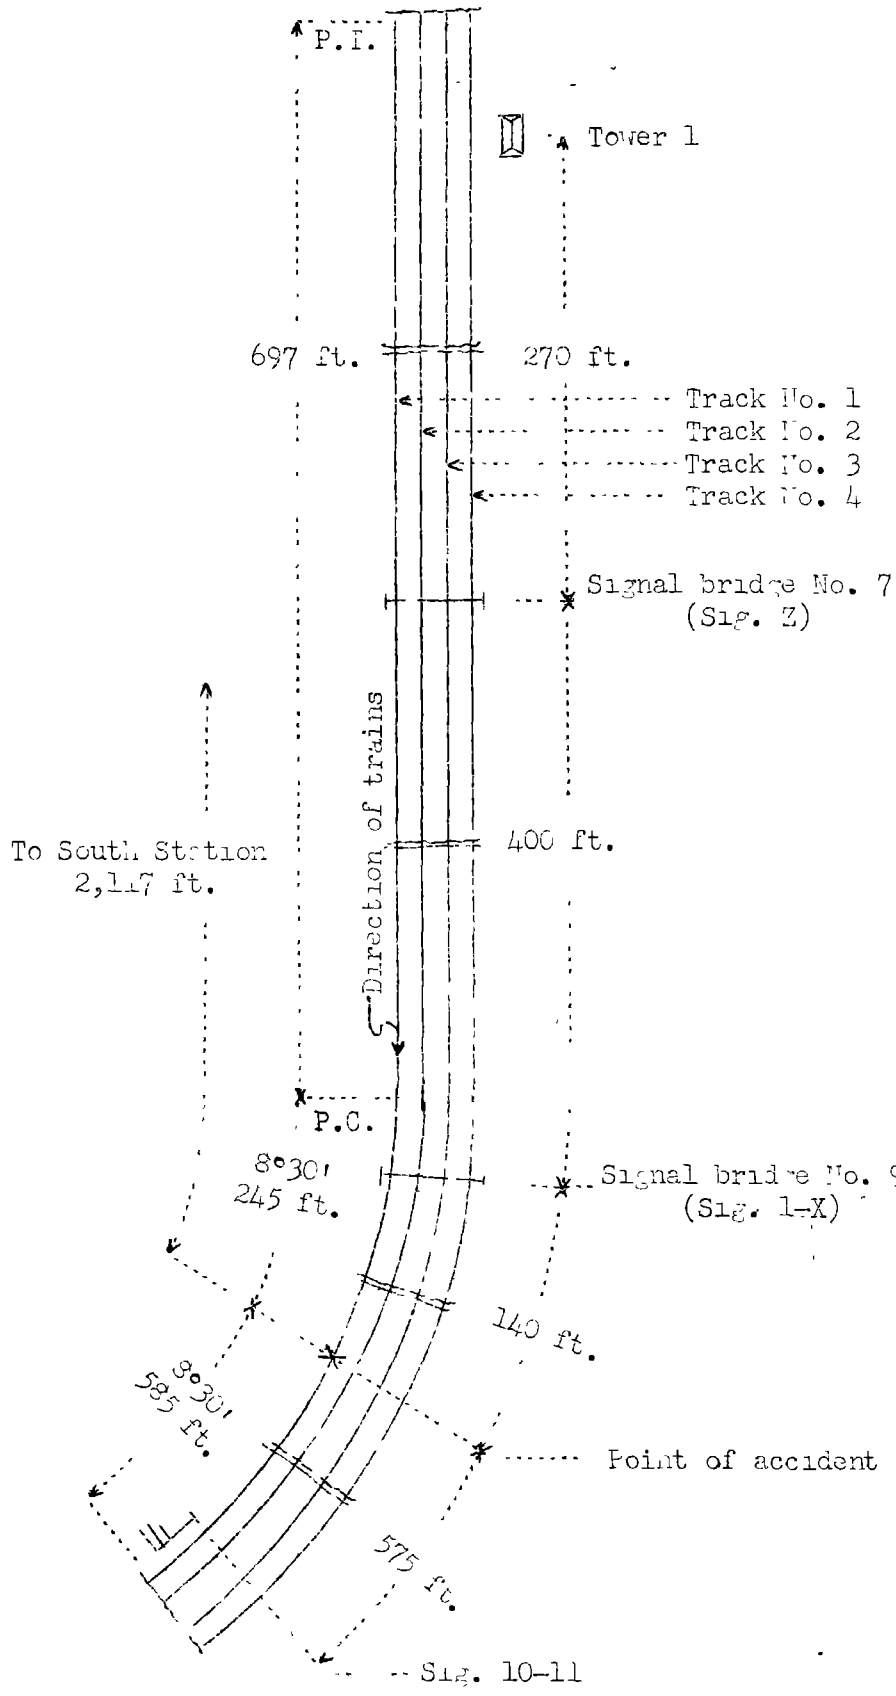
This accident occurred on that part of the railroad extending between South Station, Boston, and Terminal Yard Limit, 0.5 mile, a four-track line in the vicinity of the point of accident, over which trains are operated in either direction by signal indications. The main tracks from north to south are designated as tracks Nos. 1, 2, 3 and 4. Trains and engines of the Boston and Albany Railroad are regularly operated over tracks Nos. 1 and 2. The accident occurred within interlocking limits on track No. 1 at a point 2,117 feet west of the station. From the east on track No. 1 there is a tangent 697 feet in length, which is followed by an 8°30' curve to the right 245 feet to the point of accident and 585 feet westward. The grade is 0.70 percent descending westward.

Interlocking signals Z and 1-X, governing west-bound movements on track No. 1, are, respectively, 540 feet and 140 feet east of the point of accident, and are mounted, respectively, on signal bridges No. 7 and No. 9. These signals are controlled from Tower 1, located 810 feet east of the point of accident, and are of the two-indication, lower-quadrant, semaphore type. The involved day aspects and corresponding indications of these signals are as follows:

No. 91, a west-bound B. & A. passenger train, consisted of engine 502, three coaches and one passenger-baggage car, in the order named. All cars were of steel construction. This train departed from South Station at 3:30 p. m., on time, passed signal Z, which displayed proceed, passed signal 1-X, which displayed stop, and while moving on track No. 1 at an estimated speed of 15 miles per hour it struck engine 577 at a point 140 feet west of signal 1-X.

The force of the impact moved engine 577 and the cut of cars westward about 60 feet. The engine was derailed but remained upright and in line with the track. The engine of No. 91 was derailed to the north and stopped on its right side practically parallel to the track. Both engines were considerably damaged, and the first car of No. 91 was slightly damaged.
