# NATIONAL TRANSPORTATION SAFETY BOARD

## RAILROAD/HIGHWAY ACCIDENT REPORT

### COLLISION OF A BURLINGTON NORTHERN FREIGHT TRAIN WITH A BUS

### STRATTON, NEBRASKA AUGUST 8, 1976

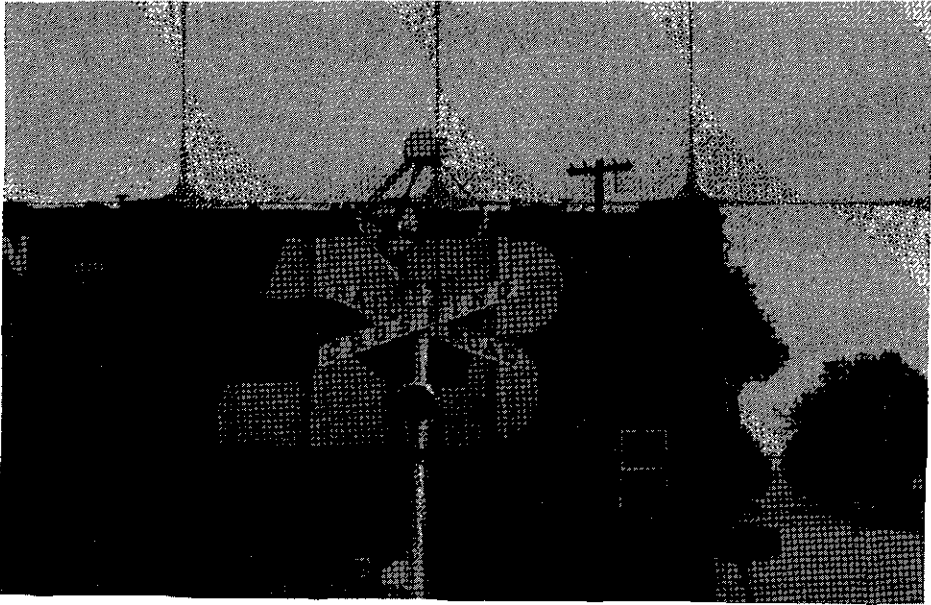
Figure 1. Wigwag Signal at Beaver Avenue Crossing.  
View looking north on Beaver Avenue.

An automatic railroad grade crossing wigwag signal was located 10 feet off the west side of Beaver Avenue, 14 feet south of the north rail of the main track. The center of the pendulum was 12 feet 2 inches above the paved surface of the roadway. The actuator for the signal was located more than 3,600 feet west of the crossing. The wigwag signal light operates on a 10-volt electrical system with a 10-watt bulb. The signal has a 20-inch-diameter wigwag pendulum designed to be attention-getting in the daytime and a 5 1/2-inch-diameter red light in the center of the pendulum for nighttime observation. The crossbuck and wigwag signal were clearly visible from the intersection of Beaver Avenue and Railway Street.

The wigwag signal installed at this grade crossing is obsolete. The wigwag pendulum is 12 feet 2 inches above the ground, the red light

is neither bright enough nor was it designed to be effective during daylight, and the signal bell is neither loud enough nor was it designed to be heard for any appreciable distance from the signal, especially within an approaching motor vehicle.

7. The warning systems were actively announcing the approach of the train to the crossing:
  - o The wigwag signal pendulum was working.
  - o The wigwag signal light was illuminated, although it was not bright enough to attract the attention of a motor vehicle driver under daylight conditions.

"In cooperation with the Burlington Northern Railroad, Inc., install an improved railroad/highway grade crossing protection system on Beaver Avenue in accordance with the Recommended Practices of the Association of American Railroads (1974). (Class II, Priority Followup) (H-77-10)"

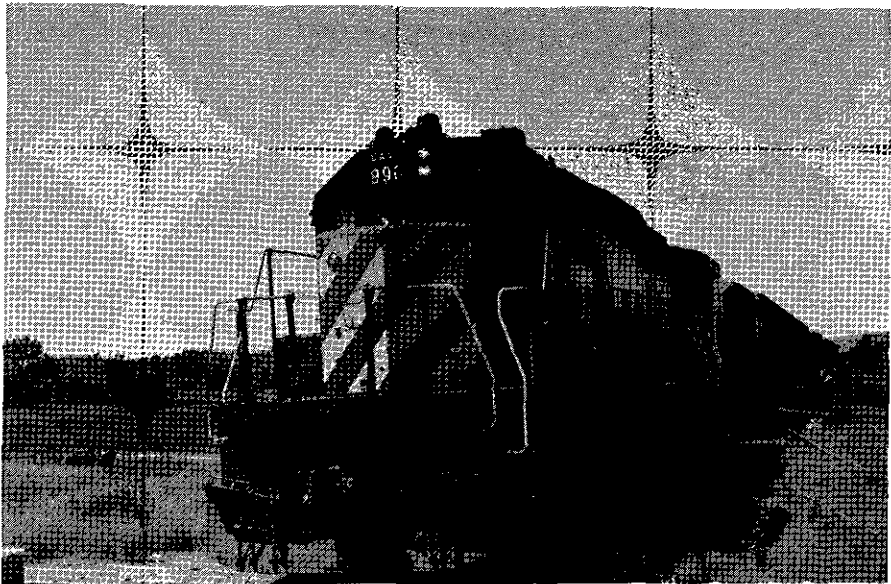
Figure 2. Frontal view of a Burlington Northern  
Railroad locomotive. The two verticle  
headlights are burning. The white  
diagonal stripes are on a background of  
olive green.

As the bus first turned onto Beaver Avenue a tree located north of the tracks and west of Beaver Avenue might have created for the busdriver a brief, partial view obstruction of the headlights and diagonal white stripes on the front of the lead locomotive while the rest of the train blended into the green foliage in the background.

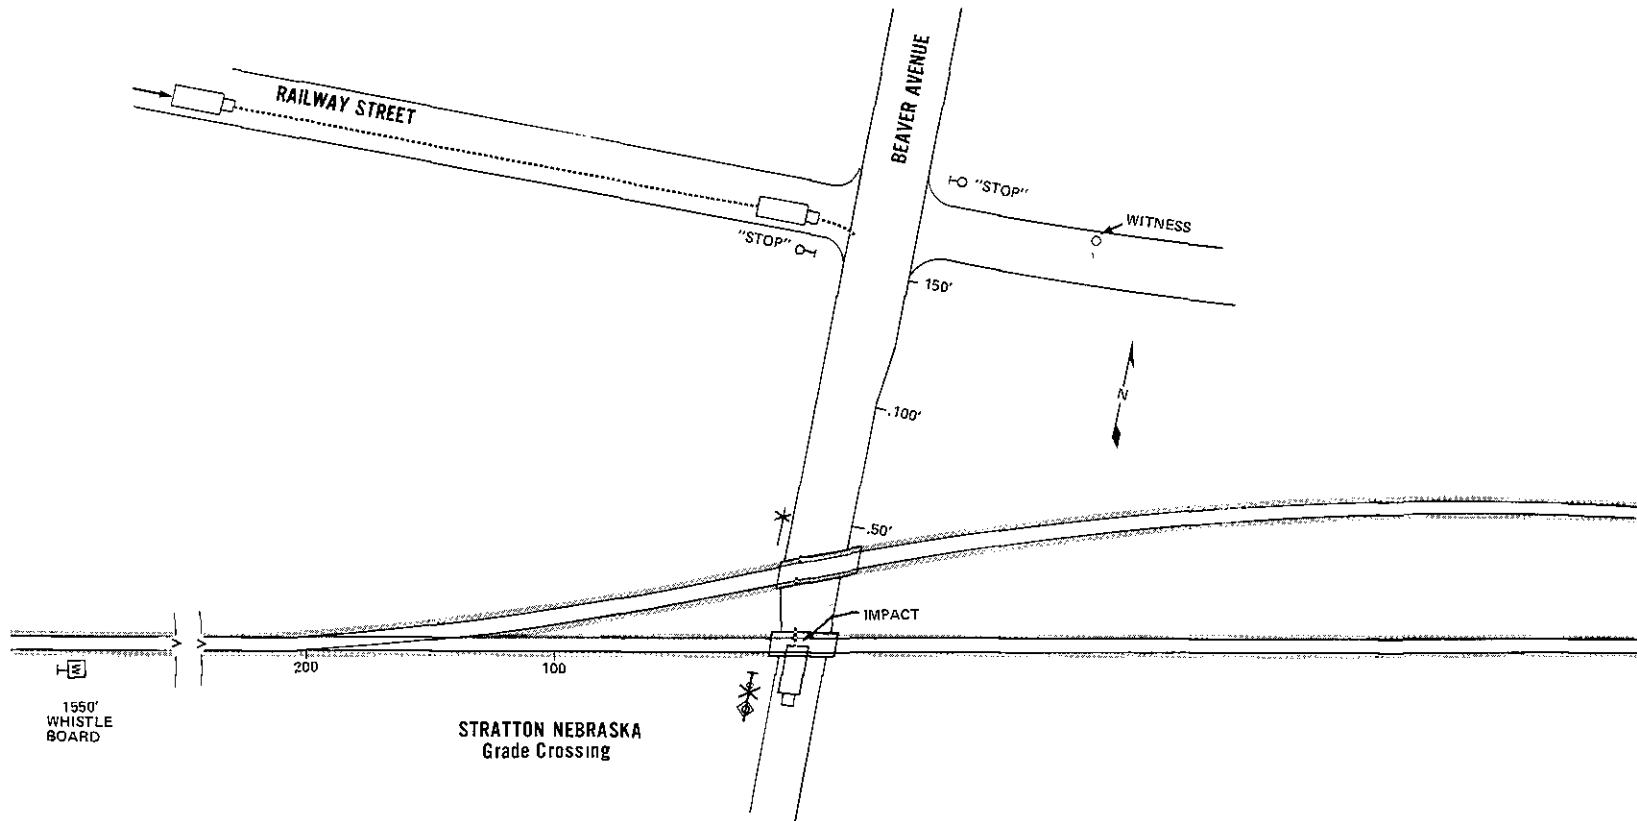
Figure 3. Plan view of accident site.

A standard railroad crossing advance warning sign is located on the northwest corner of the Beaver Avenue/Railway Street intersection, facing north along Beaver Avenue. This sign was not visible to the busdriver. (See figure 3.) A standard crossbuck sign was located on the west side of Beaver Avenue 7 1/2 feet off the pavement and 7 1/2 feet north of the north rail of the spur. No warning symbols were painted on the pavement to inform southbound motorists of the presence of the crossing.
