Railroad Accident Investigation Reports

REPORT NO. 80-2
BURLINGTON NORTHERN, INC.
ALMA WISCONSIN
AUGUST 28, 1978

U.S. DEPARTMENT OF TRANSPORTATION
FEDERAL RAILROAD ADMINISTRATION
Office of Safety

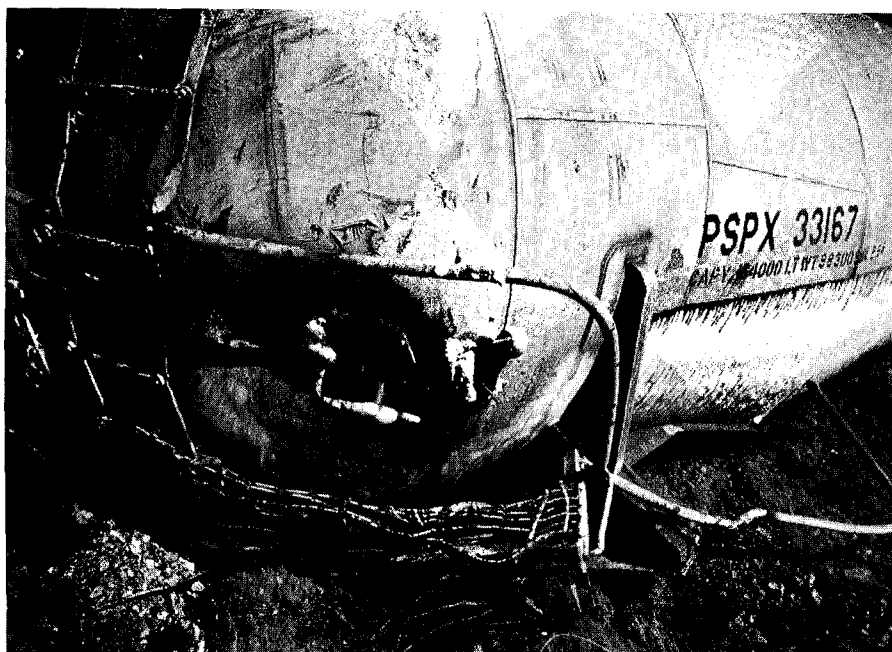
The 70th car of Extra 6530 West, PSPX 33167, was a tank car containing anhydrous ammonia. The tank was separated from both trucks in the derailment, and from the cars at either end. The tank came to rest on and parallel to the shoulder on the field side of the westbound track, tilted to the north at about 15°. The head of the tank on the west or "B" end was embedded in the roof of a covered hopper car, the 68th car. A gash in the tank head on the west end allowed the release of a considerable portion of the contents.

View of punctured tank of car PSPX 33167

During the derailment, a gash was opened in the tank head at the "B", or west, end. The gash measured 14 inches in length and two inches in width. From the size and depth of the dent, it appears that a coupler perforated the tank. There was also evidence of a coupler strike on the opposite side of the tank head.

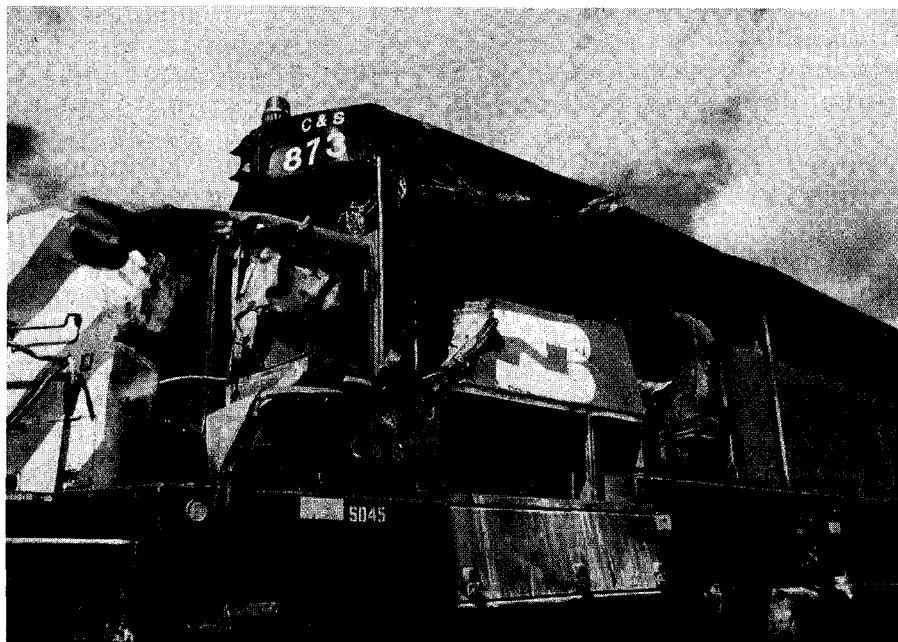
In the collision, the left front and side walkway of the front locomotive unit of Extra CS 873 East absorbed most of the impact. The front and side of the control compartment on the fireman's side, including the forward exit door, were torn out. The seats were demolished. Steps and handholds at the left

front corner and the hand rail along the left walkway were destroyed. Damage to the left front of the locomotive hood indicated that contact with the derailed car initially occurred about 11 inches inside the north rail of the eastbound main track.

View of damage to Locomotive Unit CS 873
