RAILROAD ACCIDENT REPORT

HEAD-END COLLISION OF
NINE BURLINGTON NORTHERN LOCOMOTIVE UNITS
WITH A STANDING FREIGHT TRAIN
ANGORA, NEBRASKA

FEBRUARY 16, 1980

NTSB-RAK-80-7

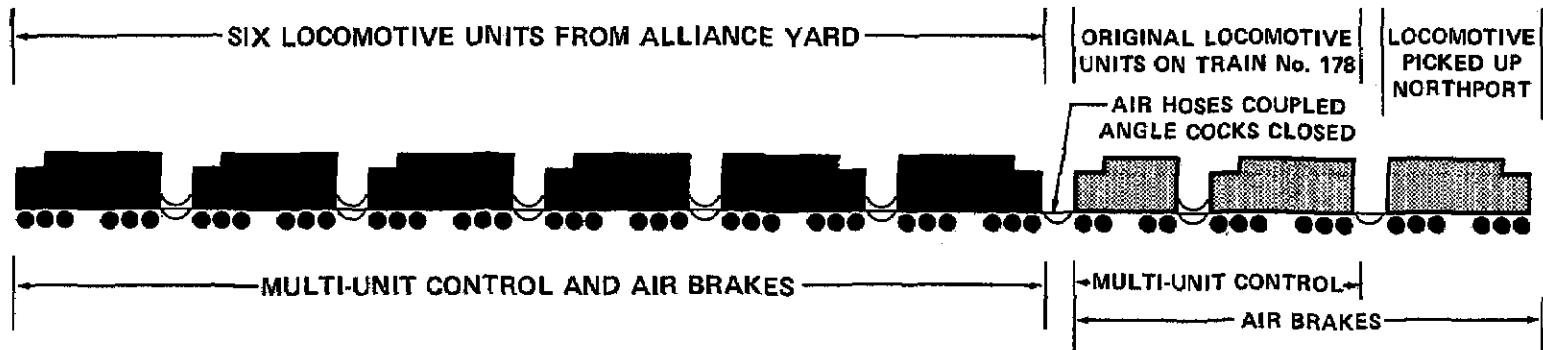
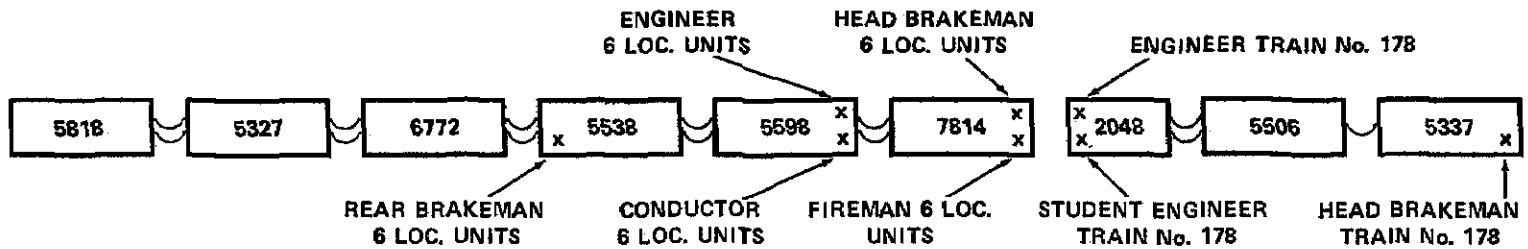
FIGURE 1

Extra 7814 West arrived 20 minutes after the locomotive units of train No. 178 had stopped on the main track at Angora. When the headlight of Extra 7814 West came into view, the engineer of train No. 178 told Extra 7814 West, over the radio, to come down and couple to his three units. As the locomotive of Extra 7814 West came close, the head brakeman of train No. 178 signaled him by lantern and the six locomotive units were coupled to the three standing units. The passing or meeting as directed by the train order was not completed, but the six locomotive units of Extra 7814 West were coupled to the east end of the three locomotive units of train No. 178. Neither the air brakes nor the multiple unit control were connected between the two sets of locomotive units. The engineer of train No. 178 instructed the fireman of Extra 7814 West to continue to operate the six units and to apply dynamic braking according to his radio instructions. The engineer and the fireman of train No. 178 were in the cab on the east end of the third unit, and the fireman of Extra 7814 West was in the cab on the west end of the fourth unit of the nine units. The conductor and the engineer of Extra 7814 West remained in the fifth unit throughout the operation. The head brakeman of train No. 178 was instructed to ride the cab on the west end of the lead unit, to maintain a lookout as the locomotives moved westward and to advise the engineer when they approached the standing train, or of any problems by radio. The engineer of train No. 178 proceeded to move the nine units toward the standing portion of train No. 178 from his position in the control compartment of the third unit. (See figure 1.)

The distance from Angora to the standing portion of train No. 178 was 4.7 miles. Because of the manner in which the nine locomotive units were coupled, the engineer on the third locomotive unit had control of the air brakes, power, and dynamic braking on the two original units of train No. 178, but he had control of only the air brakes on the lead locomotive unit, which had been added. He had no control over the six units of Extra 7814 West. The engineer stated that the visibility was poor and that he could not see beyond the lead locomotive unit because of the blowing snow. As the locomotive units descended the grade, the engineer attempted to control the speed of the nine locomotive units by using the dynamic brakes on the two original locomotive units. According to the speed tape, the speed of the locomotive units increased steadily to 25 mph, dropped to about 18 mph, increased during the next mile to 32 mph, and dropped slightly, followed by a steady increase to 46 mph. The engineer received no communication from the lead locomotive unit until he radioed to slow down because they were only "10 car lengths" from the standing train. The engineer immediately applied the air brakes

METHOD LOCOMOTIVE UNITS WERE COUPLED

LOCATION OF CREWMEMBERS PRIOR TO ACCIDENT

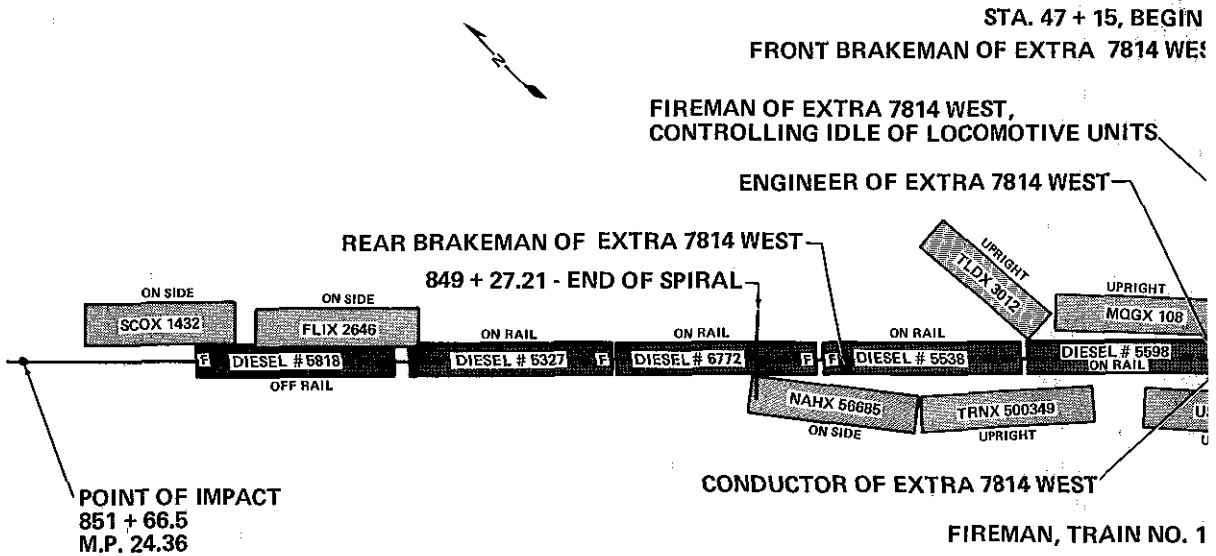
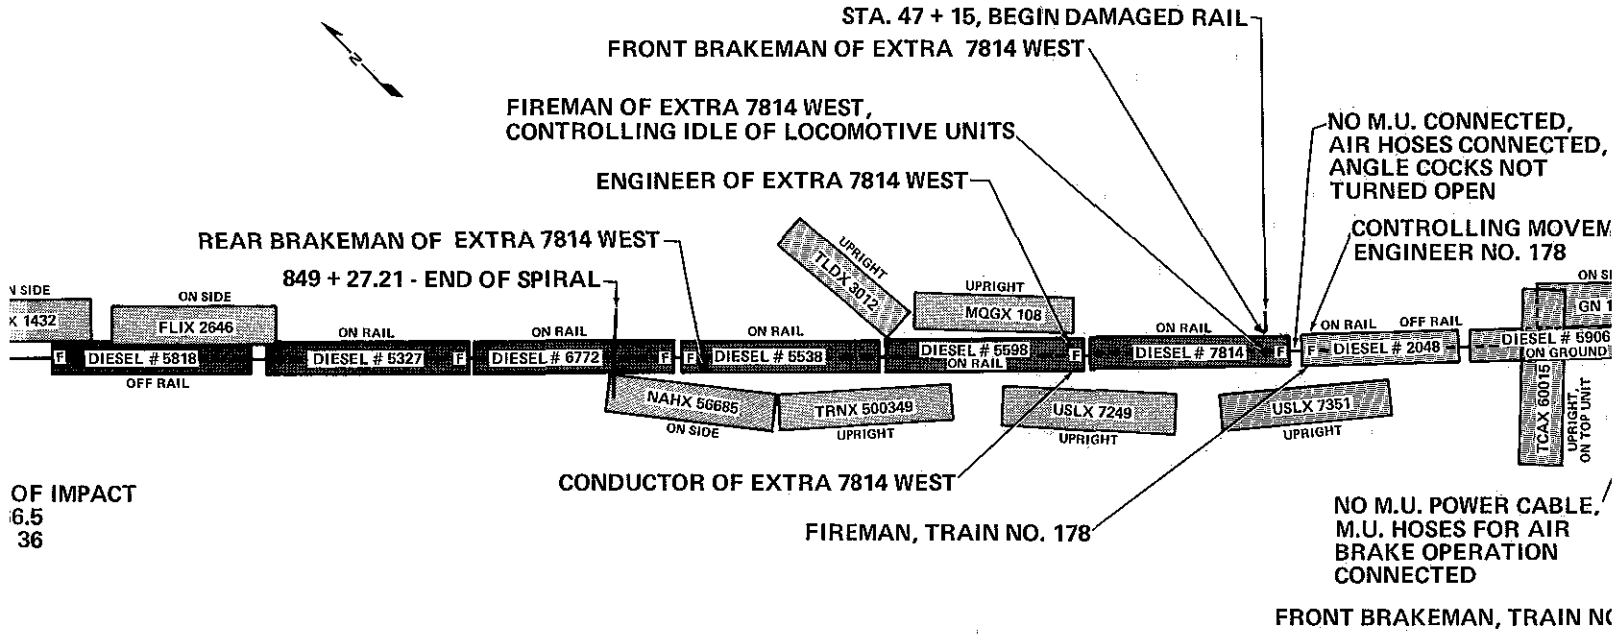
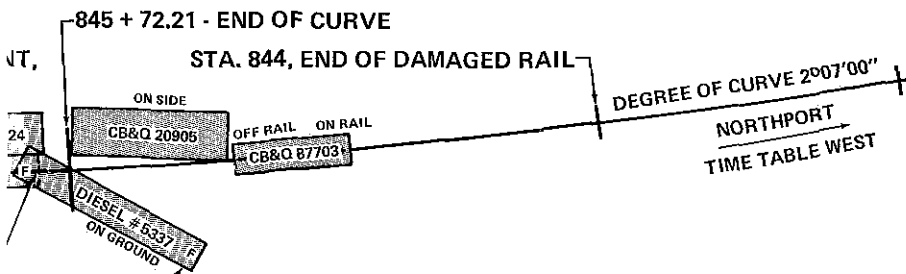
Figure 2
COLLISION OF 9 LOCOMOTIVE UNITS WITH STANDING TRAIN OF NO. 178
ANGORA, NEBRASKA
FEBRUARY 16, 1980

on the three units and radioed the fireman operating the six locomotive units of Extra 7814 to apply all available dynamic braking. However, before the fireman could apply dynamic braking, the locomotive unit collided with the standing portion of train No. 178. The head brakeman of train No. 178, in the lead unit, and the engineer of Extra 7814 West, in the fifth locomotive unit, were killed, and three other crewmembers were injured. (See figure 2.)

After the impact with the standing train, the locomotive units traveled westward 562 feet. The three leading locomotive units derailed. The lead unit was destroyed, the next four units were heavily damaged, and the following four units were slightly damaged. Eleven cars were heavily damaged and one was slightly damaged. Damage was estimated as follows:

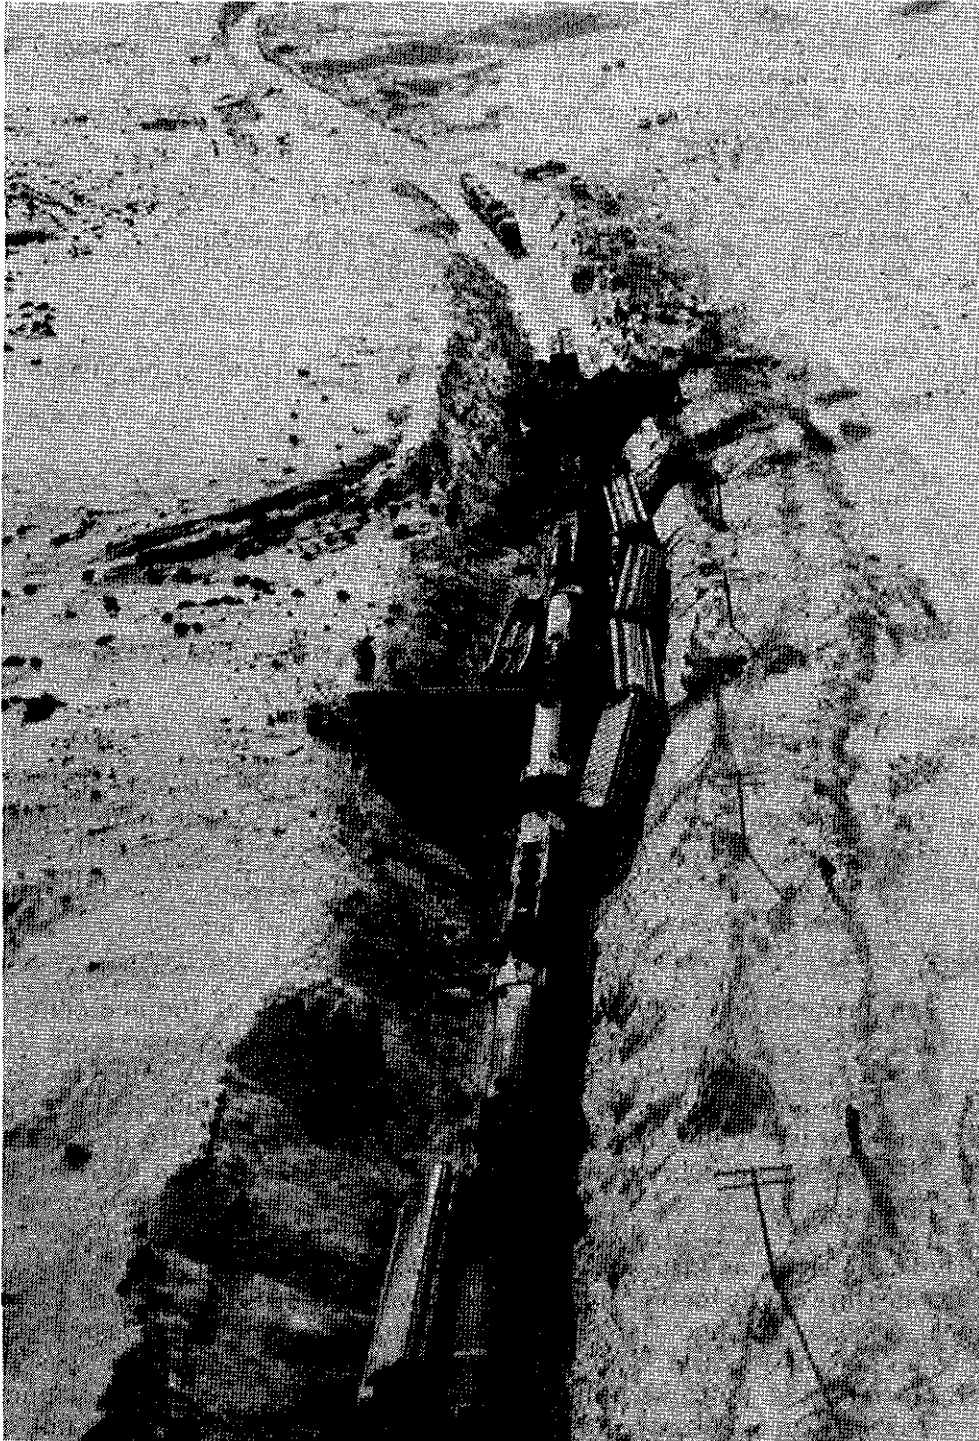
An embankment is located on each side of the track at the accident site. As the standing cars were struck, they were raised upward, overriding the lead locomotive units, and because of the embankment, some were retained on top of the locomotive units and some fell down and were held alongside the units. The overriding cars crushed and tore away much of the superstructure of the lead unit, including the operator's cab. (See figure 3.) The head brakeman of train No. 178, who was in the operating cab of this unit, was killed when the cab was destroyed. The engineer of Extra 7814 West was seated in the fireman's seat of the fifth locomotive unit and was killed when the cab section was torn away. The fireman, was riding in the fourth locomotive unit and was injured when he was thrown into the operating console; and the front brakeman, who was in the same unit, was injured when he was thrown about the cab. The rear brakeman, who was riding in the sixth locomotive unit, was slightly injured by the force of the impact. The engineer, fireman, conductor, and rear brakeman of train No. 178 were not injured.

**Figure 3.--Derailement of trains
No. 178 and Extra 7814 West.**
