NATIONAL TRANSPORTATION SAFETY BOARD

RAILROAD ACCIDENT REPORT

**DERAILMENT OF A
BURLINGTON NORTHERN FREIGHT TRAIN**

NOVEMBER 26, 1976

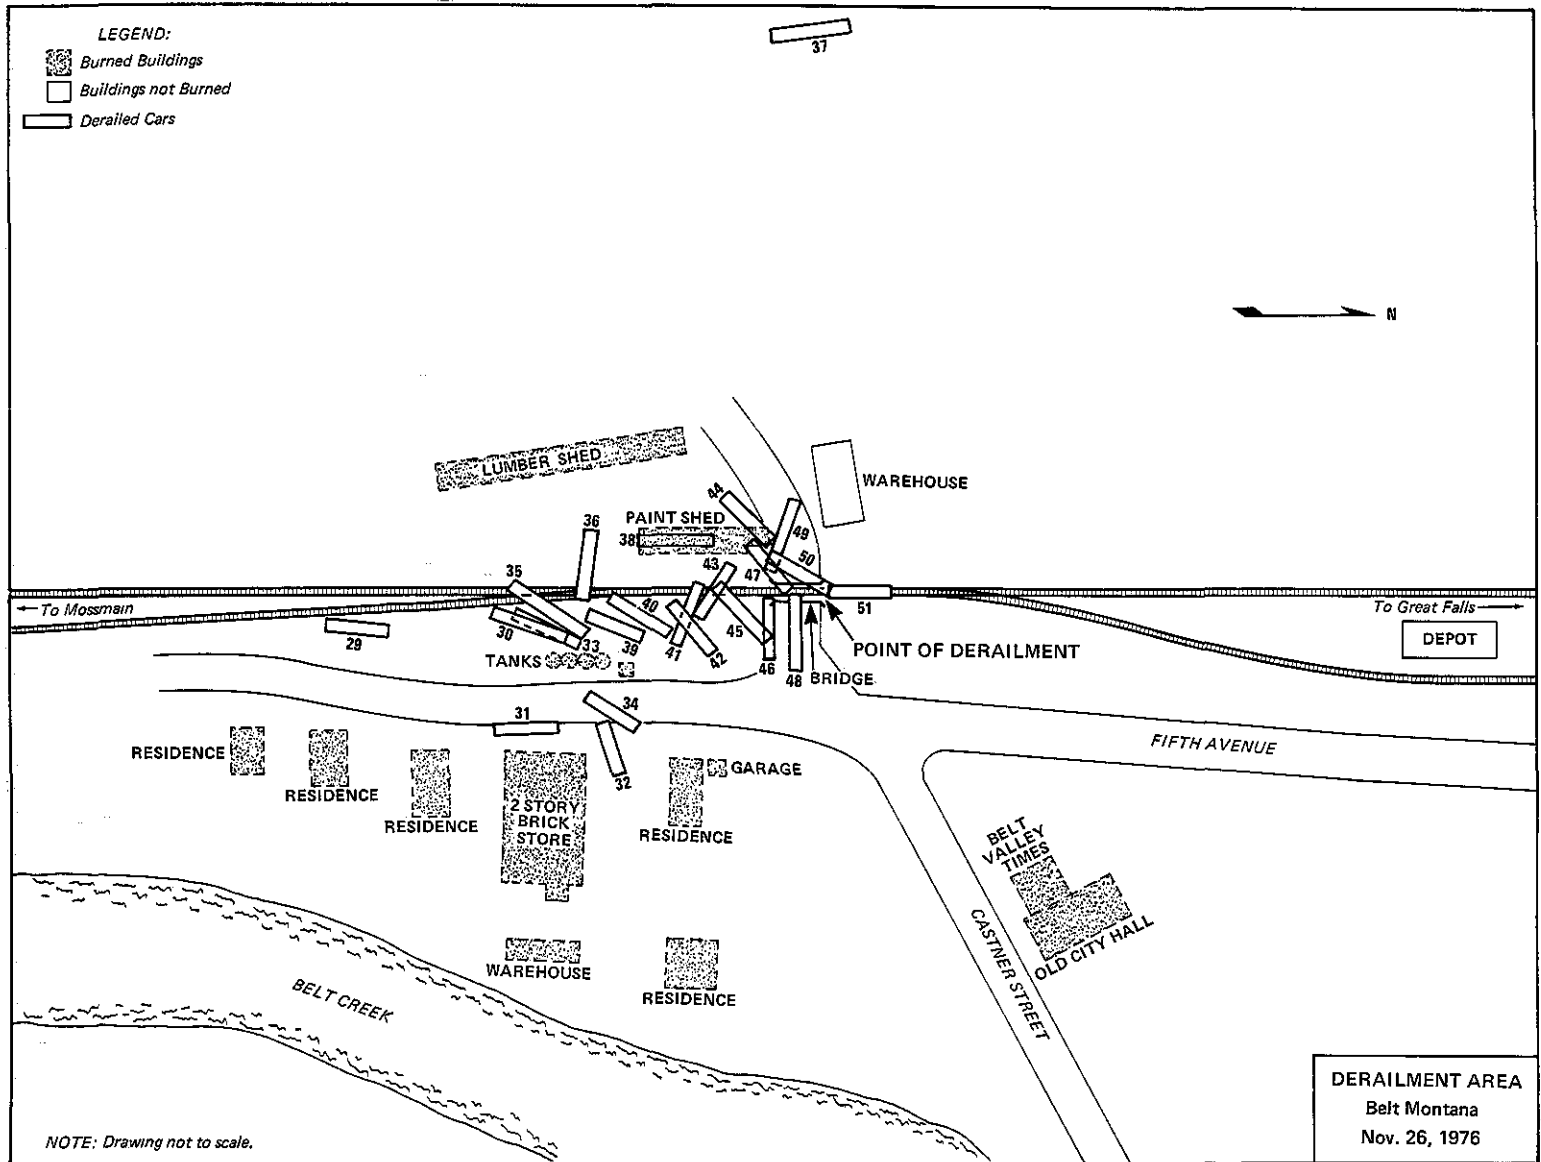
Figure 1. Plan view of accident site.

The initial derailment occurred at the north end of the overpass which carries the single track over Castner Street. The old City Hall building and a newspaper office were about 300 feet northeast of the point of derailment on Castner Street. On the east side of the tracks in the derailment area there were a two-story brick store which belonged to the Farmers Union Cooperative, a warehouse, and several dwellings. In addition, there were four vertical, above-ground, 16,000-gallon tanks for gasoline and fuel oils, two 500-gallon butane tanks, and several small propane tanks. Belt Creek is about 400 feet east of the accident site. A warehouse, a paint storage shed, and a lumber storage shed were on the west side of the tracks. (See figure 1.)

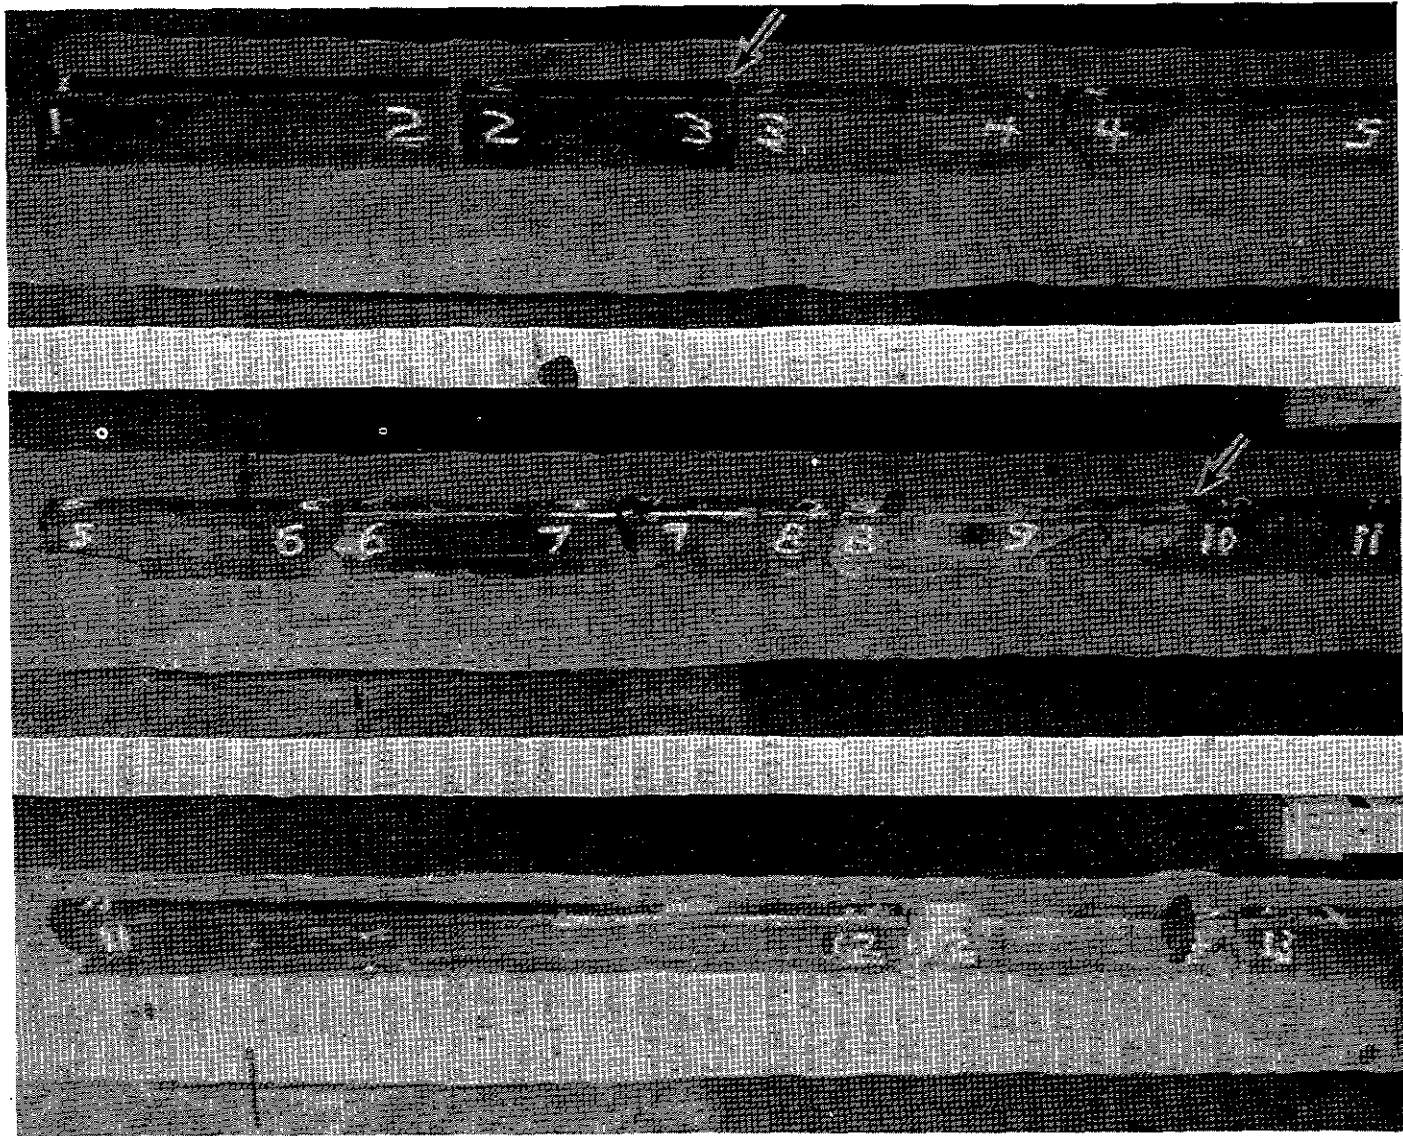
One 33-foot piece of the east rail was broken into 13 pieces. The first break was 47 inches north of the bridge and the second break was 11 feet 10 3/4 inches south of the first. (See figure 2.) Wheel battermarks on the receiving ends of the broken pieces indicated a number of wheels passed over the breaks before the rail was displaced and allowed the cars to derail. The rail was manufactured by the Bethlehem Steel Company in 1909 and was first laid in a track in 1911. It was installed at Belt about 3 years before the accident.

Figure 2. Broken sections of 33-foot rail. Arrow indicates point of initial failure.

The battermarks on the fractured surfaces of the broken rail indicate that the rail broke under the wheels of the passing train and that a few wheels passed over the two breaks before the rail was displaced and allowed the cars to derail. If the rail had been broken before the train began to move over it, the locomotive and first 28 cars would have battered the ends of the fractured rail to a much greater degree. Furthermore, the track inspector probably would have discovered the break during his inspection earlier in the day.

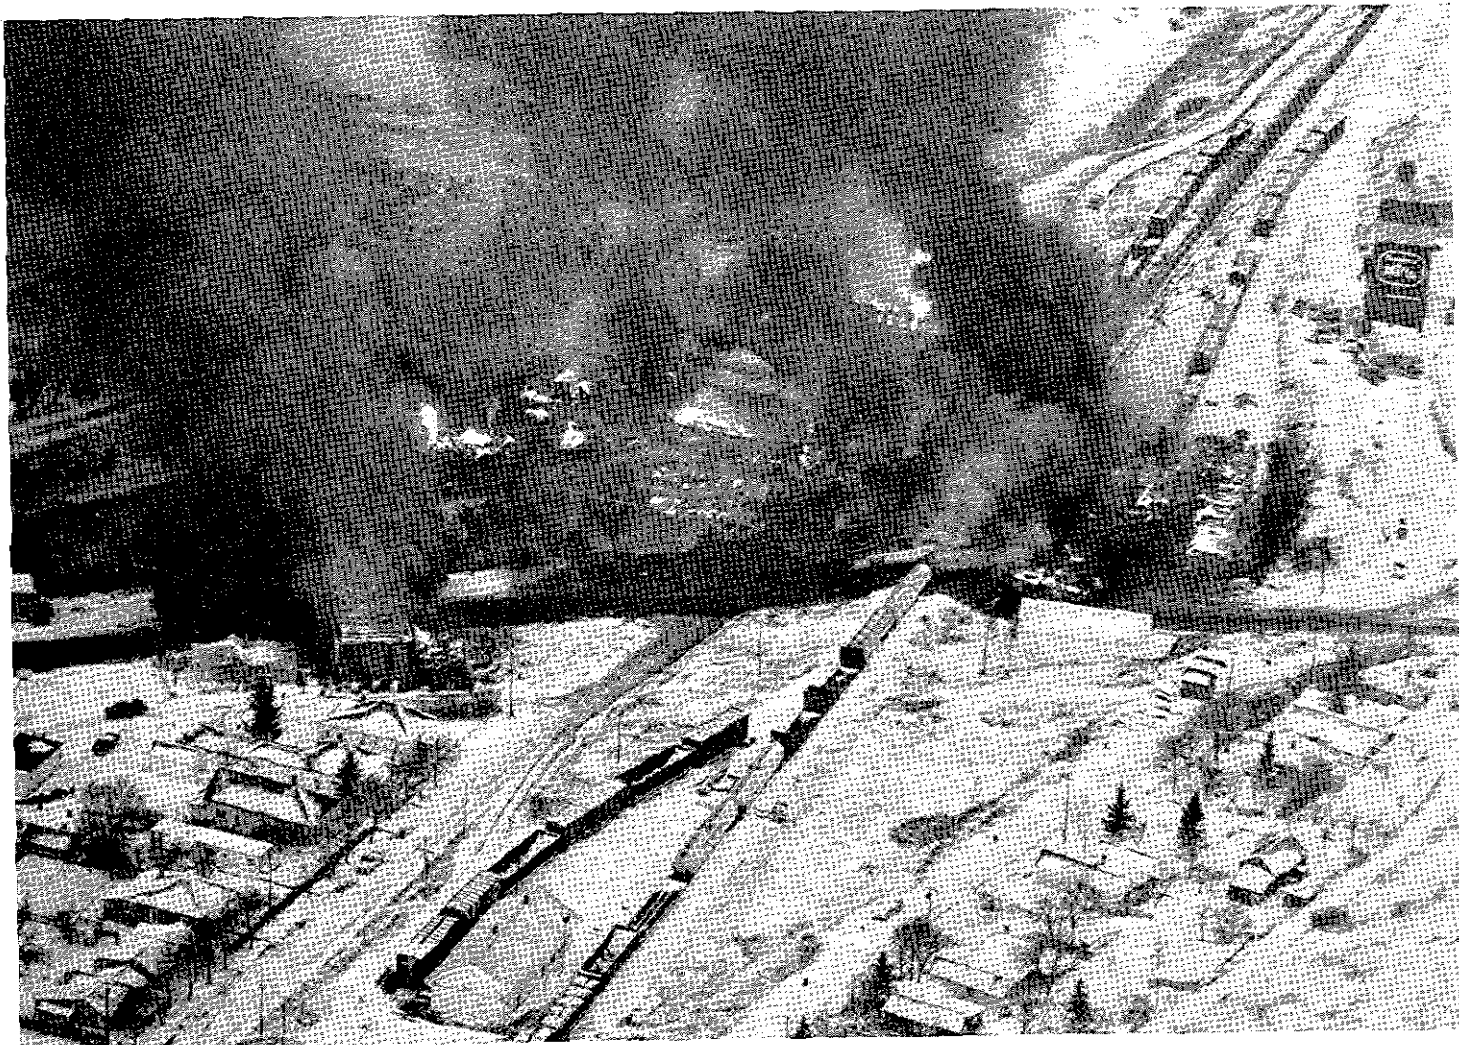
Fire erupted immediately after a tank car collided with the trackside fuel storage tank. Fifty-foot-high flames enveloped derailed cars and buildings within a 300,000-square-foot area around the tank in less than 2 seconds. In a rolling motion the fire advanced eastward toward Belt Creek and spread out to the north and south. Several explosions occurred as the fire burned the derailed cars and nearby buildings. The fires burned for over 12 hours. (See figure 3.)

Figure 3. Aerial view looking south.

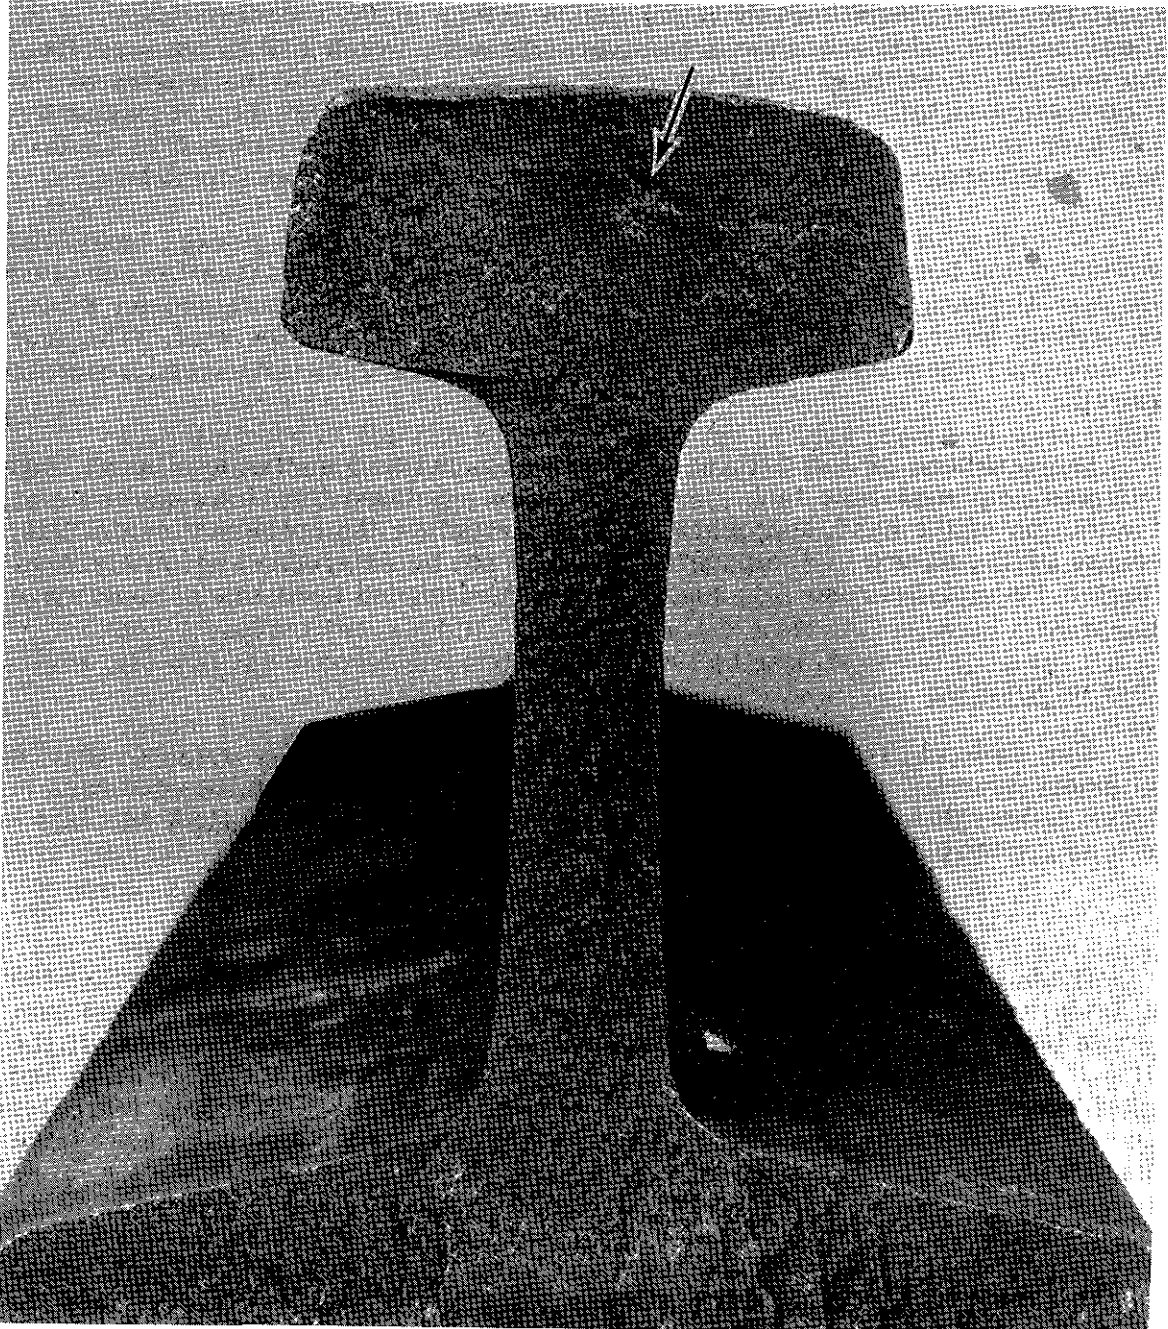
conformed closely to American Railway Engineering Association specifications except for slight deviations above maximum carbon and phosphorus content. The failed sections exhibited classic transverse fissures which had progressed from inclusions in the railhead. The inclusions extended throughout the lengths of the failed section of rail. The transverse fissure at the initial break did not exhibit the sudden or rapid growth rings normally associated with those transverse fissures which exhibit those types of growth. (See figures 4 and 5 and appendix A.)

Figure 4. Cross-section of rail section showing nucleus of initial failure.

Initial failure occurred at Section 3 on Photograph No. 13276 from a transverse fissure which had progressed from inclusions in rail head. Attached Photograph No. 13276A exhibits nucleus of initial failure. Leading batter on subsequent sections confirms nucleus. It was evident this rail length had inclusions throughout as noted at Sections 2 and 10. Attached Photograph No. 13276 B exhibits the transverse fissure which had also progressed at Section 10.

"Relegate rail section of 100 pounds or less, made of noncontrol-cooled steel, to locations where service failures will not result in catastrophic derailments. (Class II, Priority Followup) (R-77-31)"

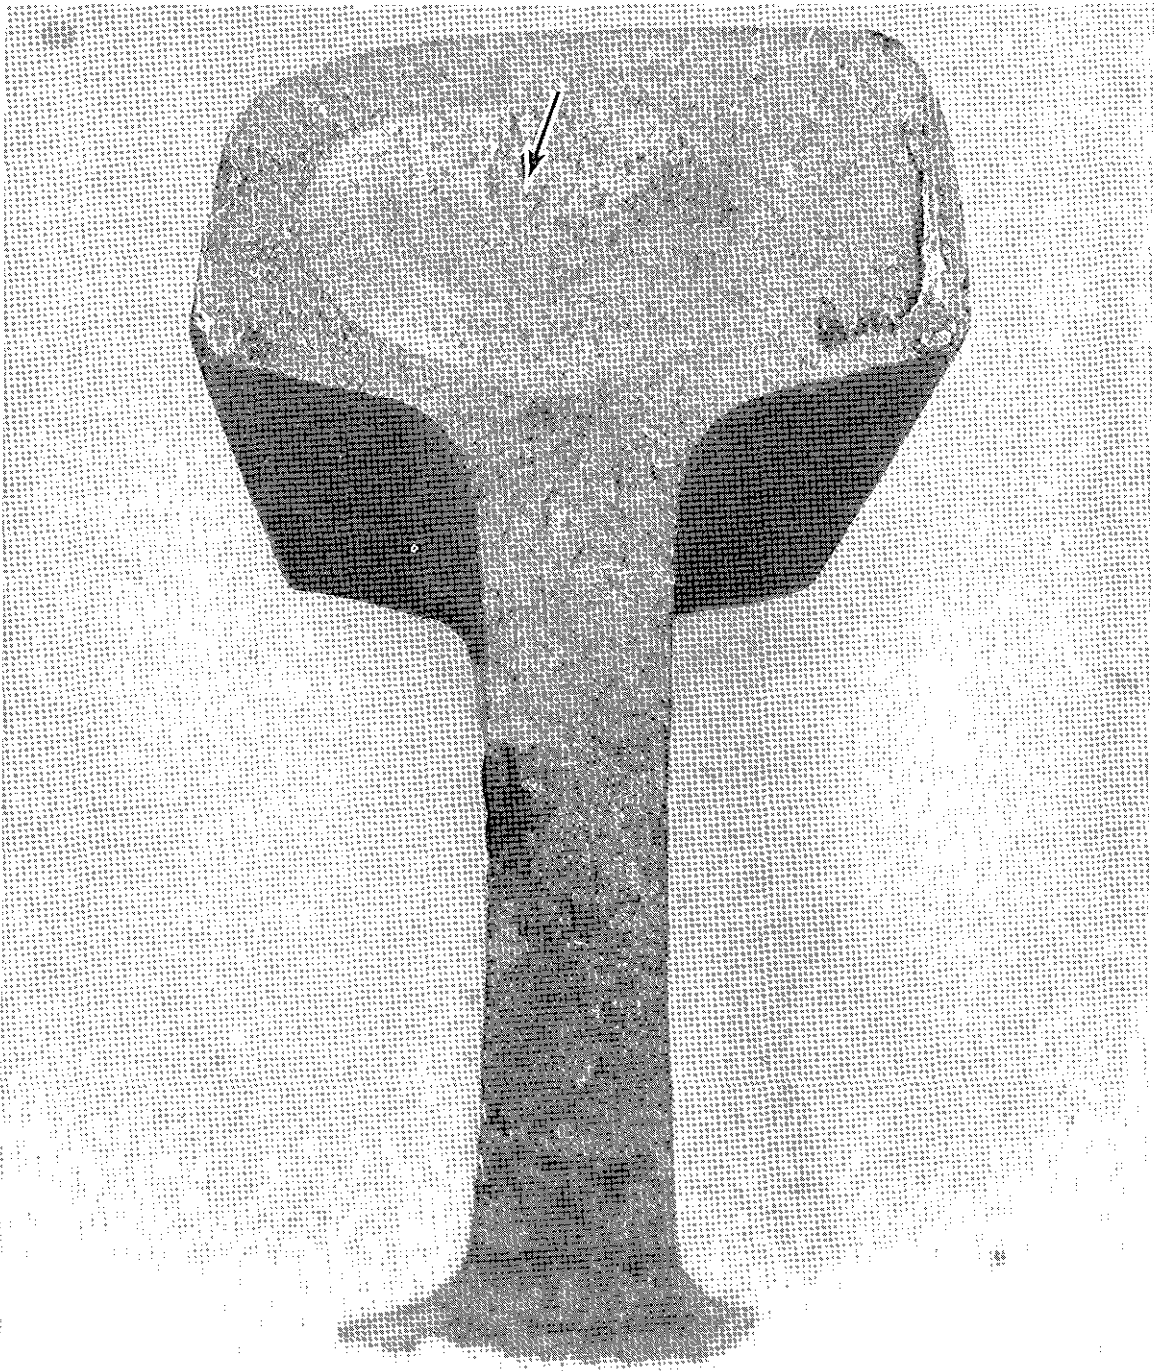
Figure 5. Cross-section of failed rail showing transverse fissure.

The number and appearance of the transverse fissures in the broken rail suggest that at least some of them should have been detectable when the detector tests were made in July and August. The inclusion in the head of the rail should have been detectable also. BN should review the capability of its rail flaw detection testing, its quality control, and the analysis of its findings. A review of the history of this 90-pound rail, its overstressing by heavy wheel loads, and the tendency of such rail to develop transverse fissures under such service suggest that the rail should have been removed from mainline service.

"Revise 49 CFR 213.237, Inspection of Rail, to insure the discovery of internal defects in all tracks, Classes 3 to 6, inclusive, before those defects develop into failures. (Class II, Priority Followup) (R-77-29)"

"Evaluate the capability of its internal rail defect testing program and make the necessary changes to insure that internal defects are detected before they develop to the failure stage. (Class II, Priority Followup) (Class II, Priority Followup) (R-77-30)
