Railroad Accident Investigation Reports

ACCIDENT REPORT NO. 79-1

BURLINGTON NORTHERN, INC.

JANUARY 15, 1978

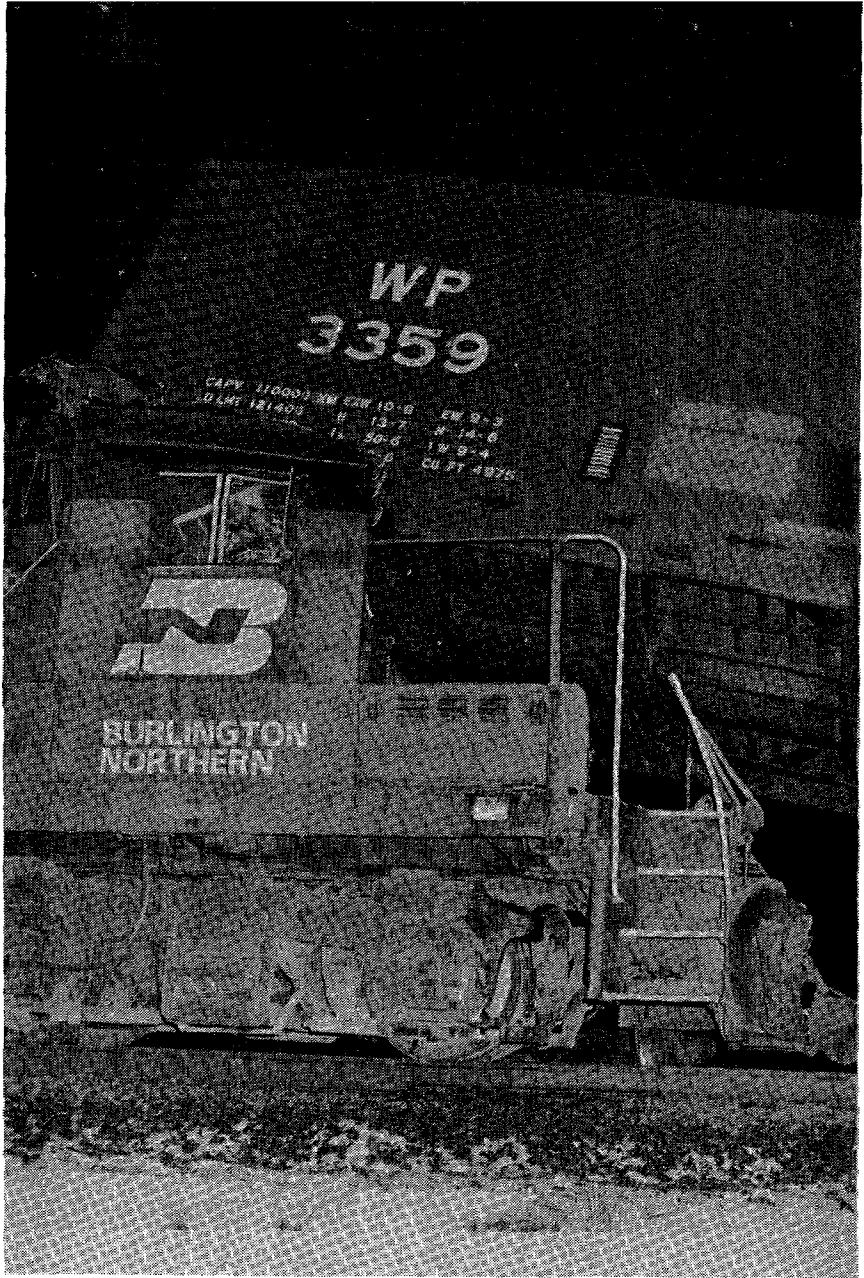
According to the engineer of Extra 2211 West, he had been operating the train on the ascending grade at a steady rate of speed in the throttle "eight" position. As the train reached the top of the grade, the train's speed began to increase. The engineer stated that he had changed the throttle position from "eight" to position "five" in an attempt to slow the train. The engineer said that he had observed the yard limit sign and was conversing with the front brakeman as the train entered the curve. He first observed the rear end of Extra 2526 West after emerging from the cut approximately 700 feet short of the caboose. He immediately made an emergency application of the train brakes and warned the front brakeman of the impending collision. Moments later, Extra 2211 West struck the caboose of Extra 2526 West. The caboose overturned on its side to the south alongside the main track. The east end of the next car, boxcar WP 3359, overrode the front of the locomotive unit BN 2211, shearing off the short hood and the control cab, as shown in the photograph. The boxcar stopped in an upright position, leaning to the south with the east end supported by the control cab of the locomotive unit.

The caboose and rear end of the preceding train were derailed. Those cars and the car ahead were substantially damaged. The first locomotive unit of the following train was substantially damaged, but did not derail. The carrier estimated the cost of damages to train equipment at \$102,000.

Locomotive Unit BN 2211 and Boxcar WP 3359
