RAILROAD ACCIDENT REPORT

Head-On Collision of Two
Burlington Northern Freight Trains
near Maquon, Illinois
May 24, 1972

Report Number: NTSB-RAR-73-4

Adopted: APRIL 11, 1973

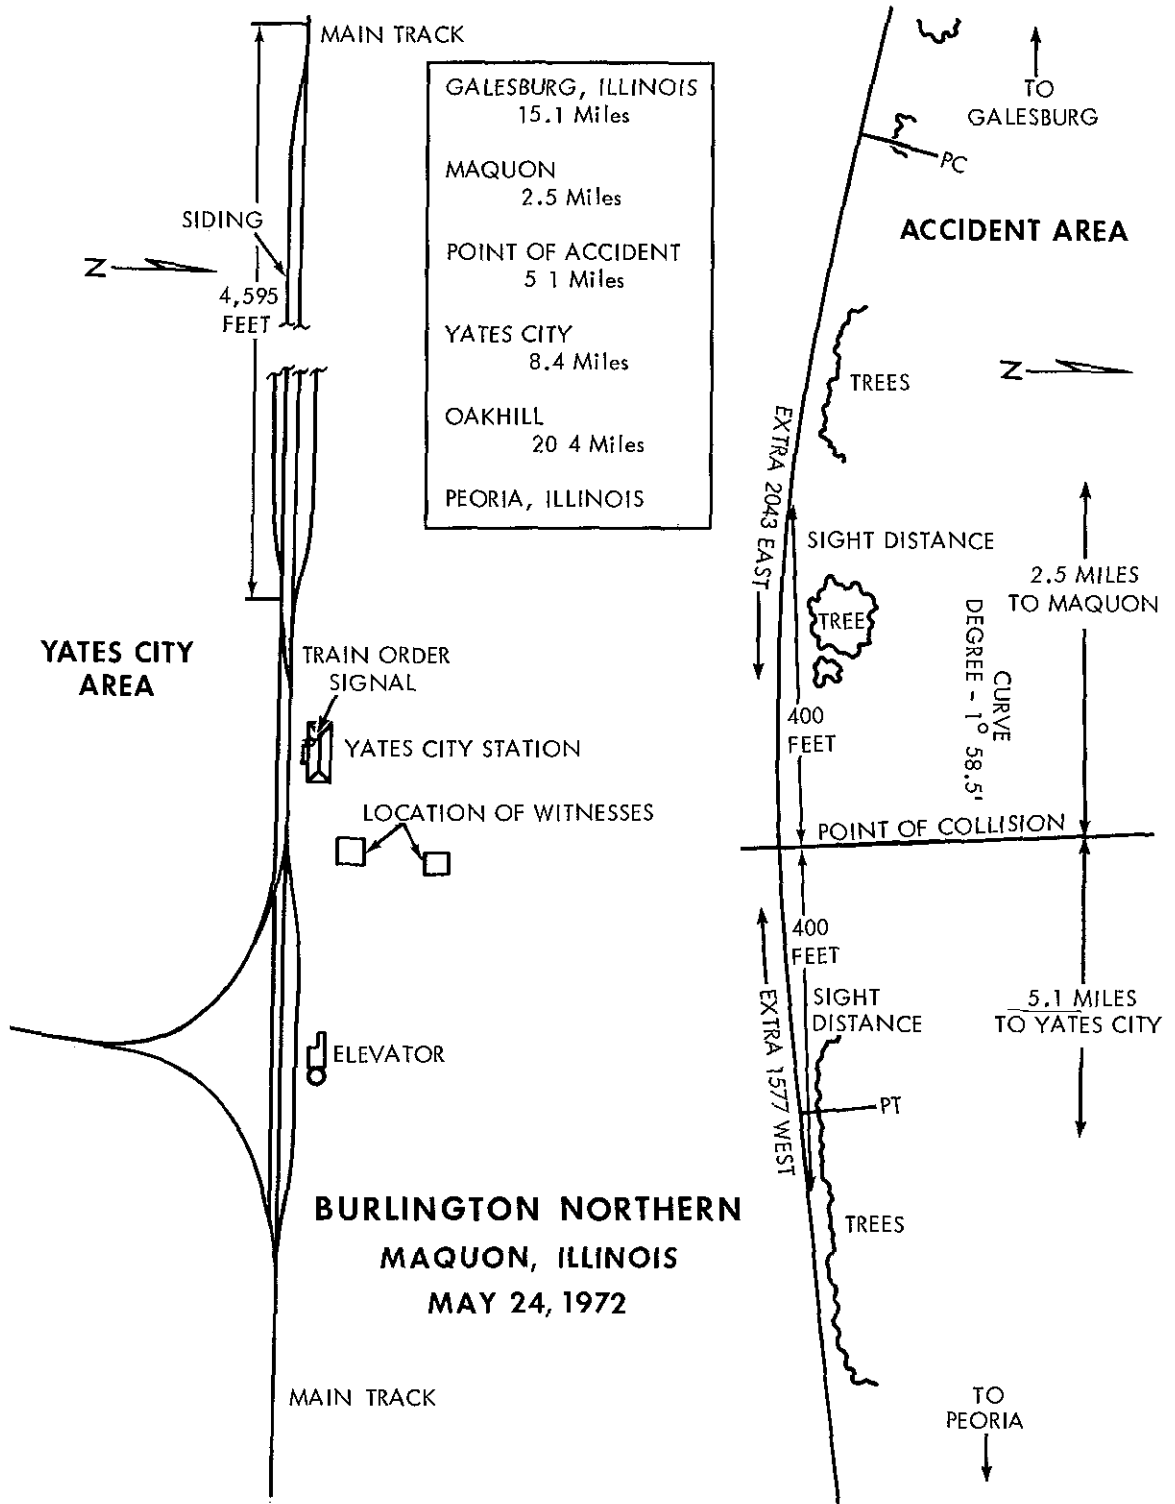
Impact occurred 15.1 miles east of Galesburg, 321 feet west of the east end of a 1°58' curve to the north. (See Figure 1.) The track east and west of this curve was straight for a considerable distance. Trees restricted visibility on the curve to about 450 feet on either side of the impact point. A one-percent downgrade began about

Figure 1 Map of the accident area

- 14 Visibility between the trains was reduced to about 800 feet by the curve of the track.
- 15 The fire which developed after the collision resulted from the ignition of diesel oil spilled from the ruptured tanks of the locomotive units.

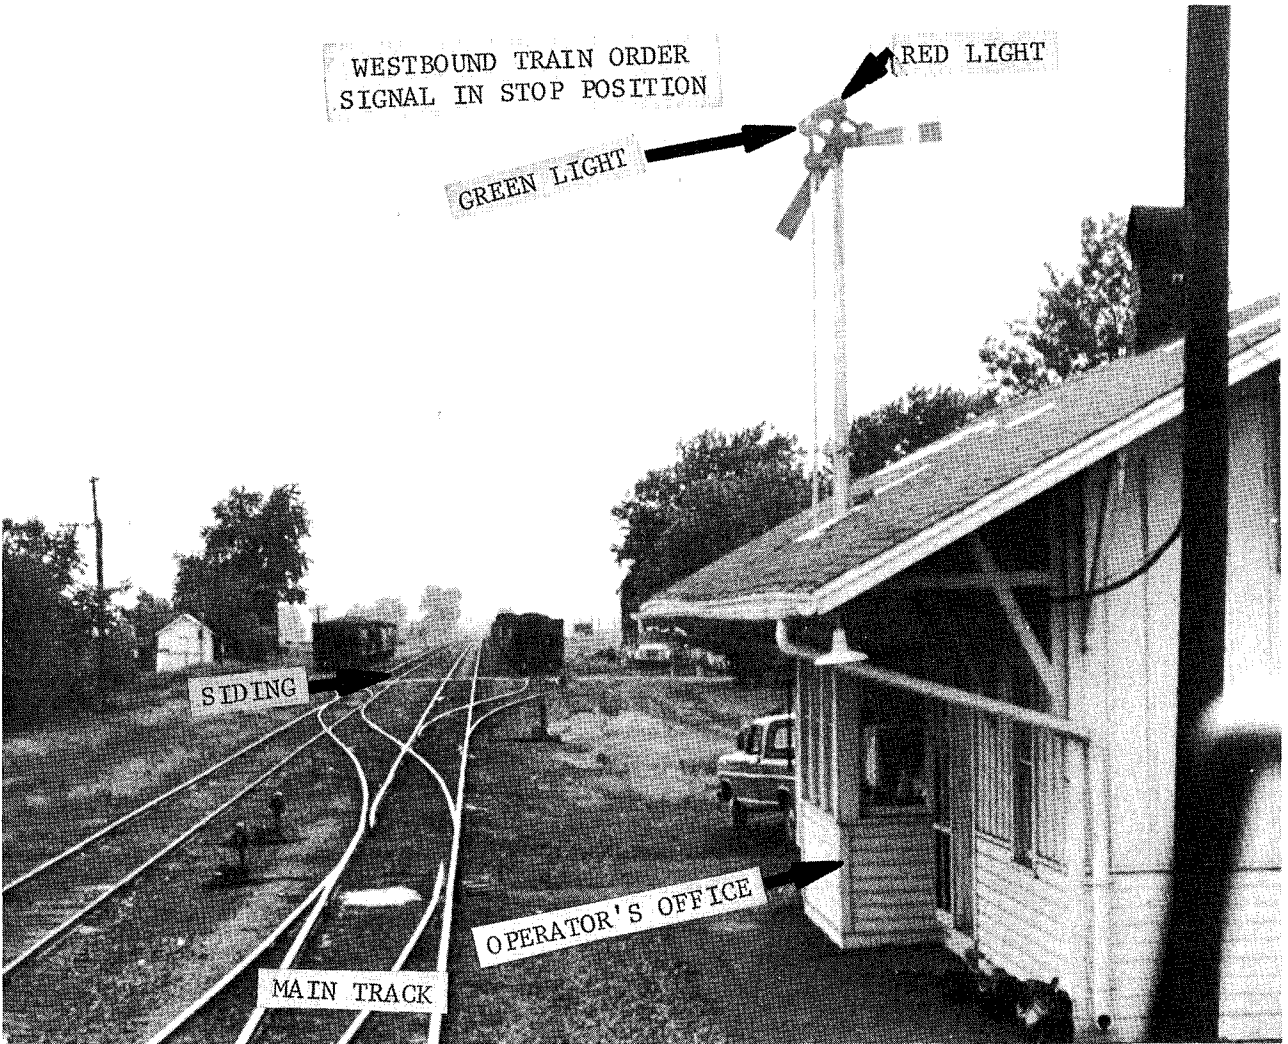
semaphoric displayed two aspects. When the semaphore arm was horizontal, it indicated stop; when the arm was 30° below horizontal, it indicated proceed. A red light on the semaphore lighted when the arm was in the stop position, and a green light when in the proceed position. The two semaphores were manually operated by means of levers located in a room adjacent to the station operator's office. Because the train order signal was above the roof, the station operator could not see the aspects displayed by the signal for either direction. (See Figure 2.)

Figure 2. Train-order signal and station at Yates City.

After the accident, the westbound train-order signal at Yates City was observed at about the same time of day and under similar weather conditions as were present when Extra 1577 West passed through Yates City on the day of the accident. With the semaphore set in the stop position, the red roundel was in the vertical position directly in front of the lighted lamp. The green roundel was to the left of the mast at an angle about 45° from the vertical. There was nothing to shield this roundel, and the rays of the sun from the west shone through the green lens. This made the green light more prominent than the red light. The red light could not be seen until the observer was close to the signal. When the eastbound signal was in proceed position, the green roundel of that signal was in the vertical position, but facing the opposite direction, and the red roundel of the eastbound signal was blanked. If the westbound signal was in stop position and the eastbound signal in proceed position with the sun shining brightly west of the signal, the engineer of a westbound train approaching the signal would see a green light until the train arrived at a point close to the signal.

- 1 The Burlington Northern change the design of their train-order signals so that there is no possibility that a phantom aspect will be displayed.⁴ (Recommendation No R-73-19)
- 2 The Burlington Northern review its operating rules and its interpretation of these rules to assure that train movements are adequately protected. The management and employees of Burlington Northern should take any action necessary to insure that the operating rules are complied with. (Recommendation No R-73-20)
- 3 The Burlington Northern adopt a system of safety analysis of their operating rules and practices to disclose conditions of inadequate protection of train operations. (Recommendation No R-73-21)

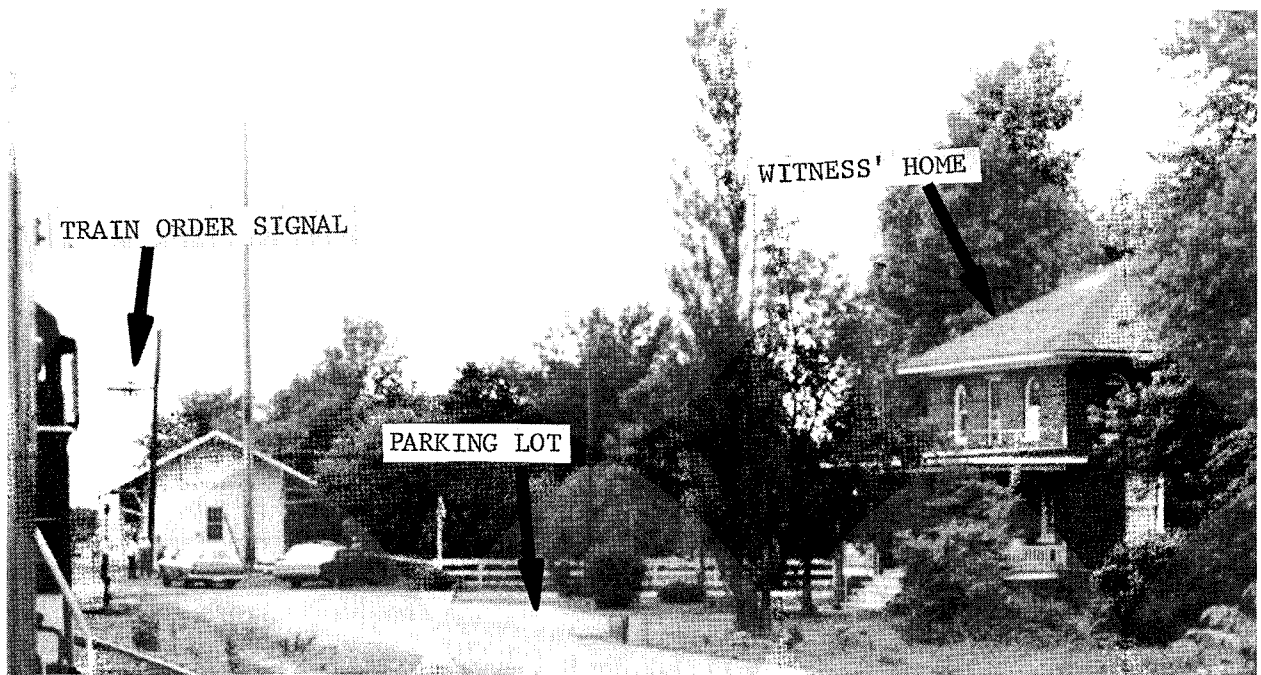
Figure 3. Location of witnesses in relation to the Yates City station.

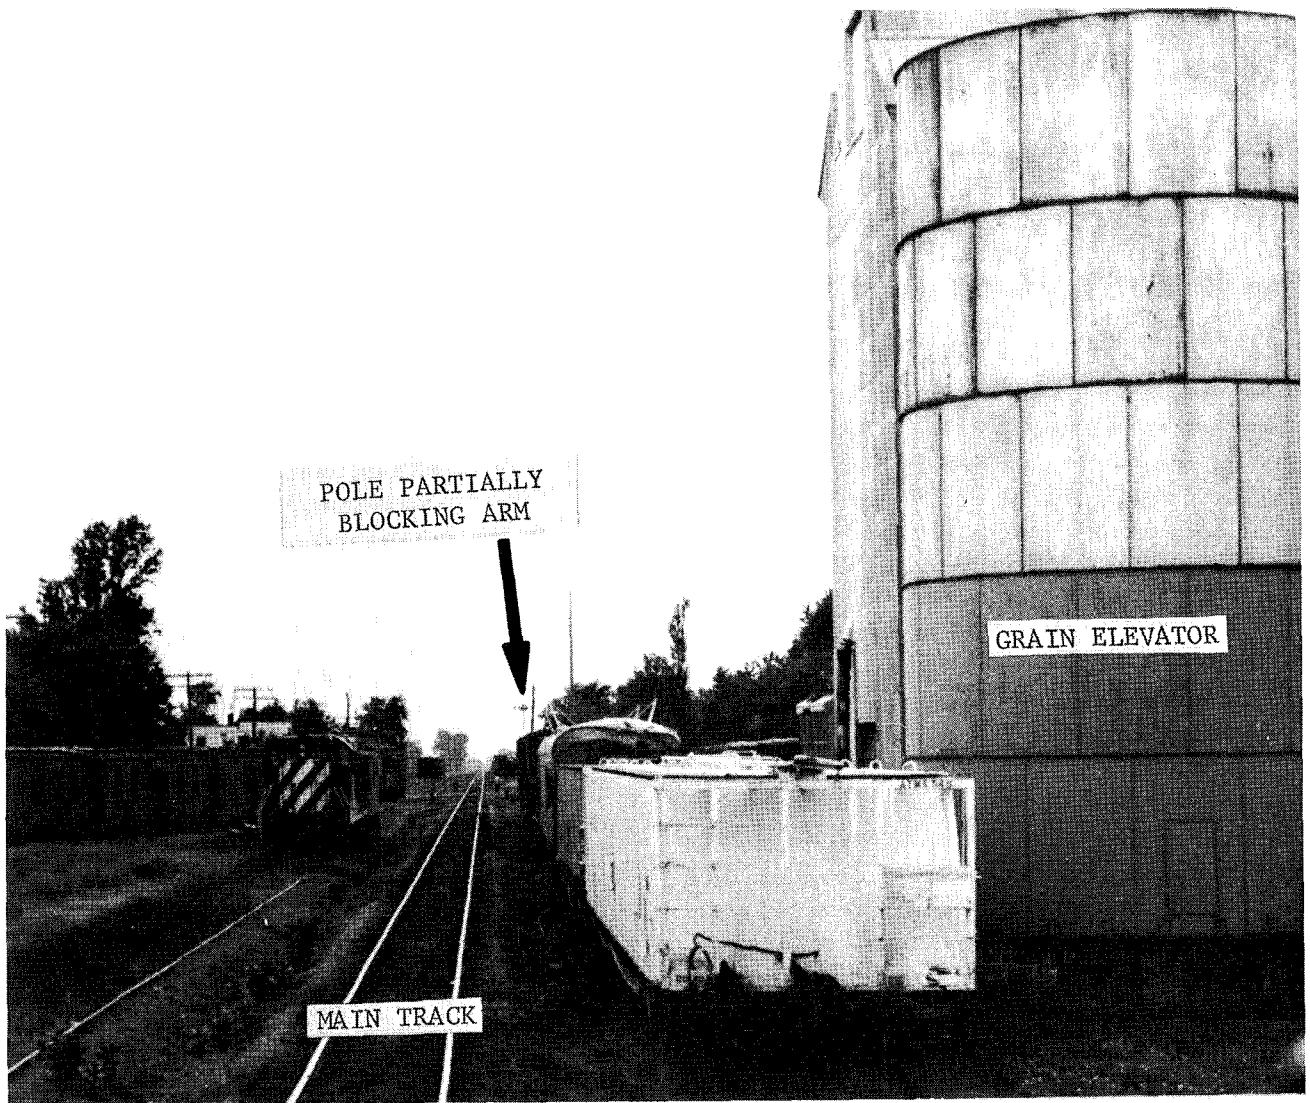
It was also found that when the signal first came into view, a utility pole partially blocked

Figure 4. Westbound train-order signal (picture taken from vicinity of grain elevator east of the station).

The shining of the sun through the green lens of the signal and the partial blocking of the arm by the utility pole might have caused the flagman to mistake the aspect displayed. Furthermore, when the flagman looked at the signal, the locomotive had passed the station and no attempt had been made by the engineer to reduce the speed of the train, which could have strengthened the flagman's conviction that the signal was in proceed position.
