RAILROAD ACCIDENT INVESTIGATION FEB 7 1972

REPORT NO. 4169

BURLINGTON NORTHERN INCORPORATED

JUNE 6, 1970

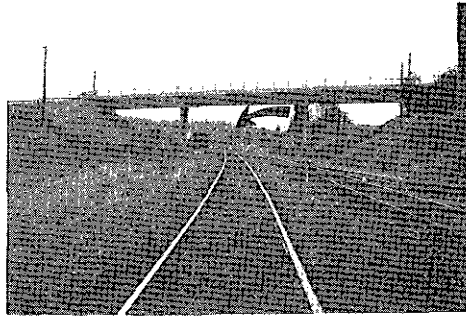
A highway bridge spans the main track and an auxiliary track on the north, 470 feet east of the east siding-switch. In this area the main track is laid in a cut. Because of track curvature, the cut and supports for the highway bridge, enginemen of a westbound train have a restricted view of the east siding-switch and signal 1431-1 (see photograph on the following page)

View westward on main track from 875 feet east of signal 1431-1 (arrow). Auxiliary tracks at right and auxiliary-track switch at center were not involved in accident. East siding-switch is 47 feet beyond signal 1431-1.

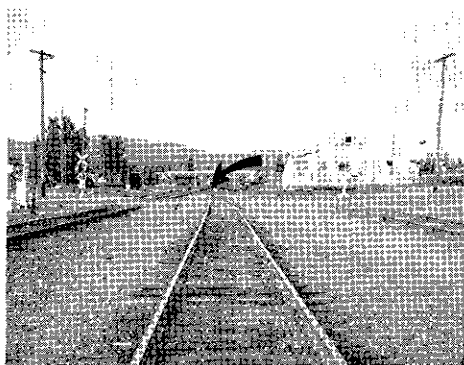
View eastward on Newport siding from collision point, 517 feet west of east siding switch (arrow). Main track is at left. Signal 1431-1 shown on other side of main track at arrow.

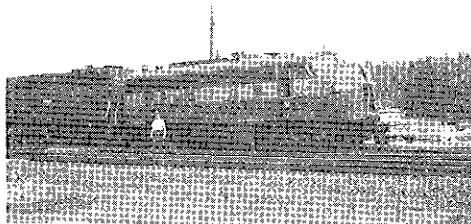
This train stopped with its front end against the front of Extra 6432 East at the collision point. Both trucks of the first locomotive unit; the left front wheel of the second unit; the rear truck of the third car, and all trucks of the fourth and fifth cars were derailed. The derailed equipment stopped upright on and in line with the siding structure. Damage to the train was relatively minor, as indicated in the following photograph of the first locomotive unit.

First locomotive unit of No. 31 with first unit of Extra 6432 East attached.

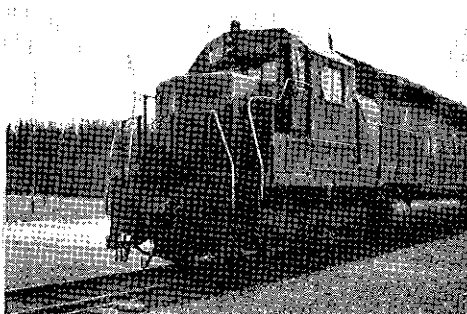
No equipment of this train was derailed. Damage to the train was minor, as indicated in the photograph on the following page.

Front of first locomotive unit of Extra 6432 East
