RAILROAD ACCIDENT REPORT

BURLINGTON NORTHERN INC.
Derailment of Extra 5701 East
at
Sheridan, Wyoming
March 28, 1971

NATIONAL TRANSPORTATION SAFETY BOARD
Washington, D. C. 20591
REPORT NUMBER: NTSB-RAR-72-4

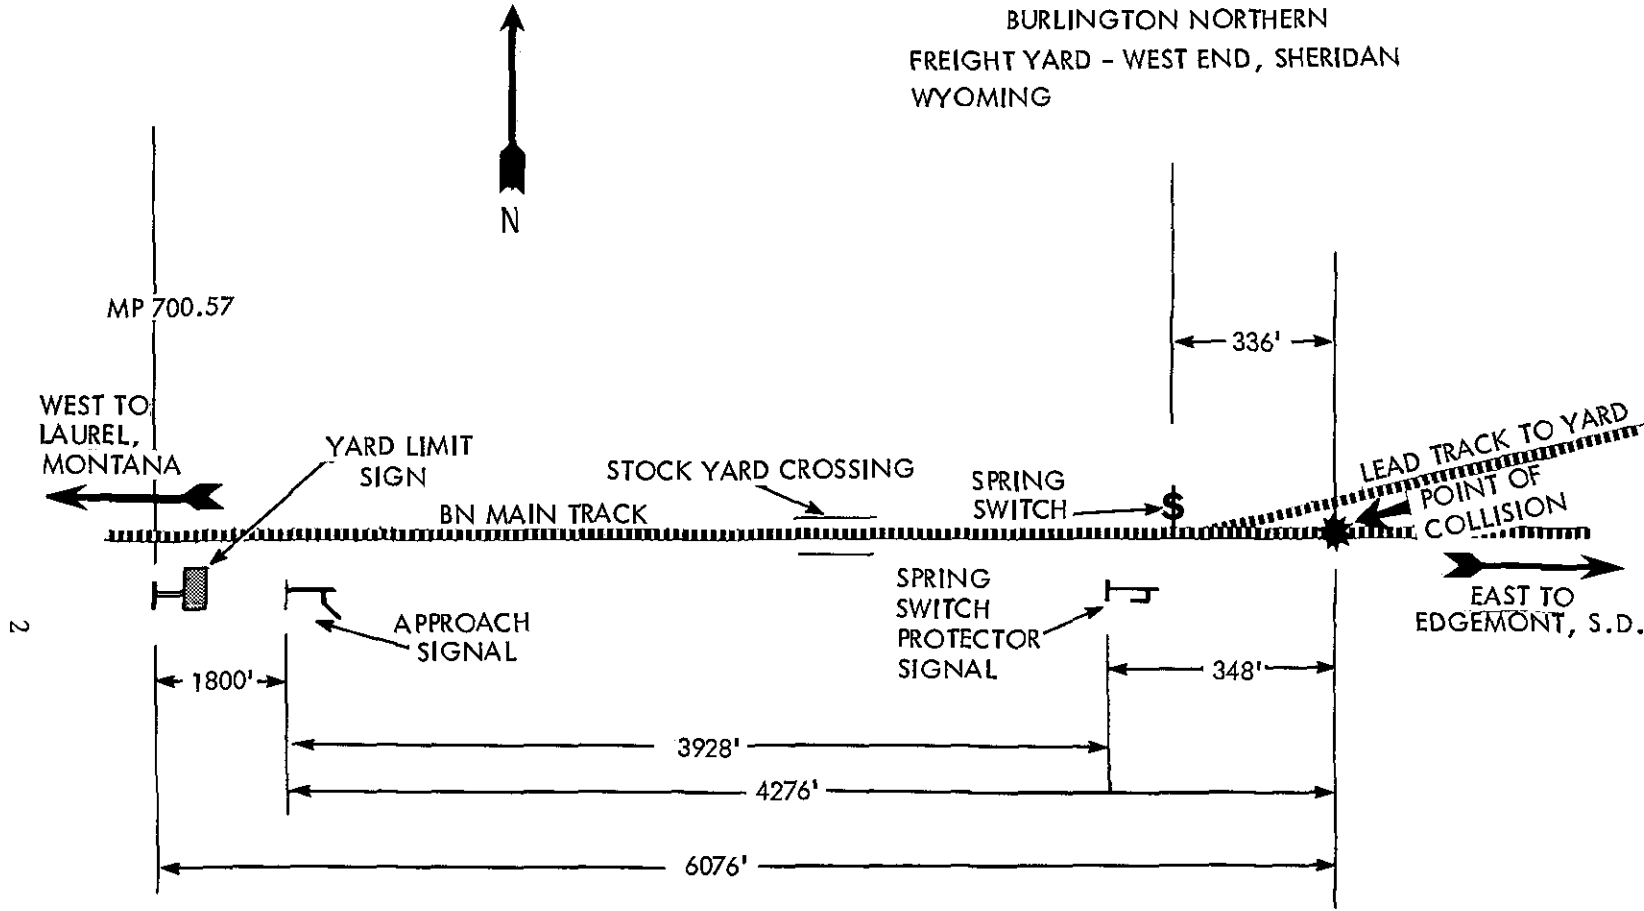
FIGURE NO. 1
RELATIVE DISTANCES FROM REFERENCE POINTS TO
POINT OF COLLISION - NOT TO SCALE

The point of collision was on the main track 348 feet east of a spring switch to the yard lead track. Other distances pertinent to the point of collision are shown in the sketch of figure No. 1.

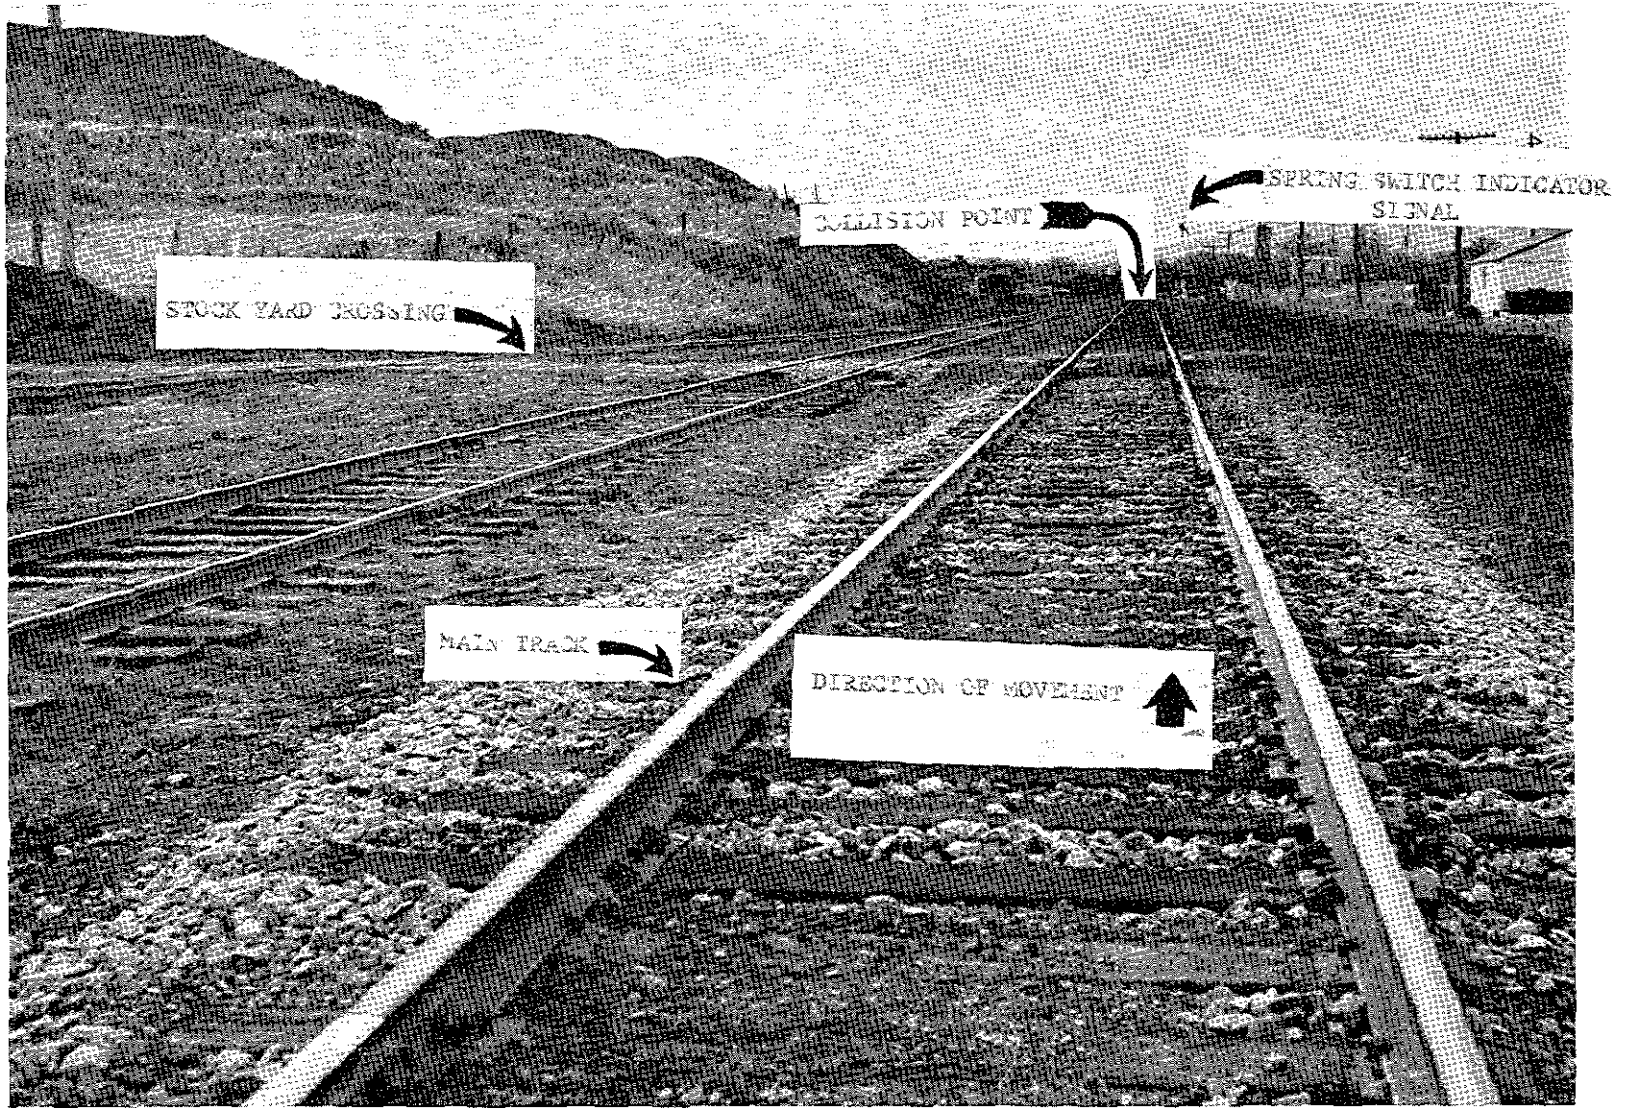
Figure 2.—General Area where derailment occurred.

There is a three-track grade crossing known as the Stock Yard Crossing, approximately 700 feet west of the lead track switch. Figure No. 2 is a picture of the immediate area where the collision occurred.

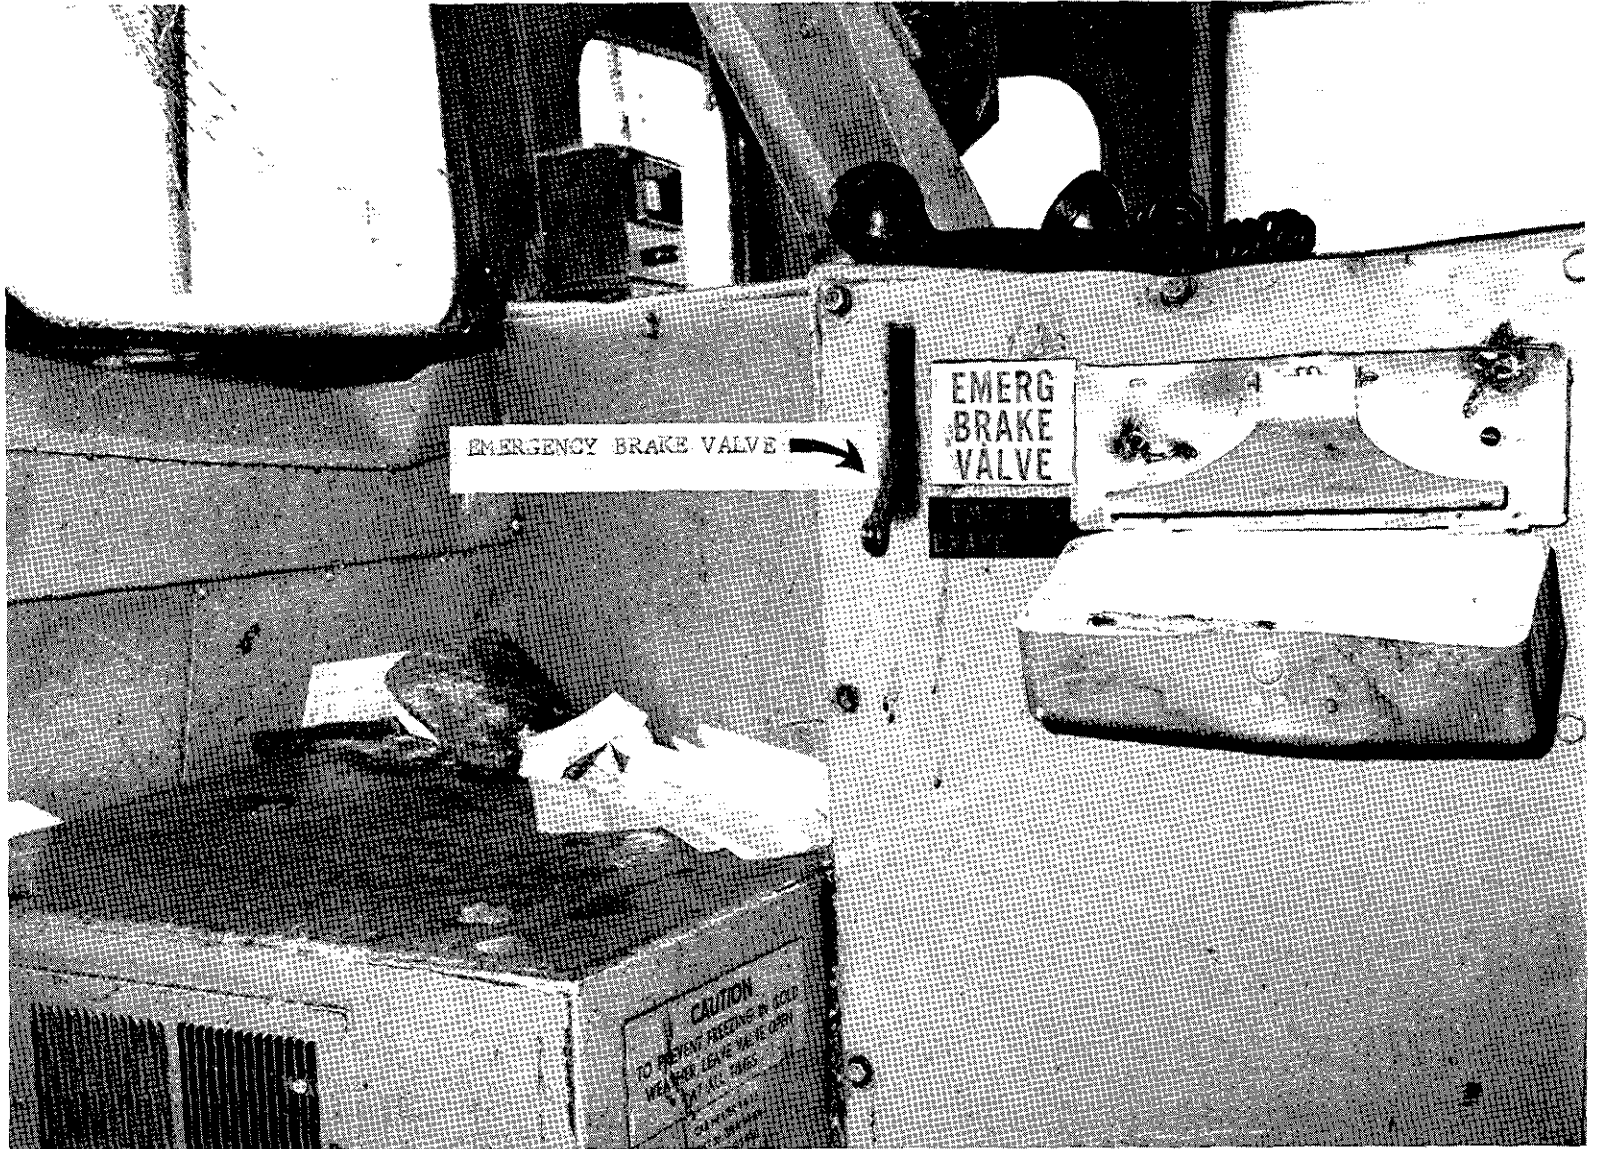
Figure 3.—Locomotive cab interior showing the emergency brake valve.

The effect of the brakeman's actions must be considered. If the brakeman had operated the emergency brake lever which was readily accessible to him on the back of the control stand, when he first saw the cars, an emergency brake application would have been initiated immediately. It has been noted in many investigations that trainmen are reluctant to override the control of the engineer (or fireman) except in cases where the engineer is incapacitated.

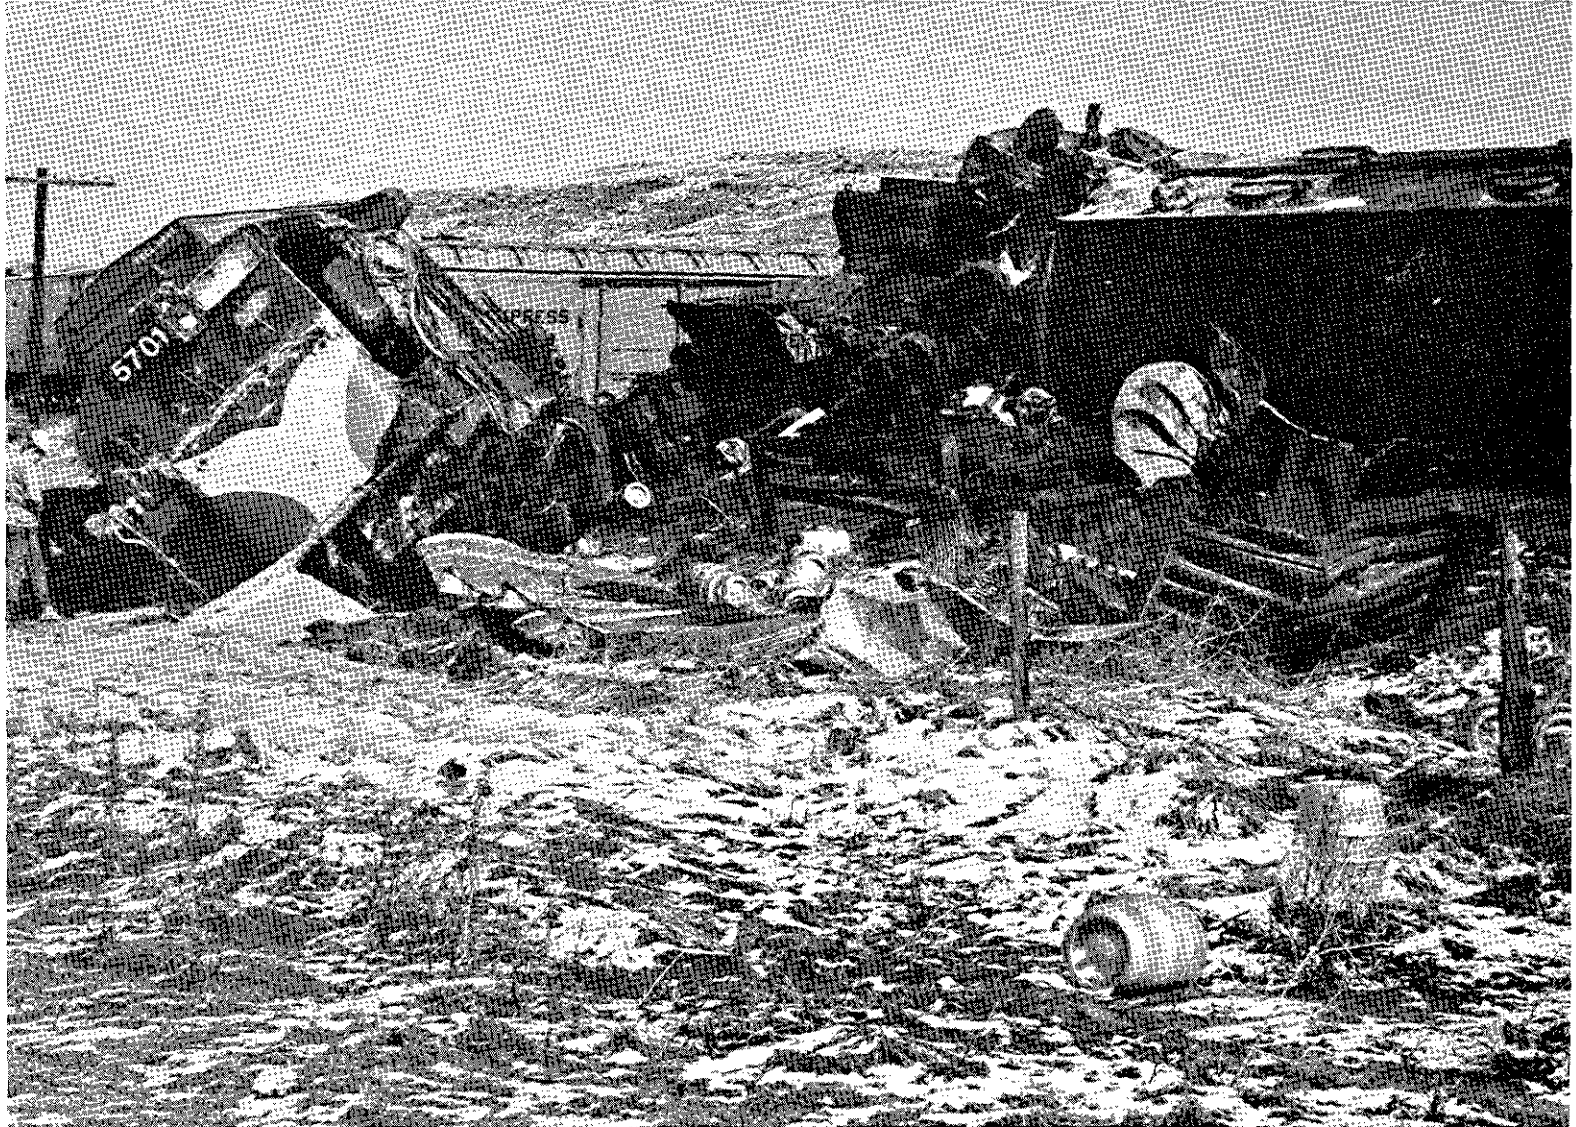
Figure 4.—Derailed unit 5701 showing location, position, and general condition after impact.

The point of collision was 348 feet east of the spring switch protective signal. Locomotive units 5701, 6457, and 6482 were derailed. The 5701 derailed to the south, leaning at a 45°

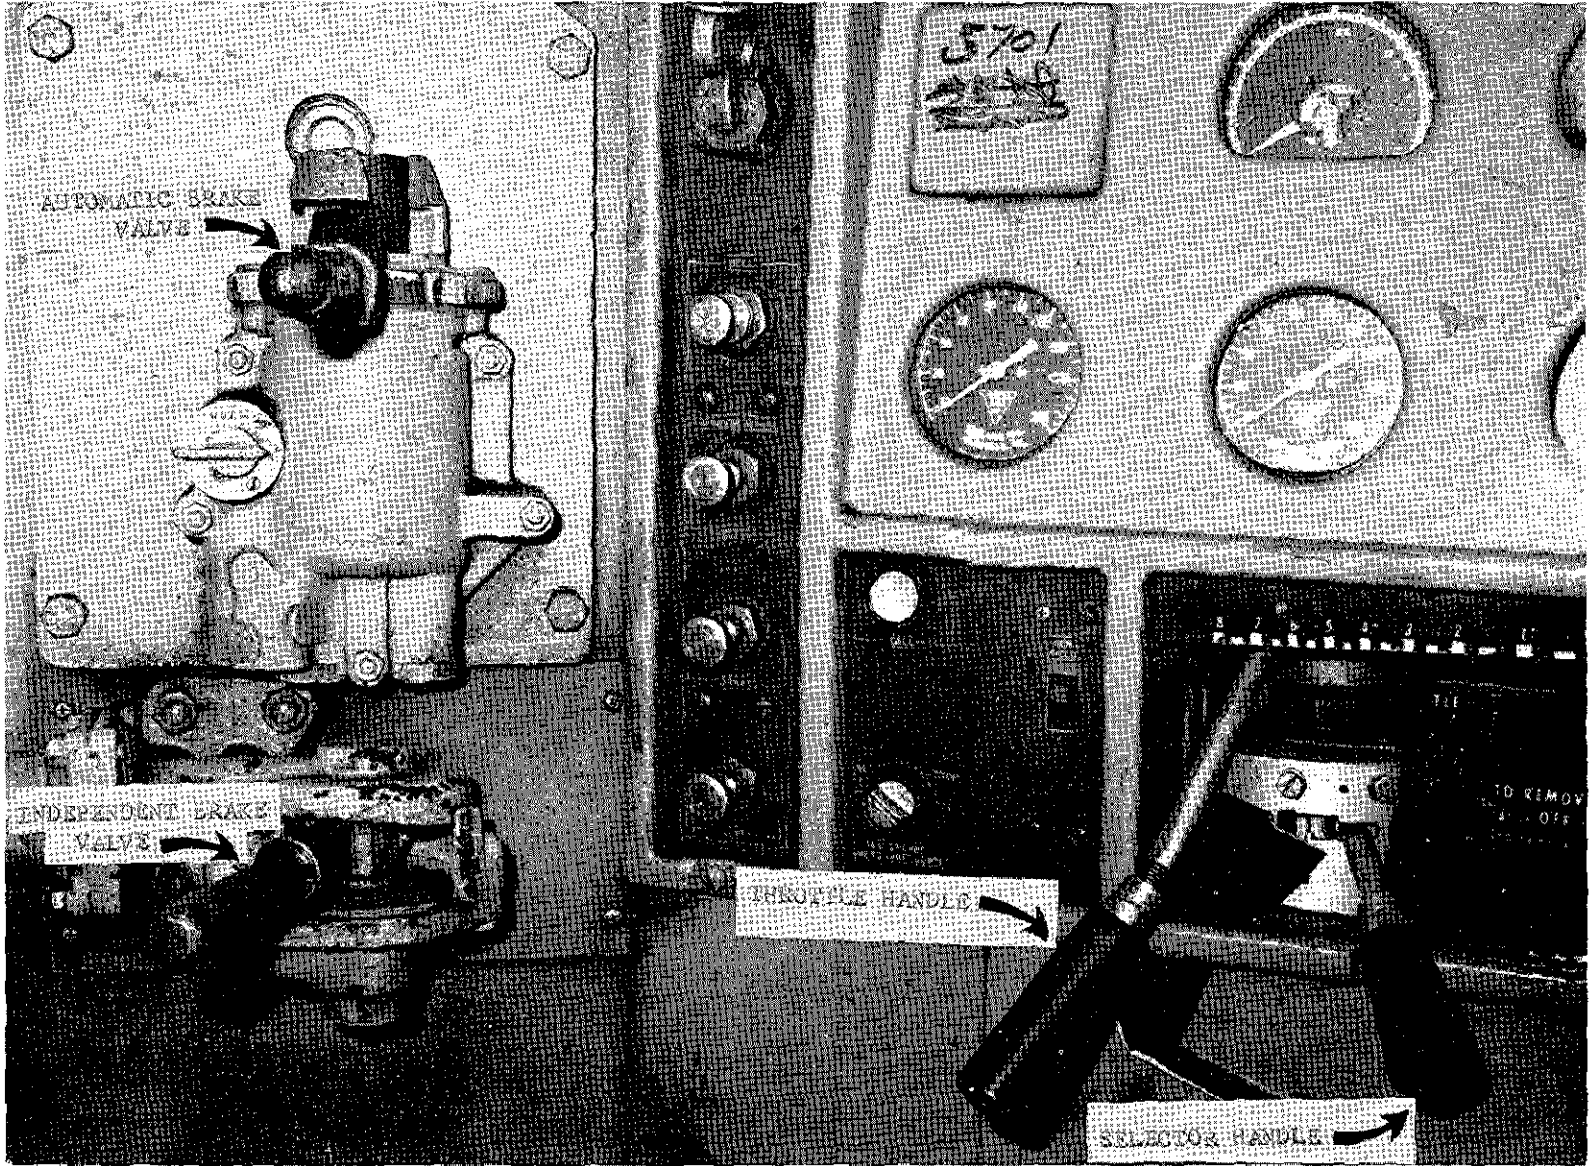
Figure 5.—Locomotive cab interior showing the brake levers and the operating controls.

The cab of diesel unit 5701 was not crushed nor badly deformed. When the locomotive hit the first car on the main track, the car started to climb up over the hood of the locomotive, but the corner of the car apparently dug into the locomotive nose and was restrained. The force of impact caused the locomotive to move to the right while the car travelled to the left without overriding the locomotive cab. It appears that with the exception of the left front corner of the cab, most of the damage resulted from loose objects within the cab. The three seats in the cab were thrown from the floor support columns. The front windows were badly cracked, but intact. The left front cab door was distorted considerably by the impact and hung as a twisted mass to the left side. The corner post around the side window was bent considerably but remained substantially in place. The seats which were fastened to the floor supports with pins became detached and were tossed around the cab. (See Figures 5 and 6.)

The window in front of the engineer's position appears to have been struck from within by a heavy object. Figure No. 5 shows the throttle handle and the selector handle bent downward. The radio speaker head and support bracket were broken.

The interior of the locomotive cab was in complete disarray. Indications were that objects from within the cab caused some of the damage. The locomotive controls indicate a heavy object hit them and bent them downward out of alignment. (See Figure 5.) This may have been the body of the fireman as he pitched forward upon impact because of lack of restraint. The badly cracked window in front of the control position is also indicative of having received a blow from within. Since the window was not penetrated, which would eliminate a heavy hard object, there is the possibility that this blow was
