✓  
**RAILROAD ACCIDENT REPORT,**

✓✓  
**BURLINGTON NORTHERN INC.**

**MONOMETHYLAMINE NITRATE EXPLOSION**

✓✓  
**REPORT NUMBER: NTSB-RAR-76-1 .**

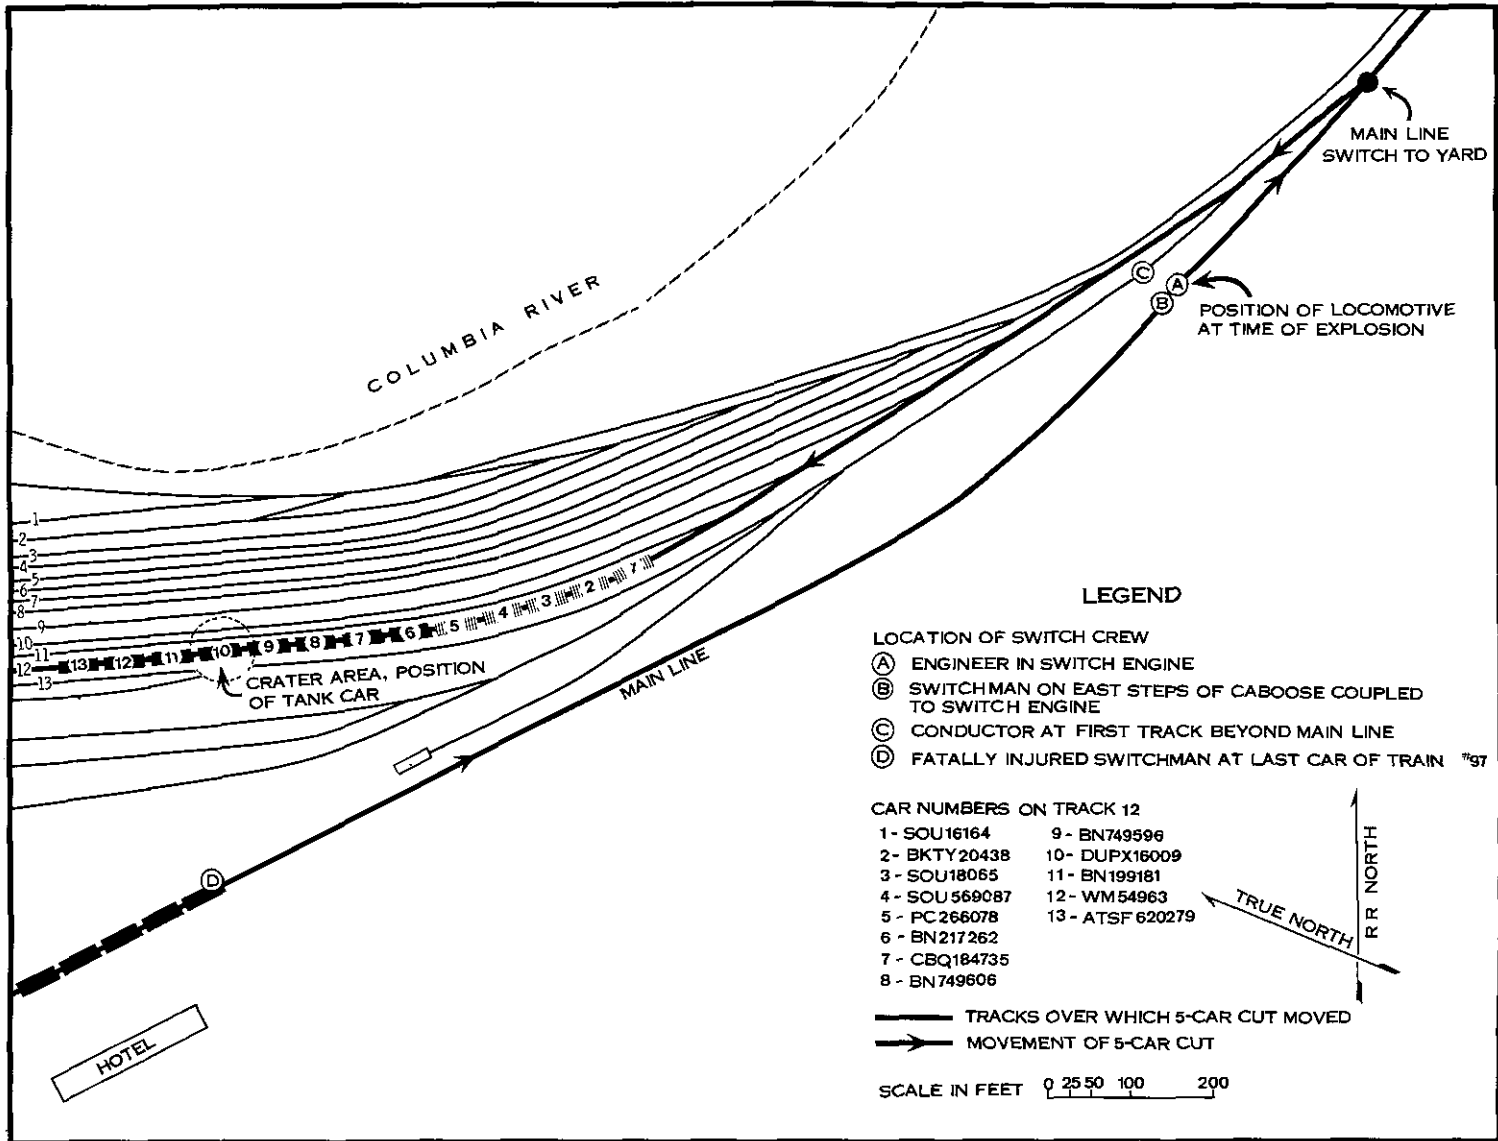
Figure 2. Accident area, Wenatchee, Washington, August 6, 1974.

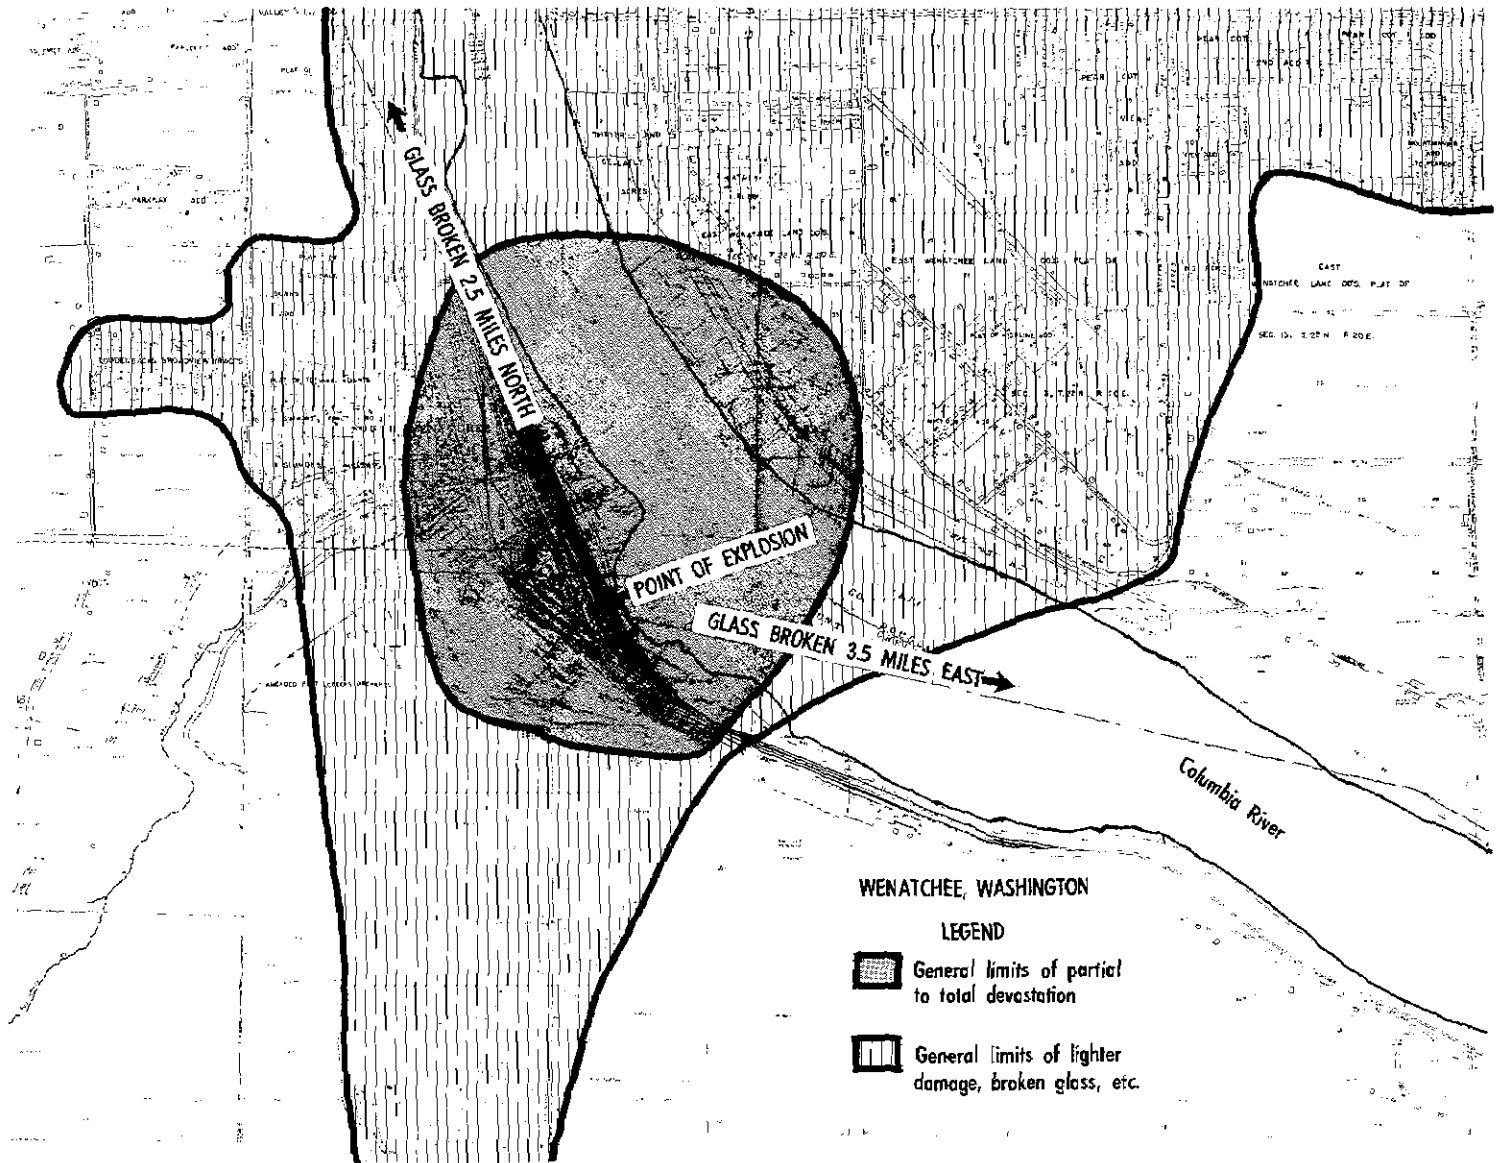
Concussion and fire caused most of the damage. (See Figure 3.) Parts of the tank car were found up to 1 mile from the site. Many cars in Apple Yard were ignited, and hundreds of acres of grassland in Chelan and Douglas Counties burned. Most of the structural damage was within a radius of about 1 mile, but broken glass was reported 3.5 miles east and 2.5 miles north.

Figure 3. Explosion damage patterns, Wenatchee, Washington, August 6, 1974.

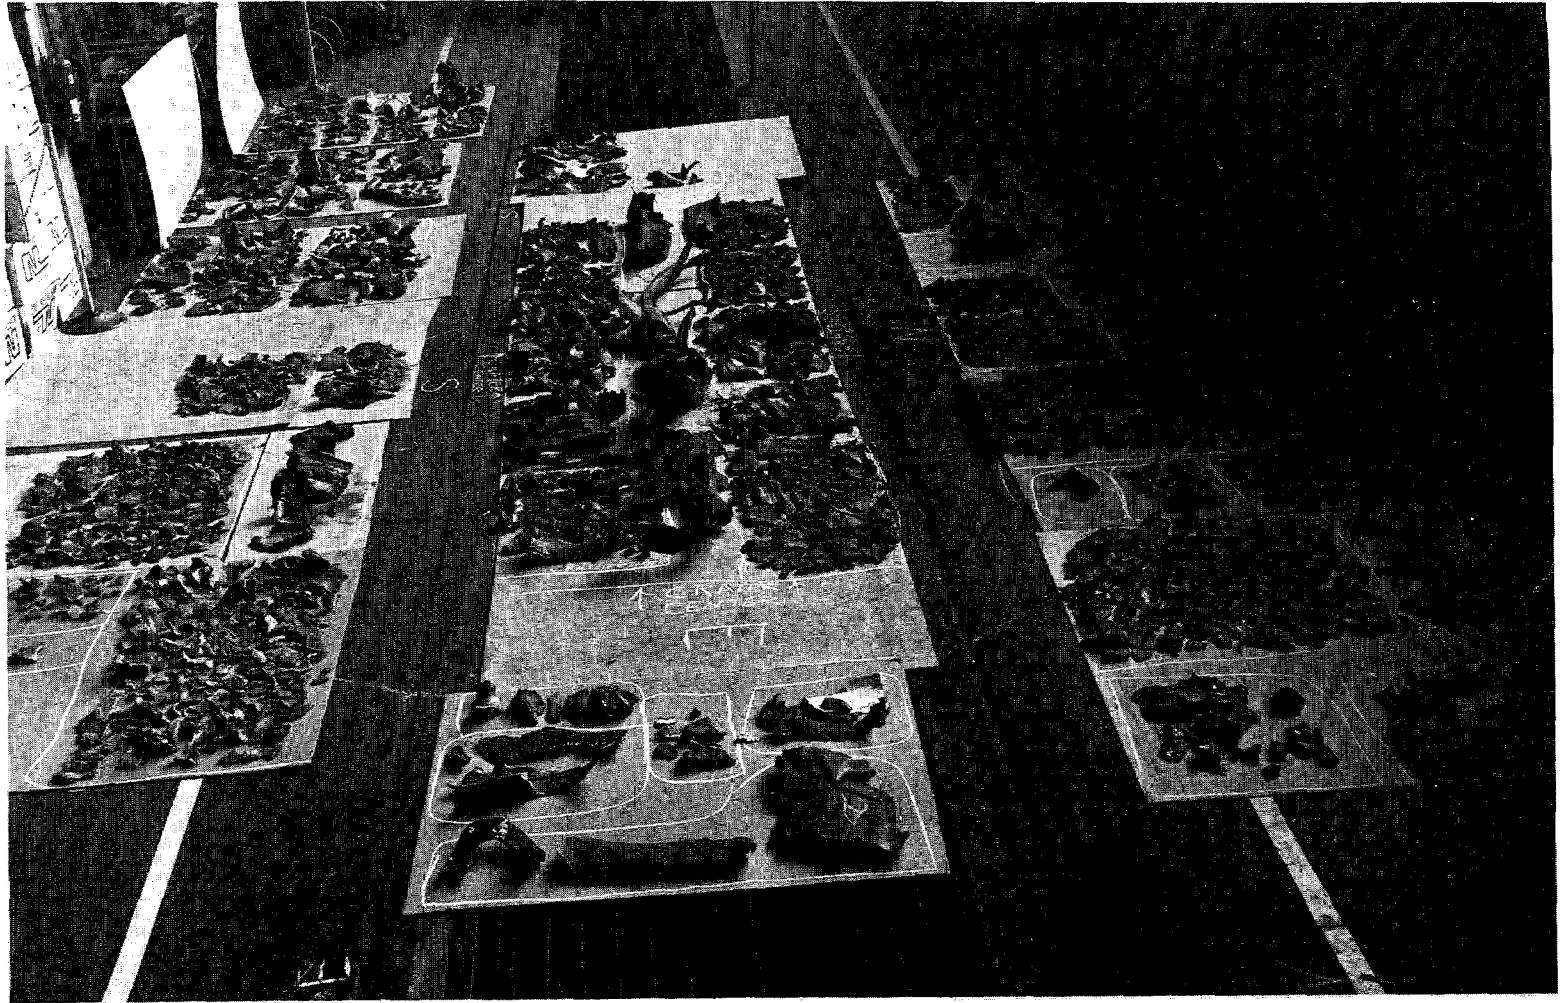
Examination of Car Debris--About 4,000 pieces weighing 3,760 lbs., or 18.8 percent of the inner tank shell, were recovered. (See Figure 4.) The size, shape, and appearance of the pieces varied widely, and included "blued" fragments; clean fragments; fragments with dark residues; hot gouges; cold gouges; collision impact marks; flattened pieces; fragments with missile impact marks and ripple marks; crushed, bent, and torn parts; and parts with splatter-shaped residues. No parts of the car were recovered undamaged.

Figure 4. Stainless steel inner tank of DUPX 16009, displayed in accordance with retrieval location.

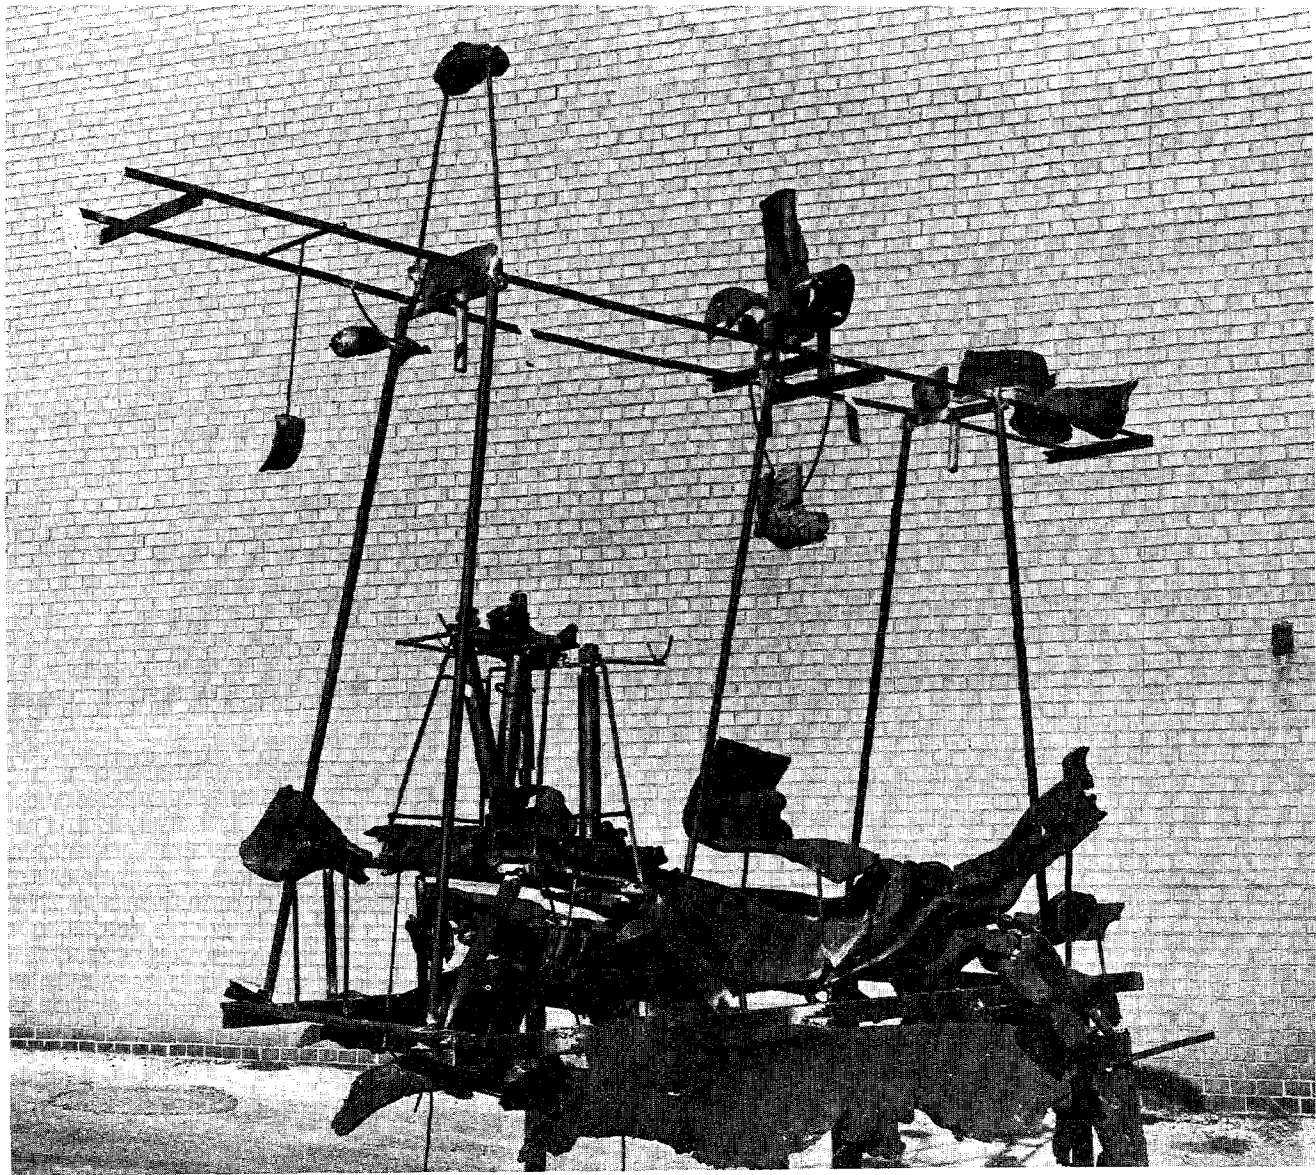
sill, were reconstructed at the AAR's test center in Chicago. Some parts identified were from the manway entrance area and adjacent valves and attachments. (See Figure 5.)

Figure 5. Full-scale reconstruction of the lower central area of the inner tank and adjacent parts of DUPX 16009.

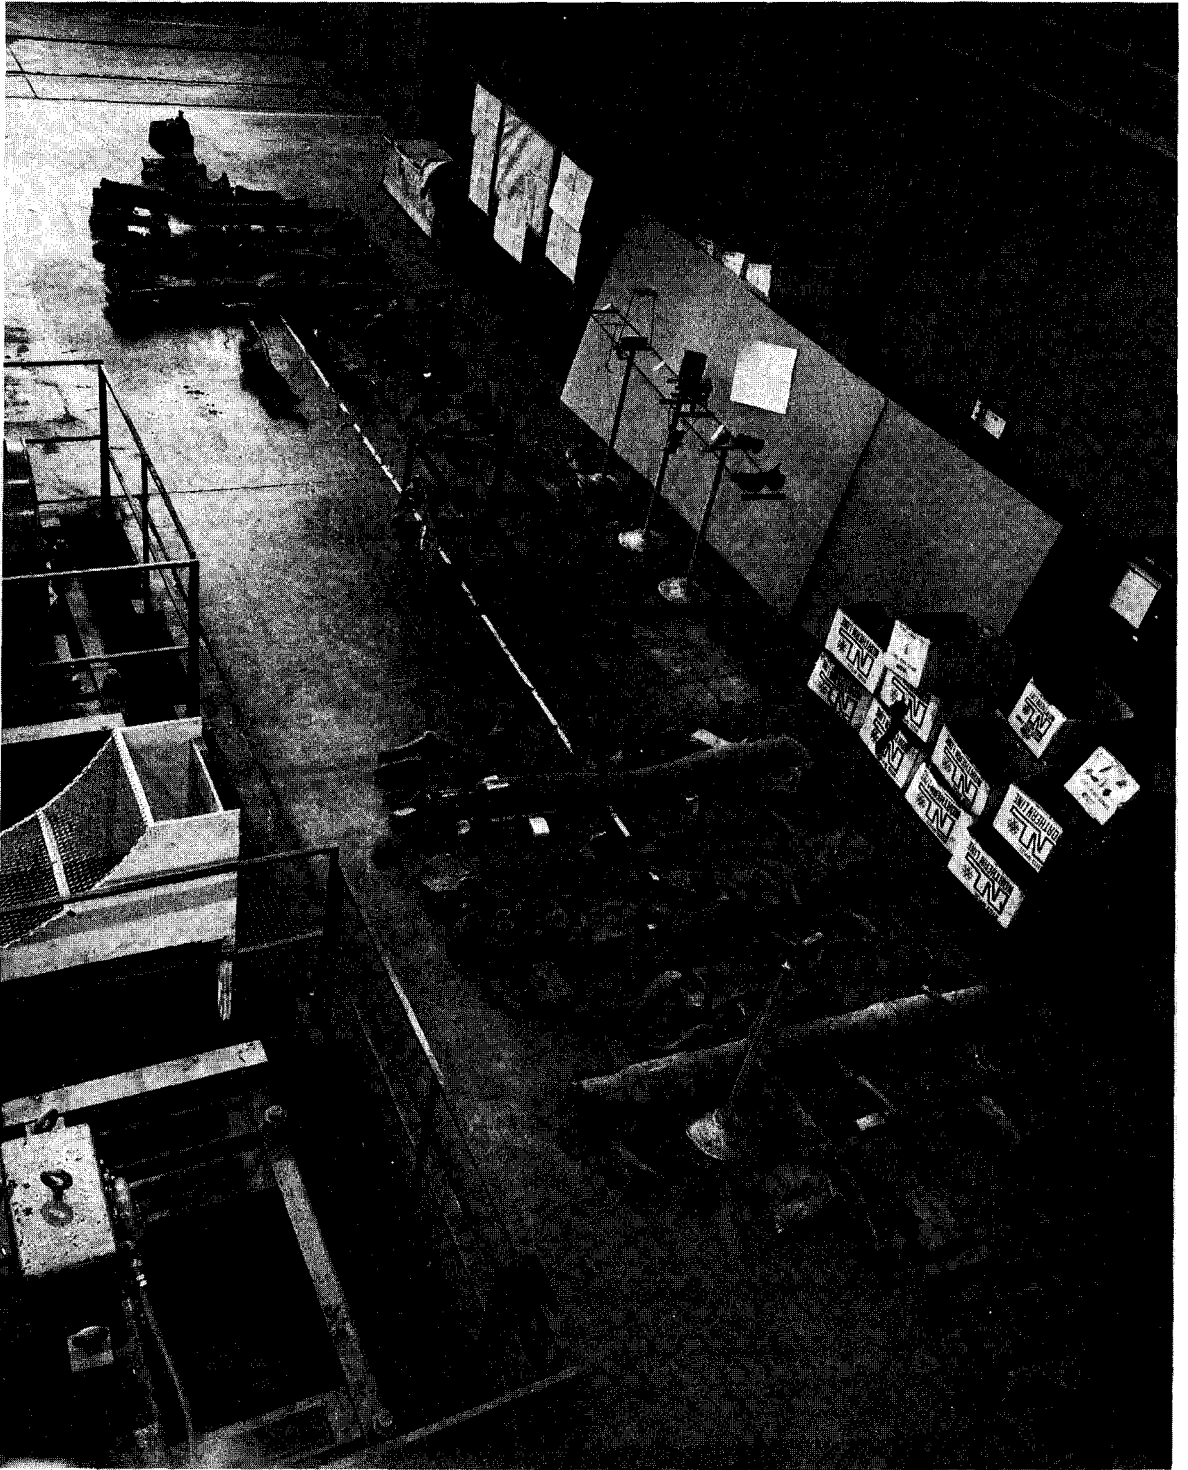
Figure 6. Reconstructed running gear sill assembly and coupler of DUPX 16009 with reconstructed portions of the inner tank.

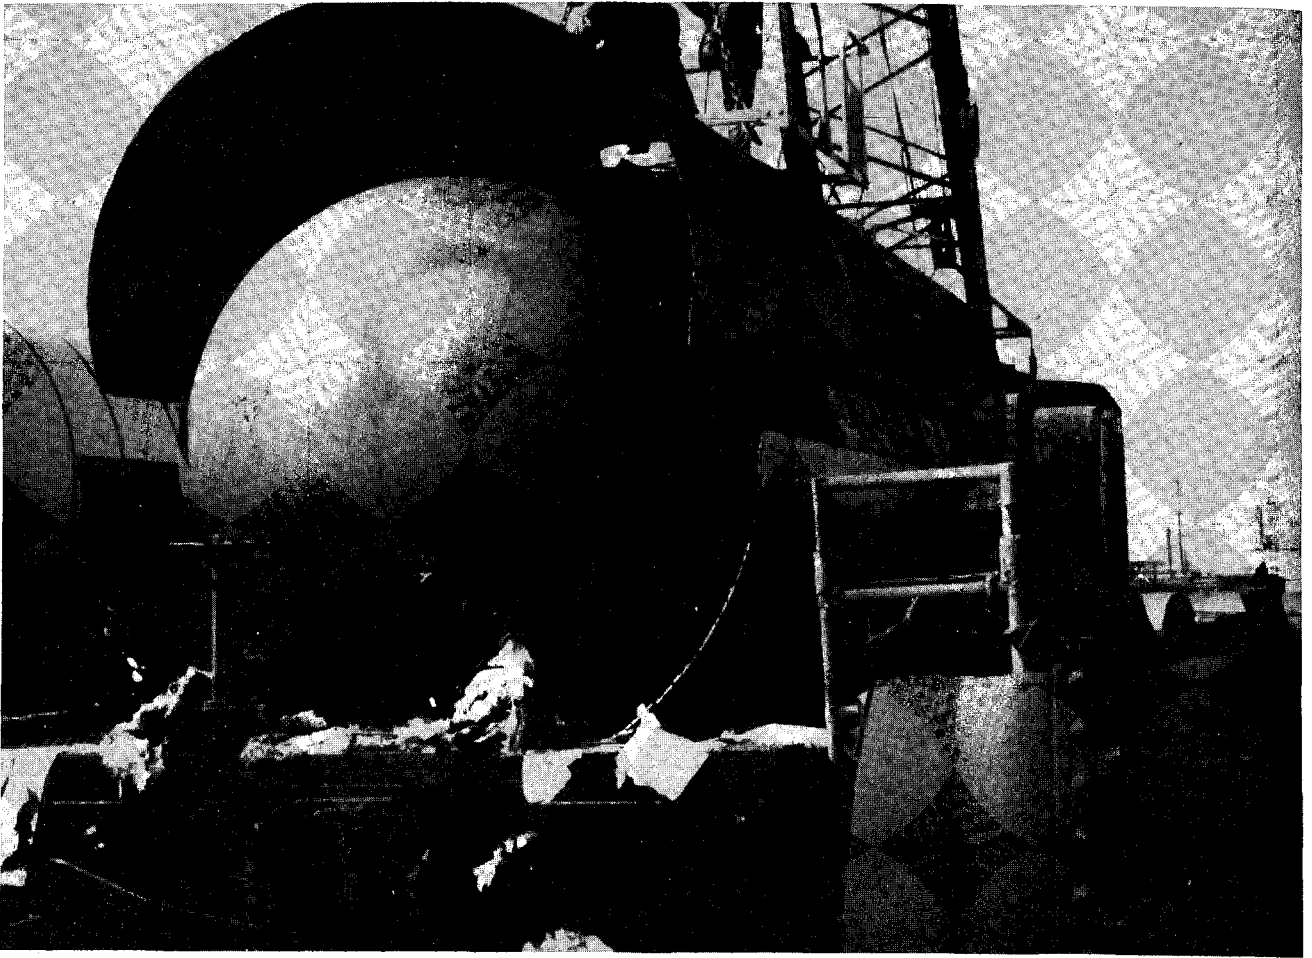
Figure 8. Disassembly and inspection of DUPX 16005.

DUPX 16005 was inspected and was in sound condition with respect to the insulation, tank, safety valve, and fittings. At 150-psig hydrostatic pressure, a pinhole leak was discovered in the external coil near the center of the car. Small grinding marks were found in the tank. A hydrostatic test of the tank indicated that a gasket on the sight glass leaked at 60 psig.

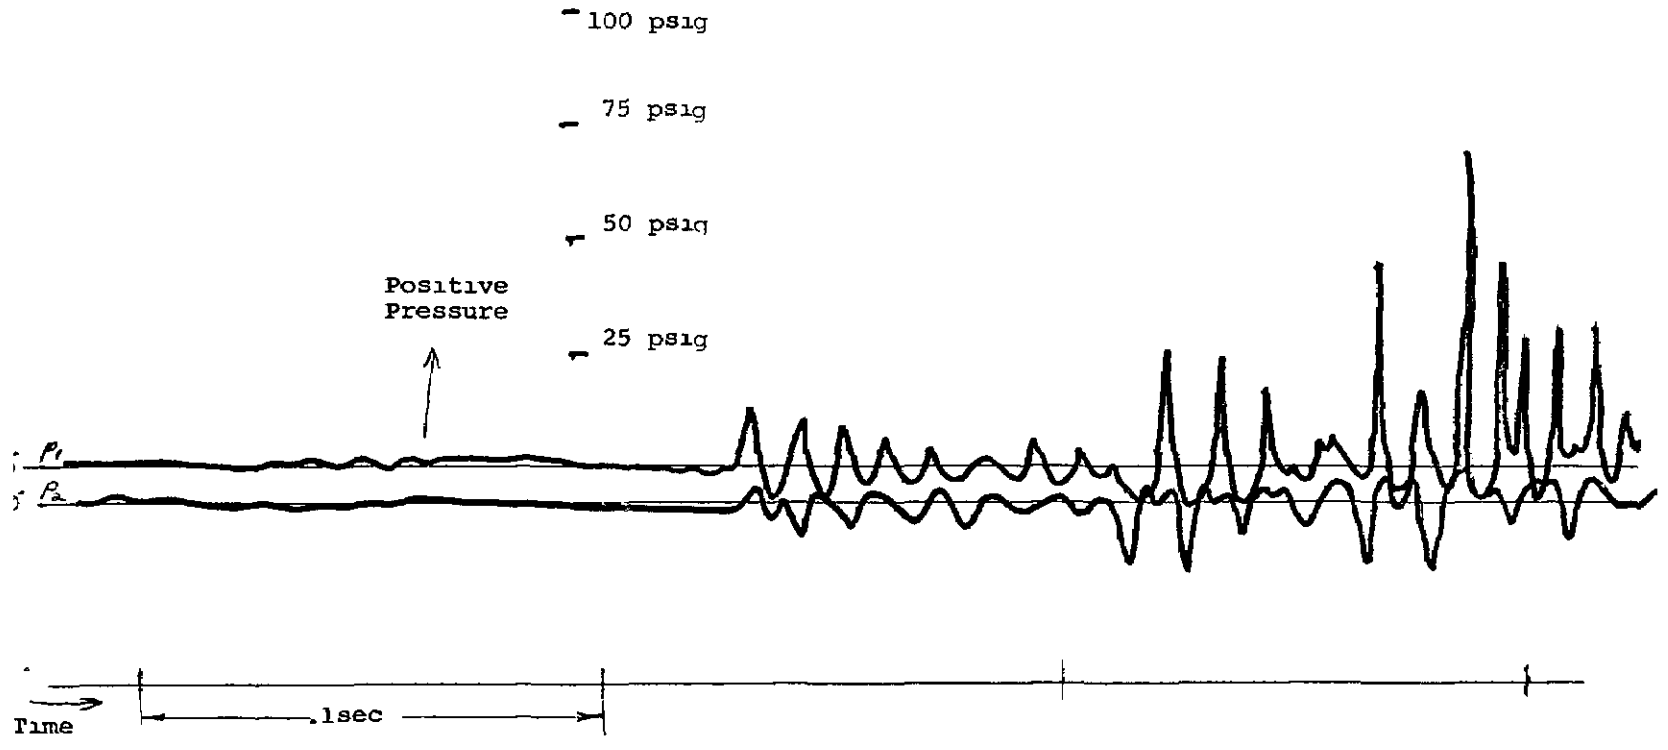
Figure 1  
Tracing of Oscillograph Record

A reaction started inside the inner tank, during successively increasing pressure peaks (See Figure 1, Appendix B.) through the cavitation or adiabatic compression mechanism, might have progressed to detonation as observed. The vapor space above the liquid could have provided room for the internal pressure to increase without detonation, if the gases generated had breached the tank or fittings above the vapor space at relatively low pressure. Such a breach might account for the first of the two explosions reported by some witnesses. Continuing deflagration at that location could have produced enough heat and pressure to trigger the detonation. The appearance of the manway ring debris suggests this possibility cannot be ruled out.
