# NATIONAL TRANSPORTATION SAFETY BOARD

## RAILROAD ACCIDENT REPORT

HEAD-ON COLLISION  
BETWEEN BURLINGTON NORTHERN RAILROAD  
FREIGHT TRAINS 602 AND 603  
NEAR LEDGER, MONTANA, ON AUGUST 30, 1991

**Abstract:** On August 30, 1991, eastbound Burlington Northern Railroad freight train 602 collided head on with westbound Burlington Northern Railroad freight train 603 at milepost 85.55 north of Ledger, Montana. Three crewmen were killed, and four were severely injured.

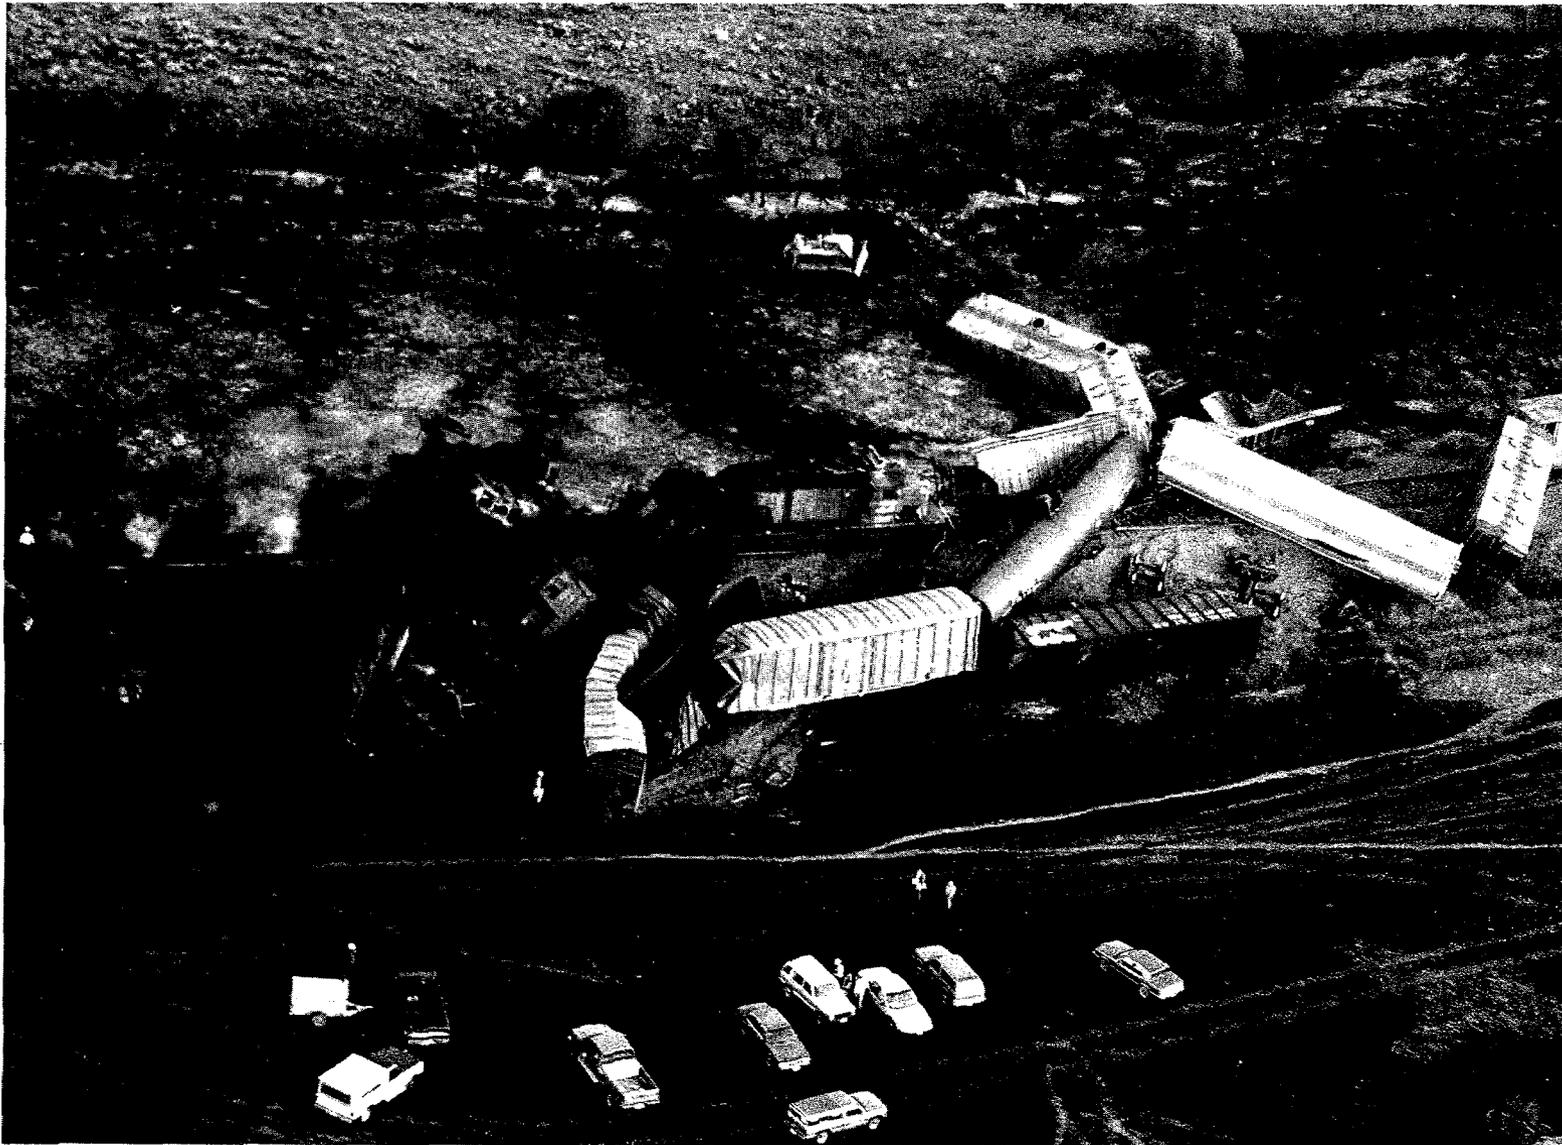
Figure 2.--Aerial view of accident scene.  
Photo courtesy of *The Independent Observer*, Conrad, Montana.

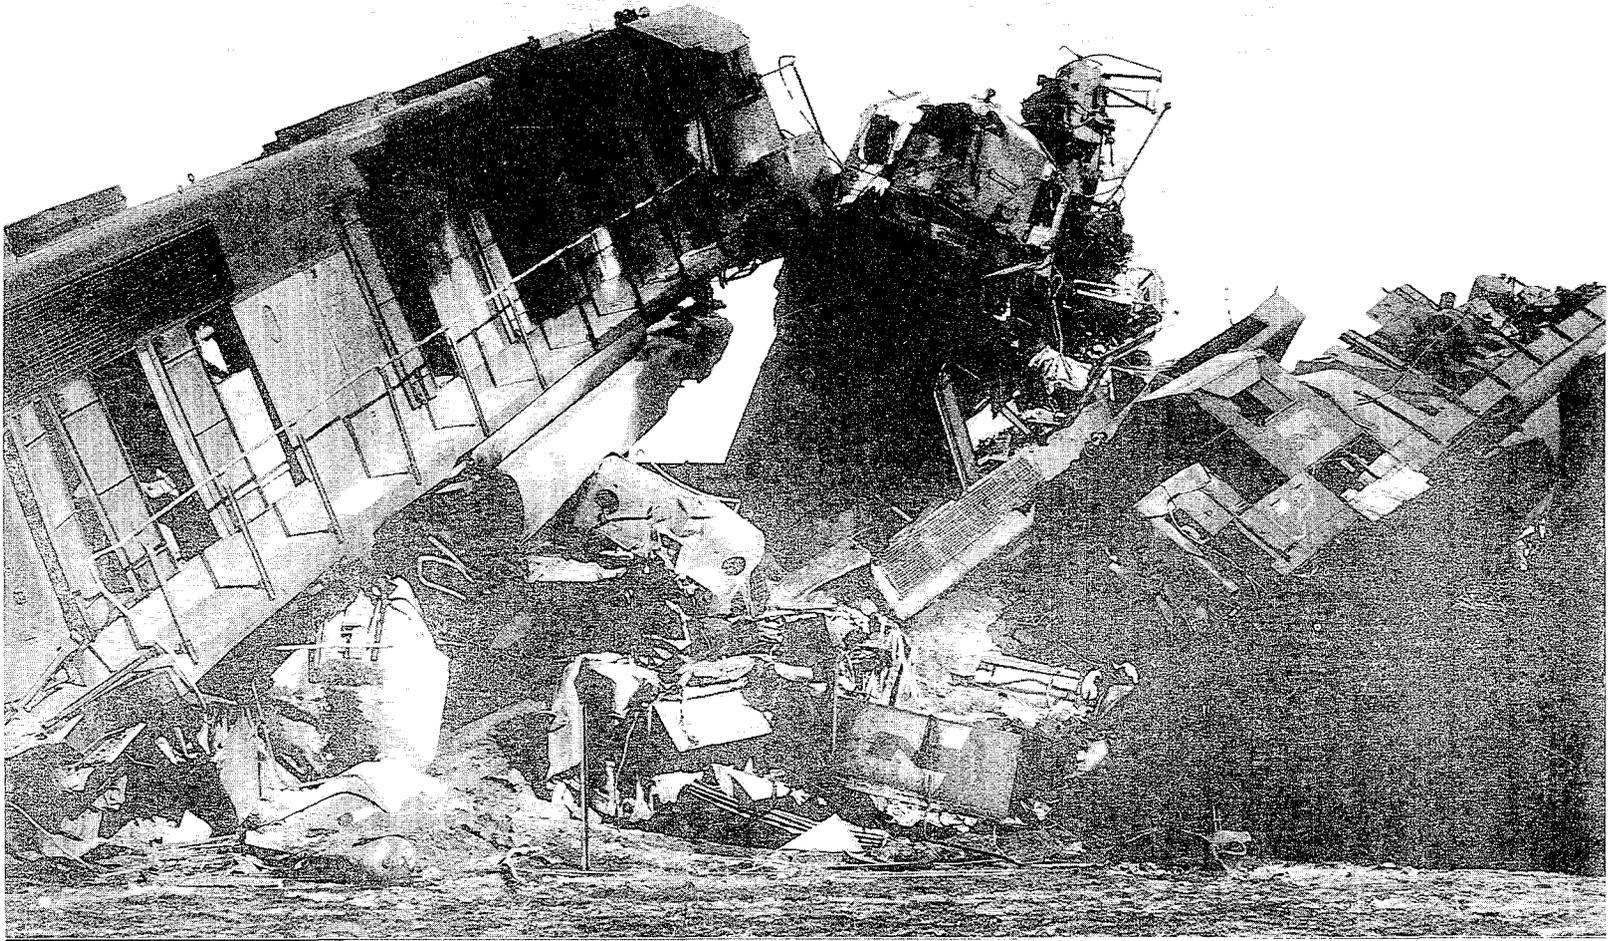
Figure 3.--Point of impact.  
Photo courtesy of Burlington Northern Railroad.

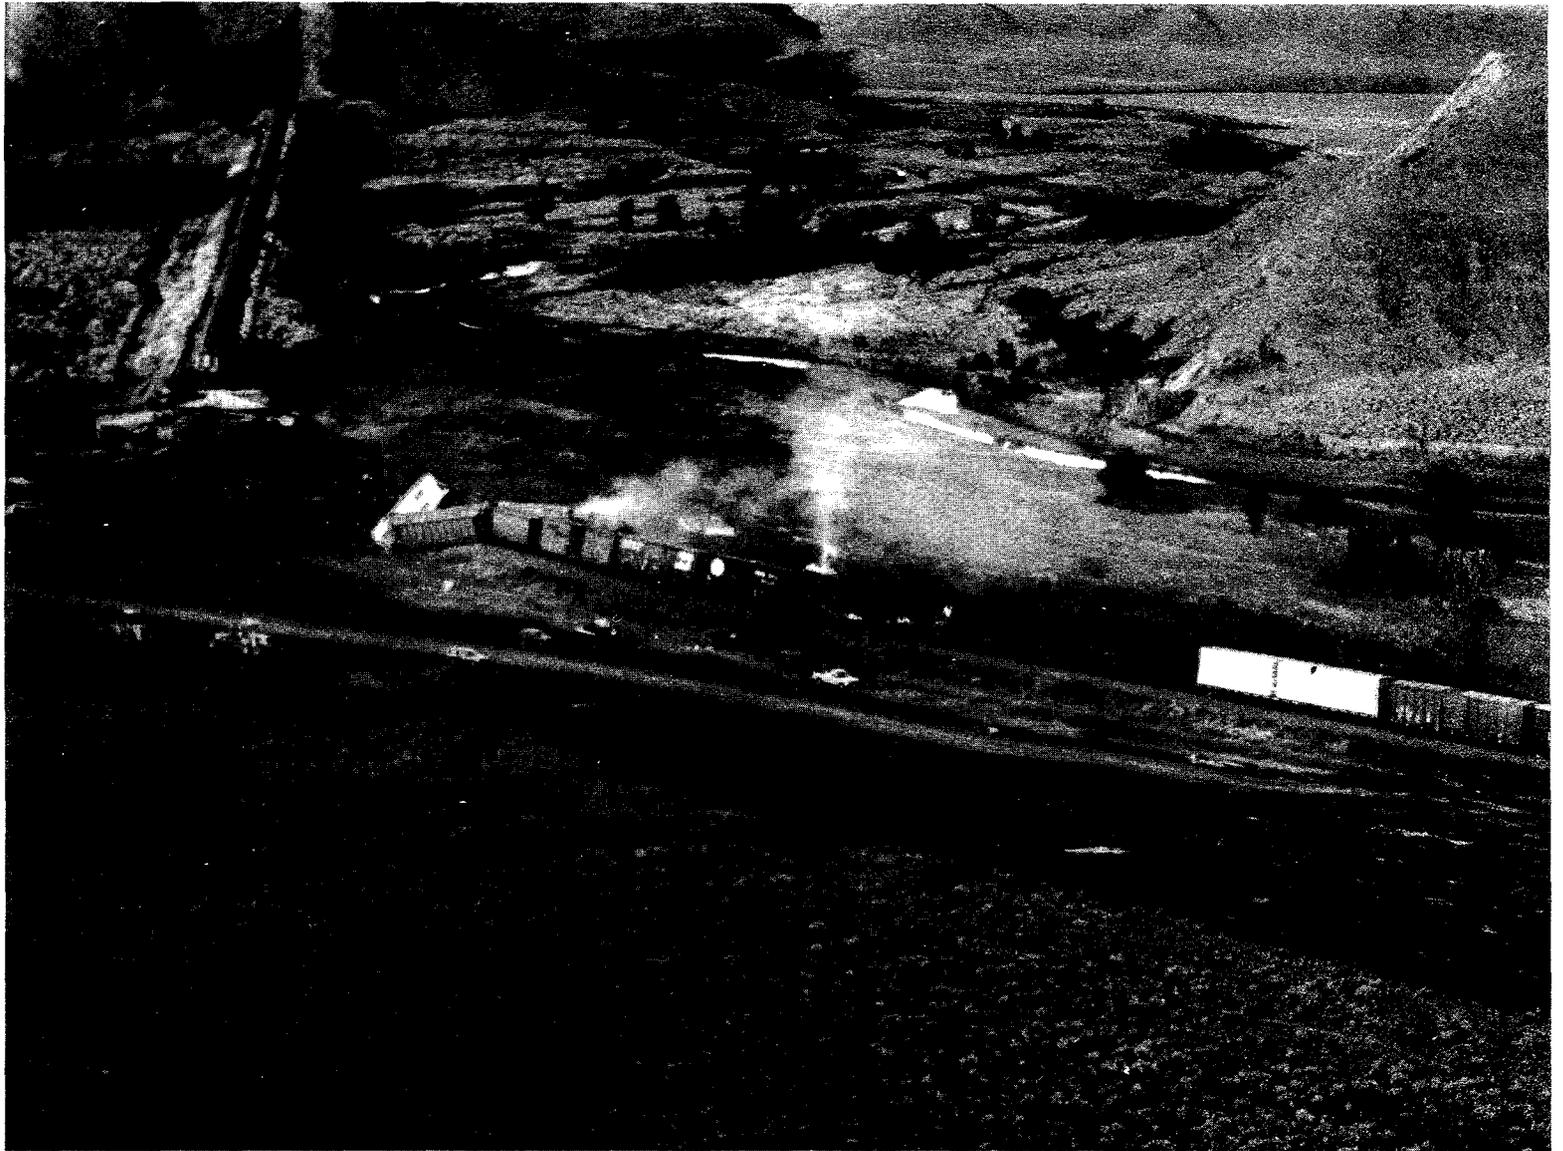
Figure 4.--Aerial view of accident scene, looking west.  
Photo courtesy of *The Independent Observer*, Conrad, Montana.
