# NATIONAL TRANSPORTATION SAFETY BOARD

## RAILROAD ACCIDENT REPORT

DERAILMENT OF  
BURLINGTON NORTHERN RAILROAD COMPANY  
FREIGHT TRAIN NO. MTC-0718  
NEAR CRYSTAL CITY, MISSOURI  
JULY 18, 1983

NTSB/RAR-84/01

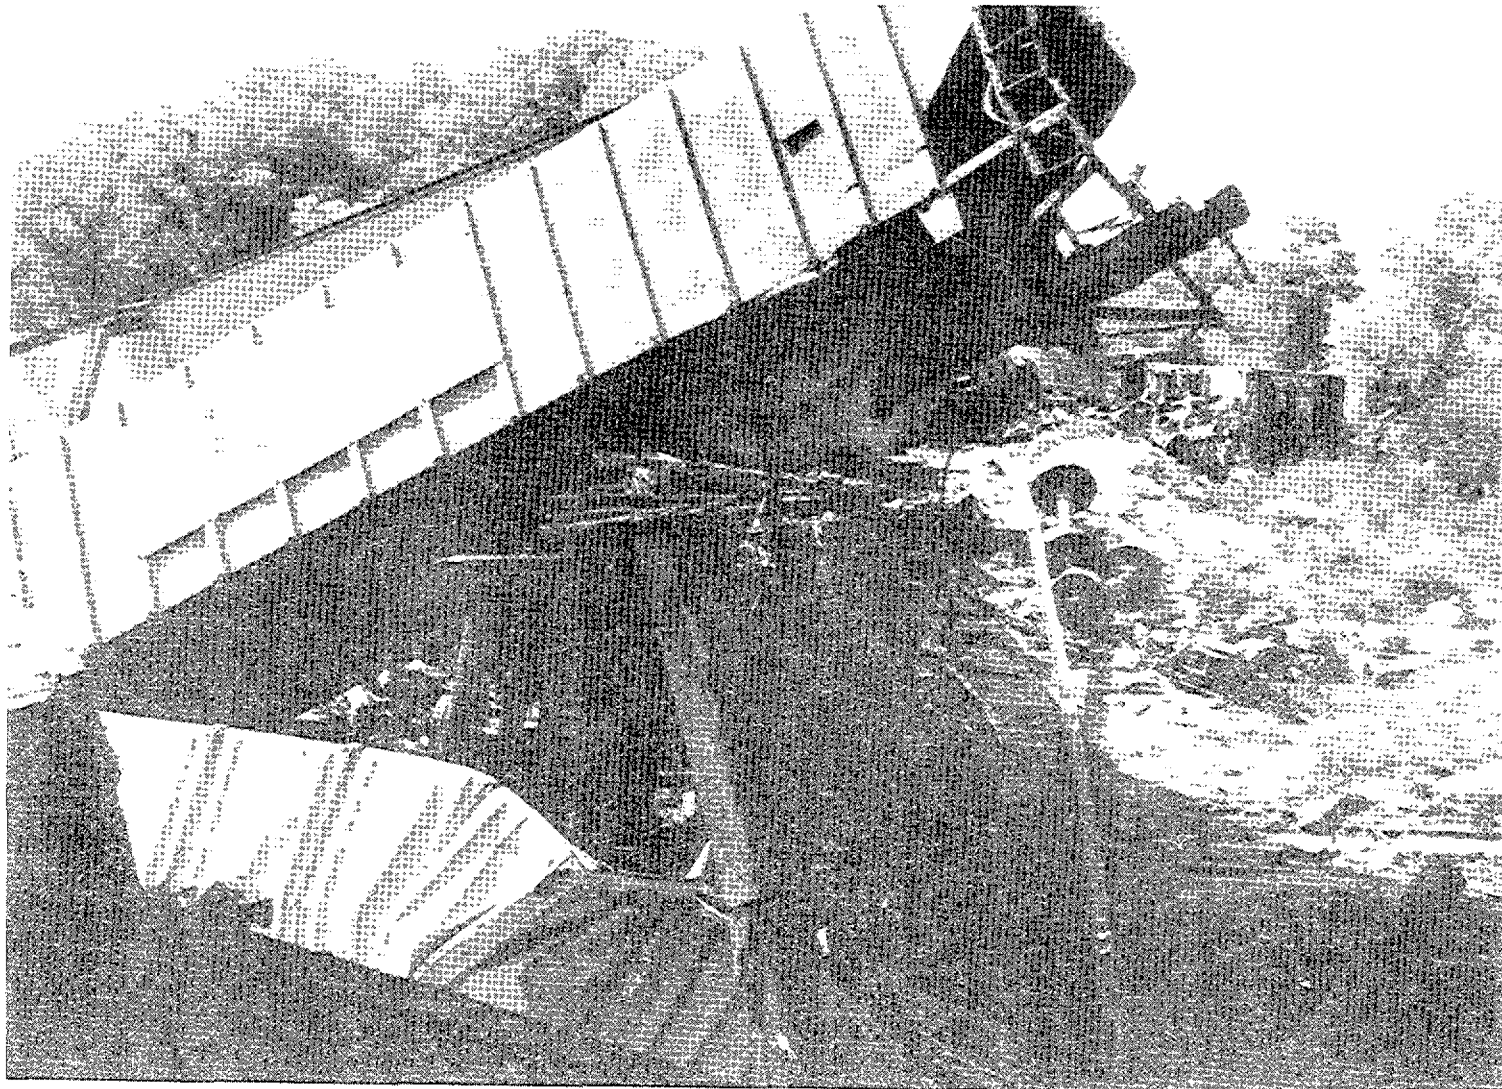
About 1,530 feet of track were damaged in the accident. A 110-foot-long, eight bent <sup>2/</sup> wooden trestle supporting the track structure across Selma Creek was destroyed in the accident. (See figure 3.) Also destroyed were the power-operated switch leading to the siding north of the trestle and a 140-foot-high microwave transmission tower situated just to the west of the switch.

Figure 3.—Derailed cars and destroyed wooden trestle at derailment site.

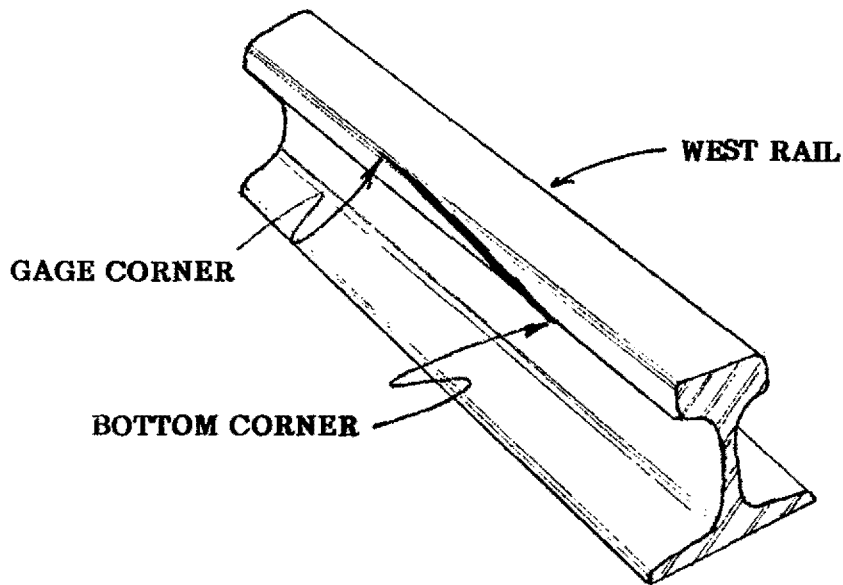
Figure 4.--Sketch of southernmost derailment marking at transition from tangent track into 3-degree curve.

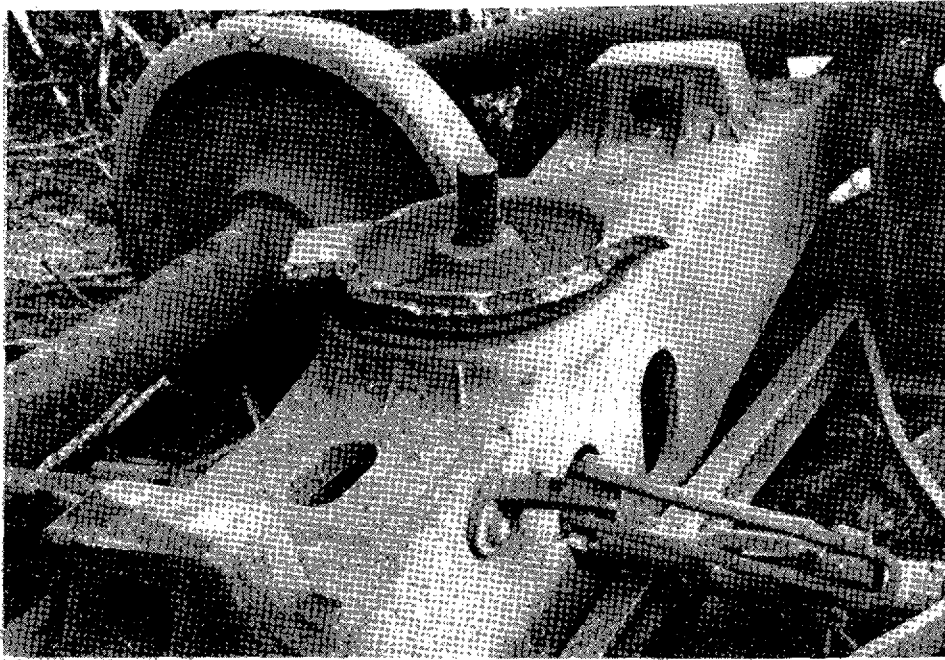
Postaccident examination of the derailed equipment disclosed that the body centerplate from the "A" end <sup>7/</sup> of hopper car BN 958200 had separated from the car body during the accident (see figures 5, 6, and 7) and had multiple fractures with rust-covered surfaces. The examination also disclosed that two other of the ballast-laden hopper cars that were derailed in the accident, BN 958104 and NP 85412, had fractured body centerplates with rusted surfaces. The cars were not overloaded. All three of the ballast cars were stenciled "MW" in accordance with 49 CFR 215.305 and were dedicated to ballast hauling services.

Figure 5.—Car body centerplate from BN 958200 shown separated from car body and resting in place on "A" end truck bolster.

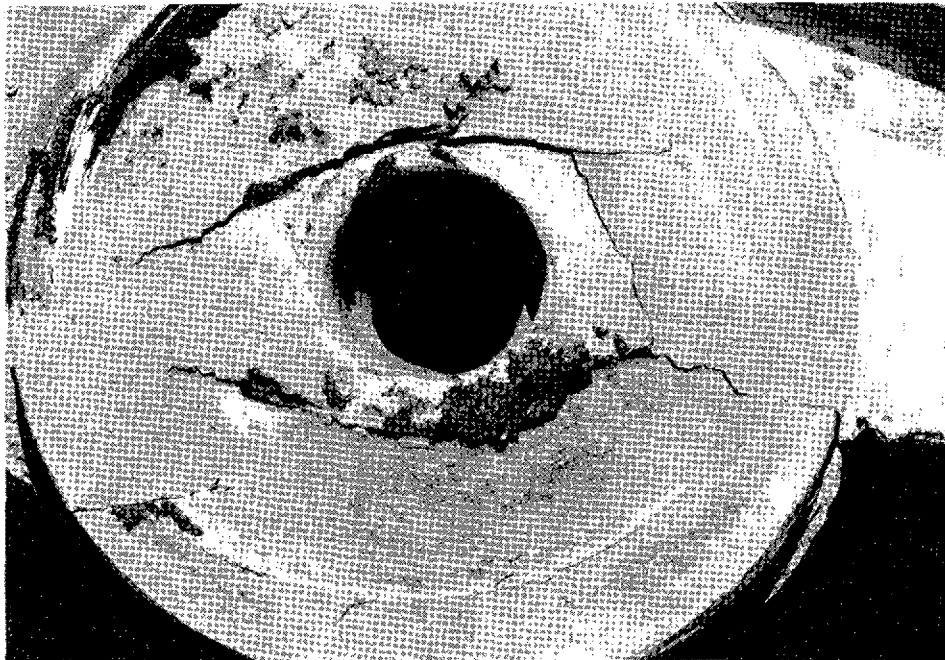
After the accident, the body centerplate from the "A" end of MW hopper car BN 958200 was taken to a BN facility for metallurgical analysis. (See appendix E.) The examination disclosed (1) the presence of weldment repair that had been performed at some undetermined time prior to the accident, (2) indications that the centerplate may have been displaced prior to the accident, (3) center pin elongation without any crack initiation in that area, and (4) multiple heavily rusted fracture surfaces.

Figure 6.—View of the underside of car body centerplate from "A" end of BN 958200 showing multiple rust-covered fracture surfaces.

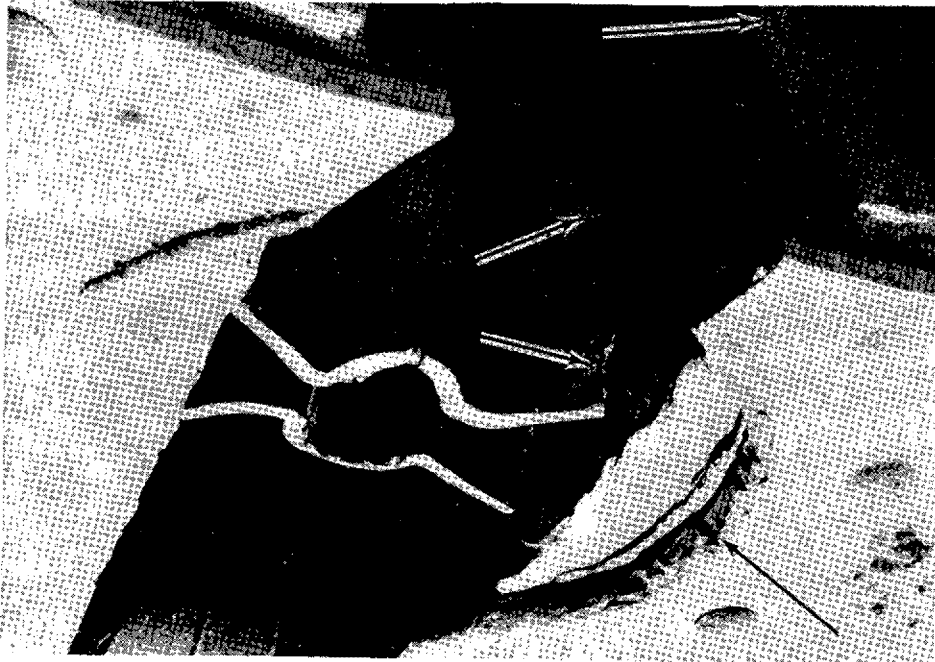
Figure 7.—Underside view of car body center casting at "A" end of BN 958200 with centerplate displaced. Note rust-covered fractures indicated by arrows.

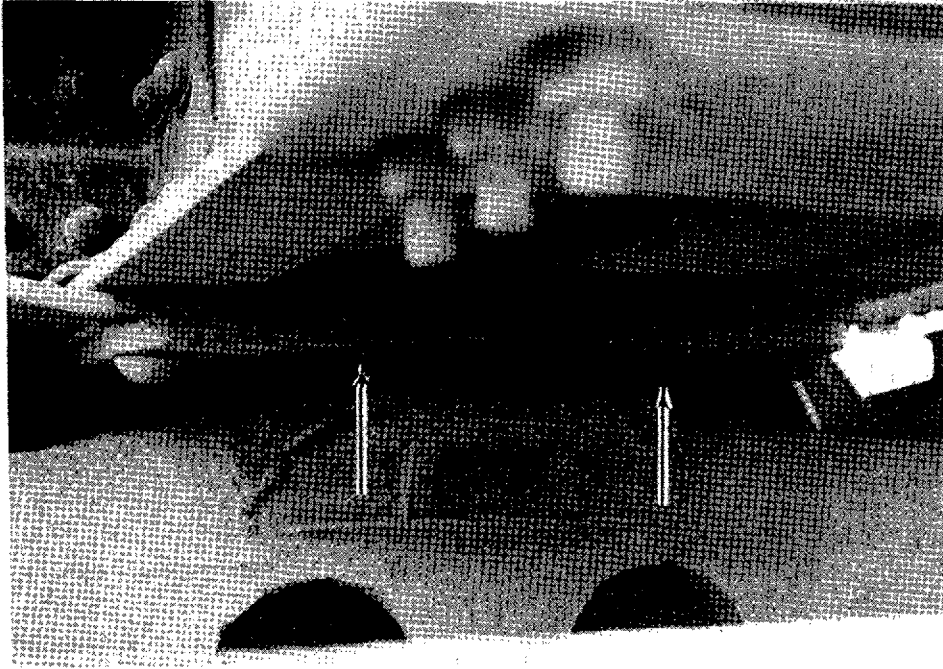
Figure 8.—Fractured centerplate at "A" end of GN 78206.

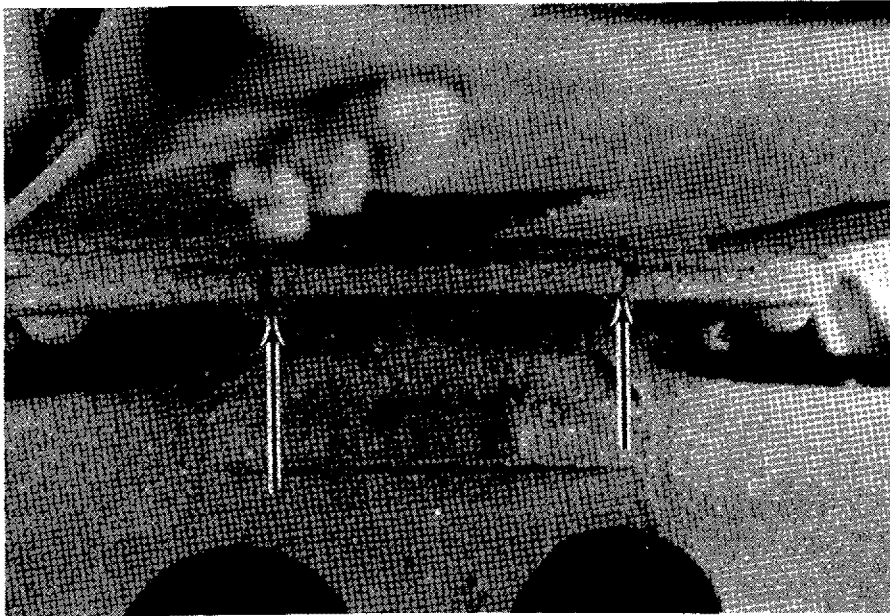
Figure 9.—Fractured centerplate at "B" end of GN 78206.

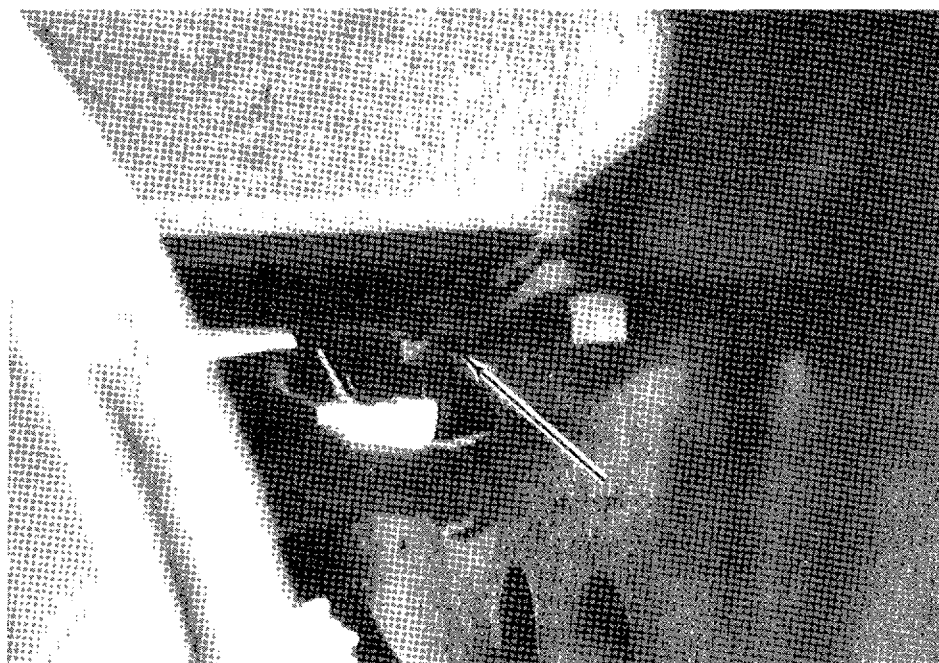
Figure 10.—Fractured centerplate at "B" end of BN 958123.

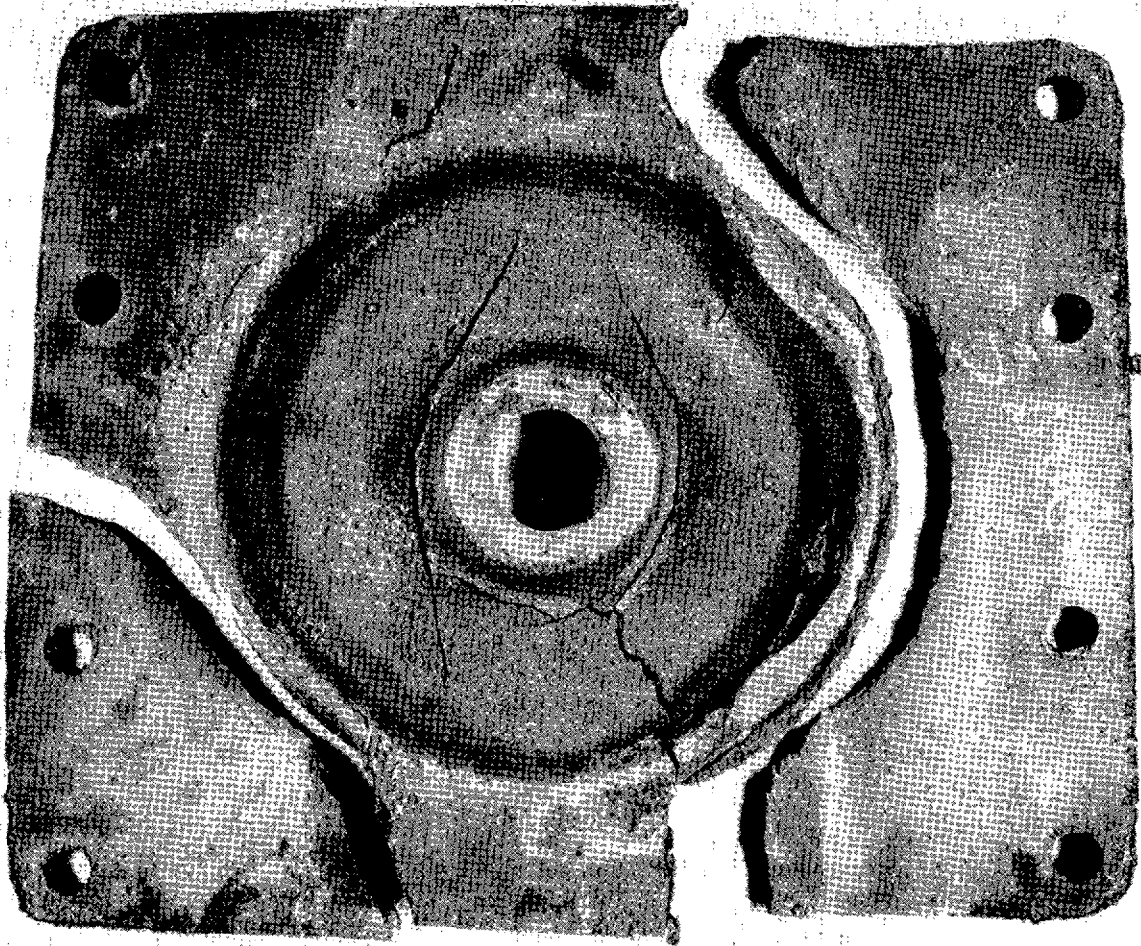
Photograph G-4516

Top view of failed body center plate from BN 958200, Crystal City, MO derailment.

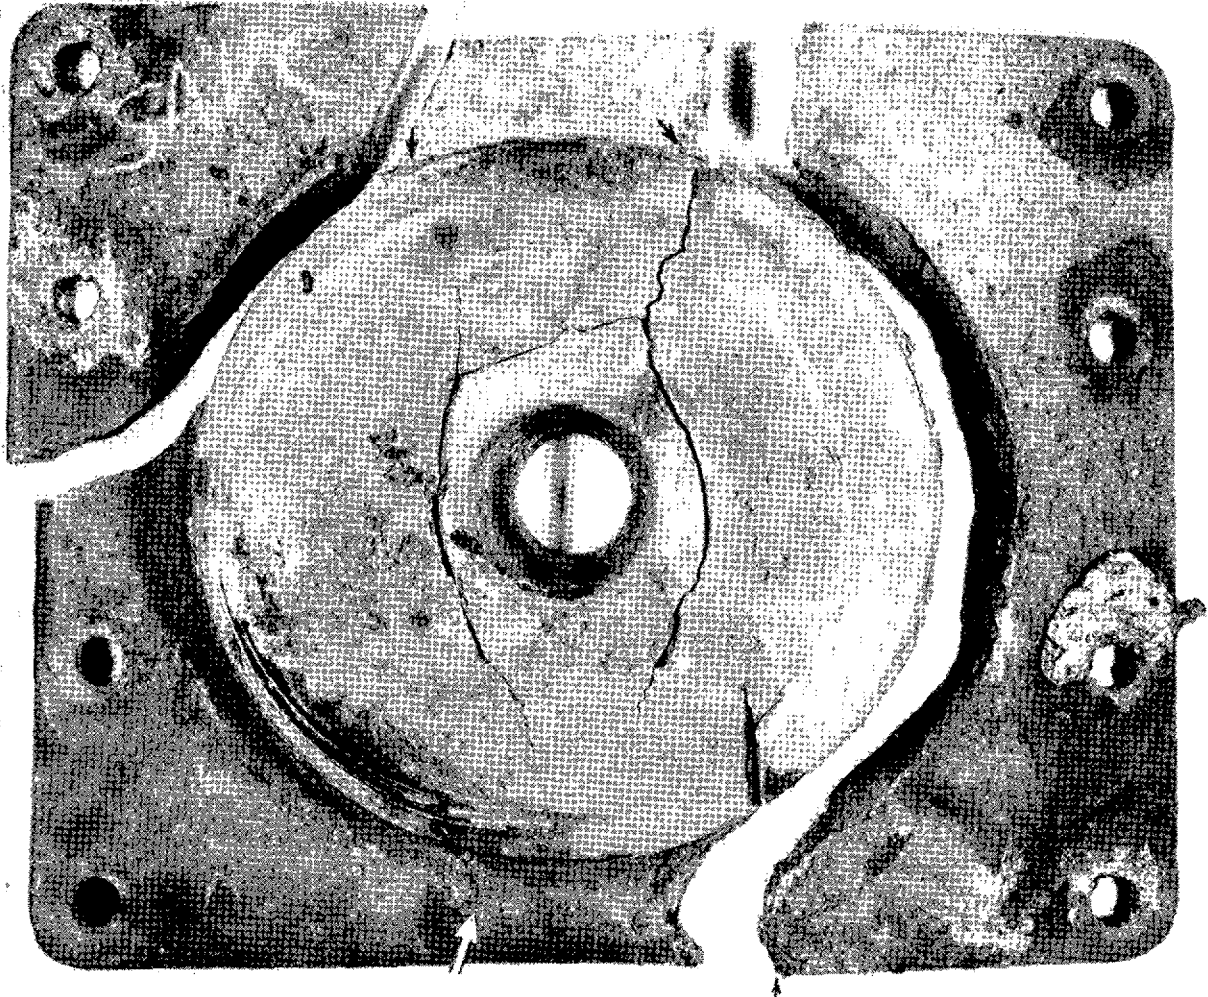
Photograph G-4517

- The overall plate and fracture surfaces were inspected visually,
- a. The plate had been repair welded at some time previously in its history. The old weld repair is shown on the bottom view of plate in Photograph G-4517. Part of the fracture parallels the old repair weld.

- b. Markings on center plate indicate it may have been displaced from the truck prior to derailment.
- c. The center hole of the plate was elongated from friction against the center pin. No crack was initiated from this area.

Bottom view of failed body center plate. Note previous repair welds present in plate (ends of welds indicated by arrows) and markings on center plate indicating it may have been displaced from truck prior to derailment.
