NATIONAL TRANSPORTATION SAFETY BOARD

RAILROAD ACCIDENT REPORT

**DERAILMENT OF AMTRAK TRAIN NO. 5
(THE SAN FRANCISCO ZEPHYR)
ON THE BURLINGTON NORTHERN RAILROAD
EMERSON, IOWA
JUNE 15, 1982**

NTSB/RAR-83/02

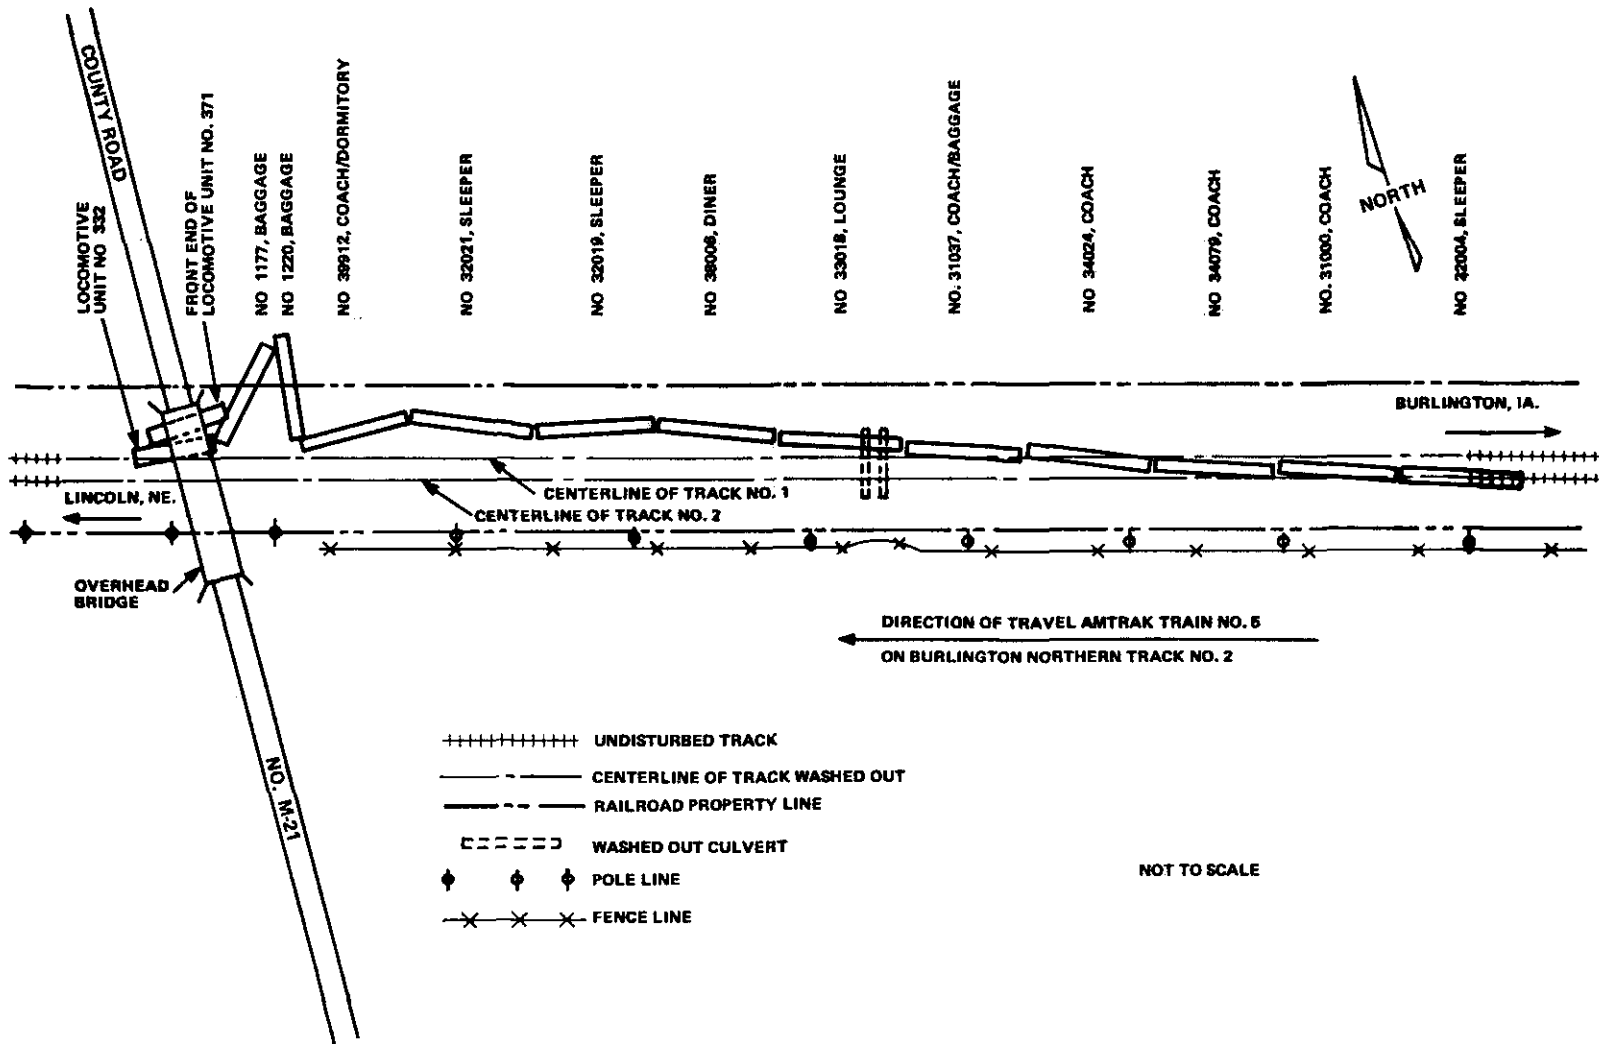
Figure 4.—Plan view of accident site.

When the train entered the water-covered track, the two locomotive units derailed to the north and separated. The lead unit rotated about 180 degrees and came to rest underneath a county highway bridge. (See figure 3.) The trailing unit came to rest about 15 feet west of the leading unit, also under the bridge. The two baggage cars separated and jackknifed, coming to rest almost perpendicular to the roadbed. The remaining cars -- one combination coach/dormitory car, one diner car, one lounge car, four coach cars, and three sleeper cars -- derailed to the north, with the forward cars leaning to the north, at a 45-degree angle. The degree of divergence lessened toward the rear of the

train. (See figure 4.) Of the 315 persons onboard the train, 1 passenger was killed, and 27 persons were injured.

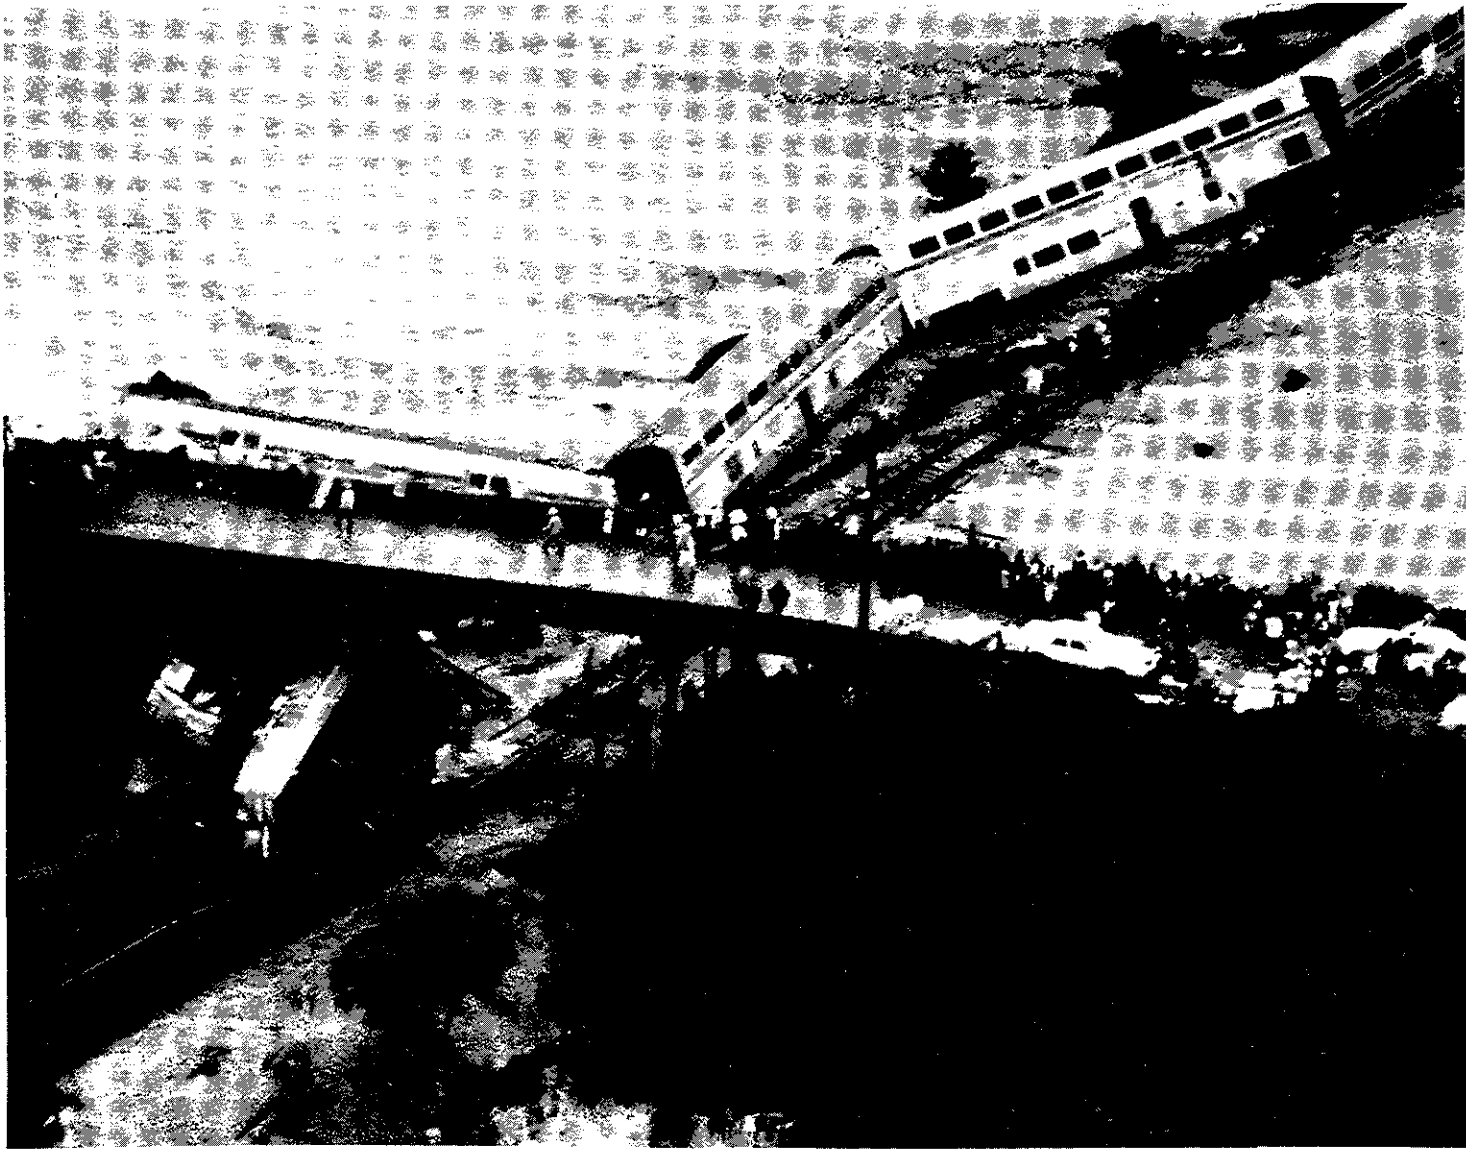
Both locomotive units were damaged extensively. (See figure 5.) The front section of the lead locomotive unit came to rest on the end of the lead baggage car, while the rear section of the lead locomotive unit was on the rear section of the trailing locomotive unit. The trailing locomotive unit came to rest on the fireman's side of the unit, partially underneath the lead locomotive unit and the lead baggage car. The lead locomotive unit struck and destroyed the north bridge pier. The lead baggage car was destroyed, and the second baggage car was damaged extensively. The following coach/dormitory

Figure 5.—Aerial view of Amtrak Train No. 5.

car sustained extensive undercar and end damage, and extensive interior mud and water damage. The following two sleeper cars also sustained structural damage and interior mud and water damage. The following diner car received undercar and structural damage and interior mud and water damage; the car's equipment room was damaged by an intruding rail. The following lounge car received undercar damage and interior mud and water damage. The following four coach cars were severely damaged, and the first three coach cars had interior mud and water damage. The last car, a sleeper car, was damaged at its leading end and at the derailed front truck.

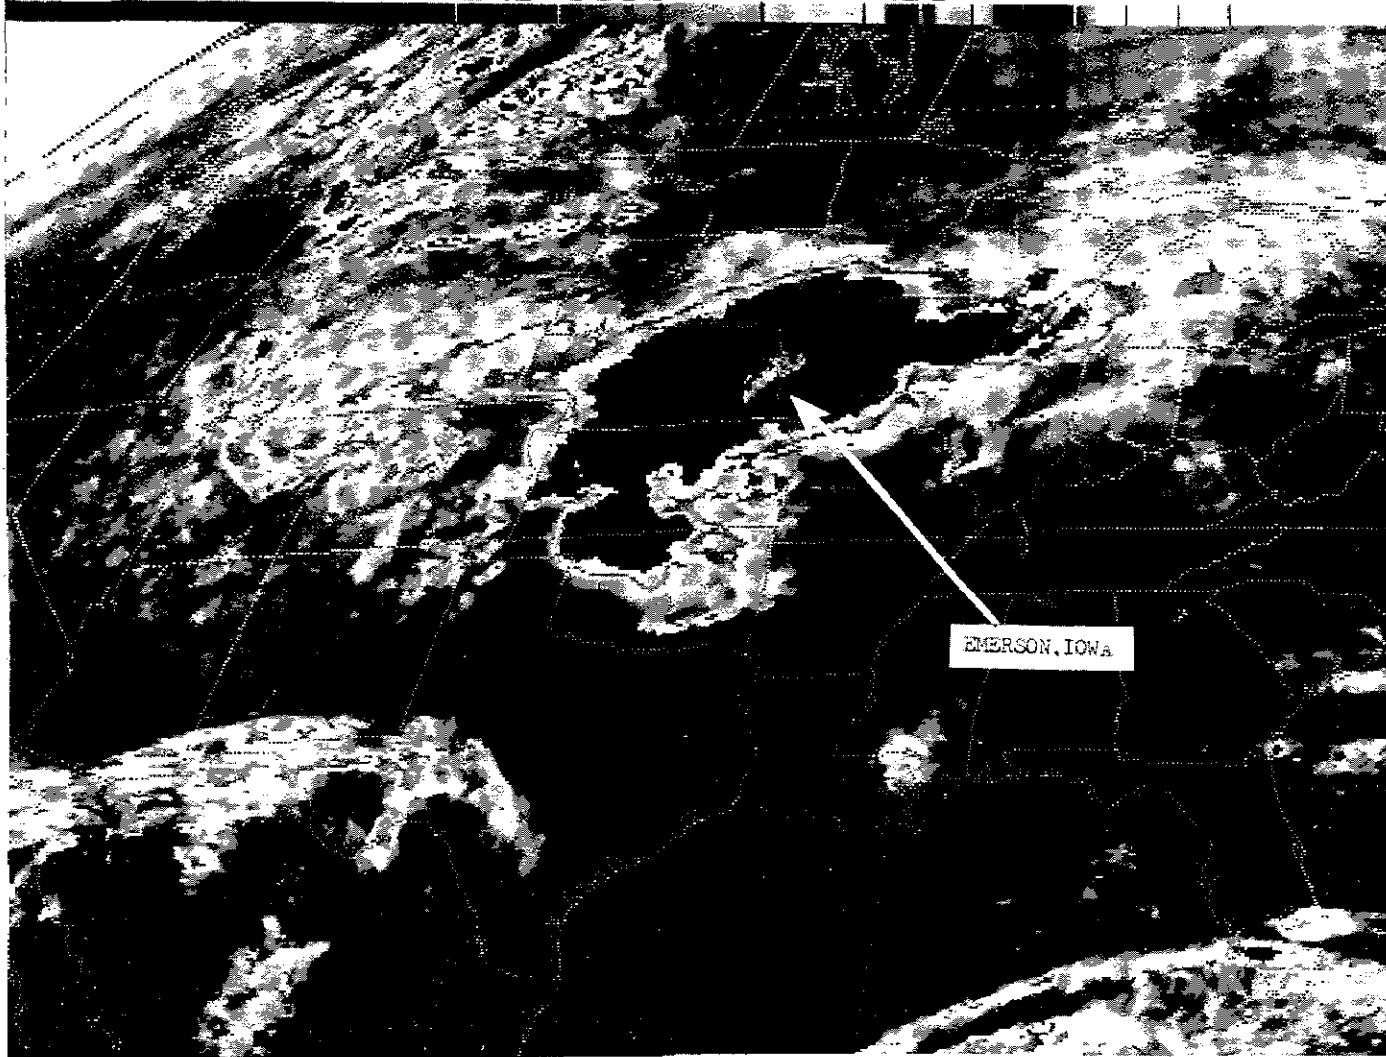
Figure 6.—Infrared photograph with contoured temperature enhancement taken by NOAA Geostationary Operational Environmental Satellite at 11 p.m. on June 14, 1982.
