# NATIONAL TRANSPORTATION SAFETY BOARD

## ✓ RAILROAD ACCIDENT REPORT

HEAD-ON COLLISION OF  
BURLINGTON NORTHERN RAILROAD  
FREIGHT TRAINS EXTRA 6760 WEST AND  
EXTRA 7907 EAST  
NEAR MOTLEY, MINNESOTA  
JUNE 14, 1984

✓  
NTSB/RAR-85/06,

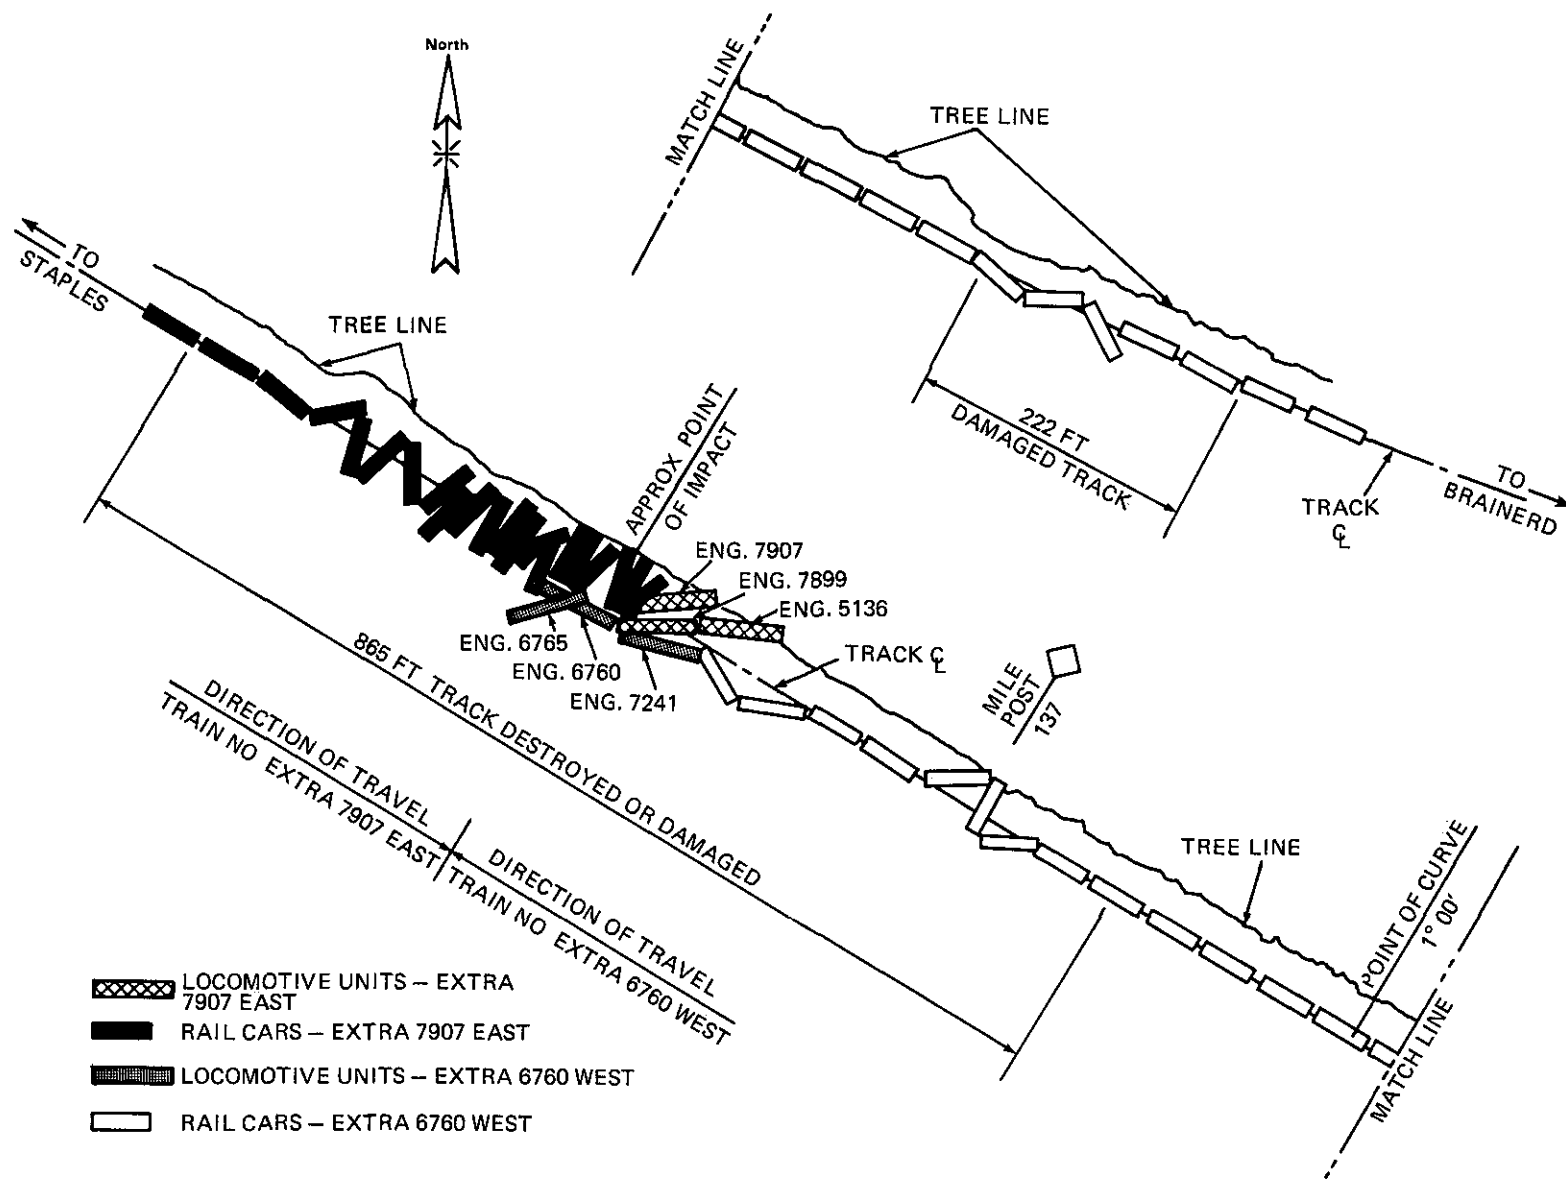
Figure 3.--Plan view of accident site.

When train Extra 6760 West passed through Brainerd, the engineer slowed the train for a 10-mph speed restriction through that vicinity. After having passed Brainerd, the engineer accelerated the train to about 49 mph. (The maximum speed at this location for an empty coal train is 49 mph.) As the locomotive of train Extra 6760 West proceeded through a 1° curve to the right and neared tangent track, the head brakeman noticed light reflecting on the rails ahead of his train. He further stated that he then "... could see another engine that we didn't have (train) orders on, and I didn't know if that engine was in a siding for awhile. It took me awhile to remember the track and realize that there was no siding in that area." The head brakeman stated that he and the engineer applied the emergency brakes at the same time and that he then stepped out onto the front platform of his locomotive unit. He further stated "... I could see it (the oncoming locomotive) was moving, I was reading engine numbers and I decided I better get off, and I jumped." The head brakeman was not able to ascertain whether the engineer also had jumped before the trains collided head on, about 1:00 a.m., near Motley, Minnesota. (See figure 3.)

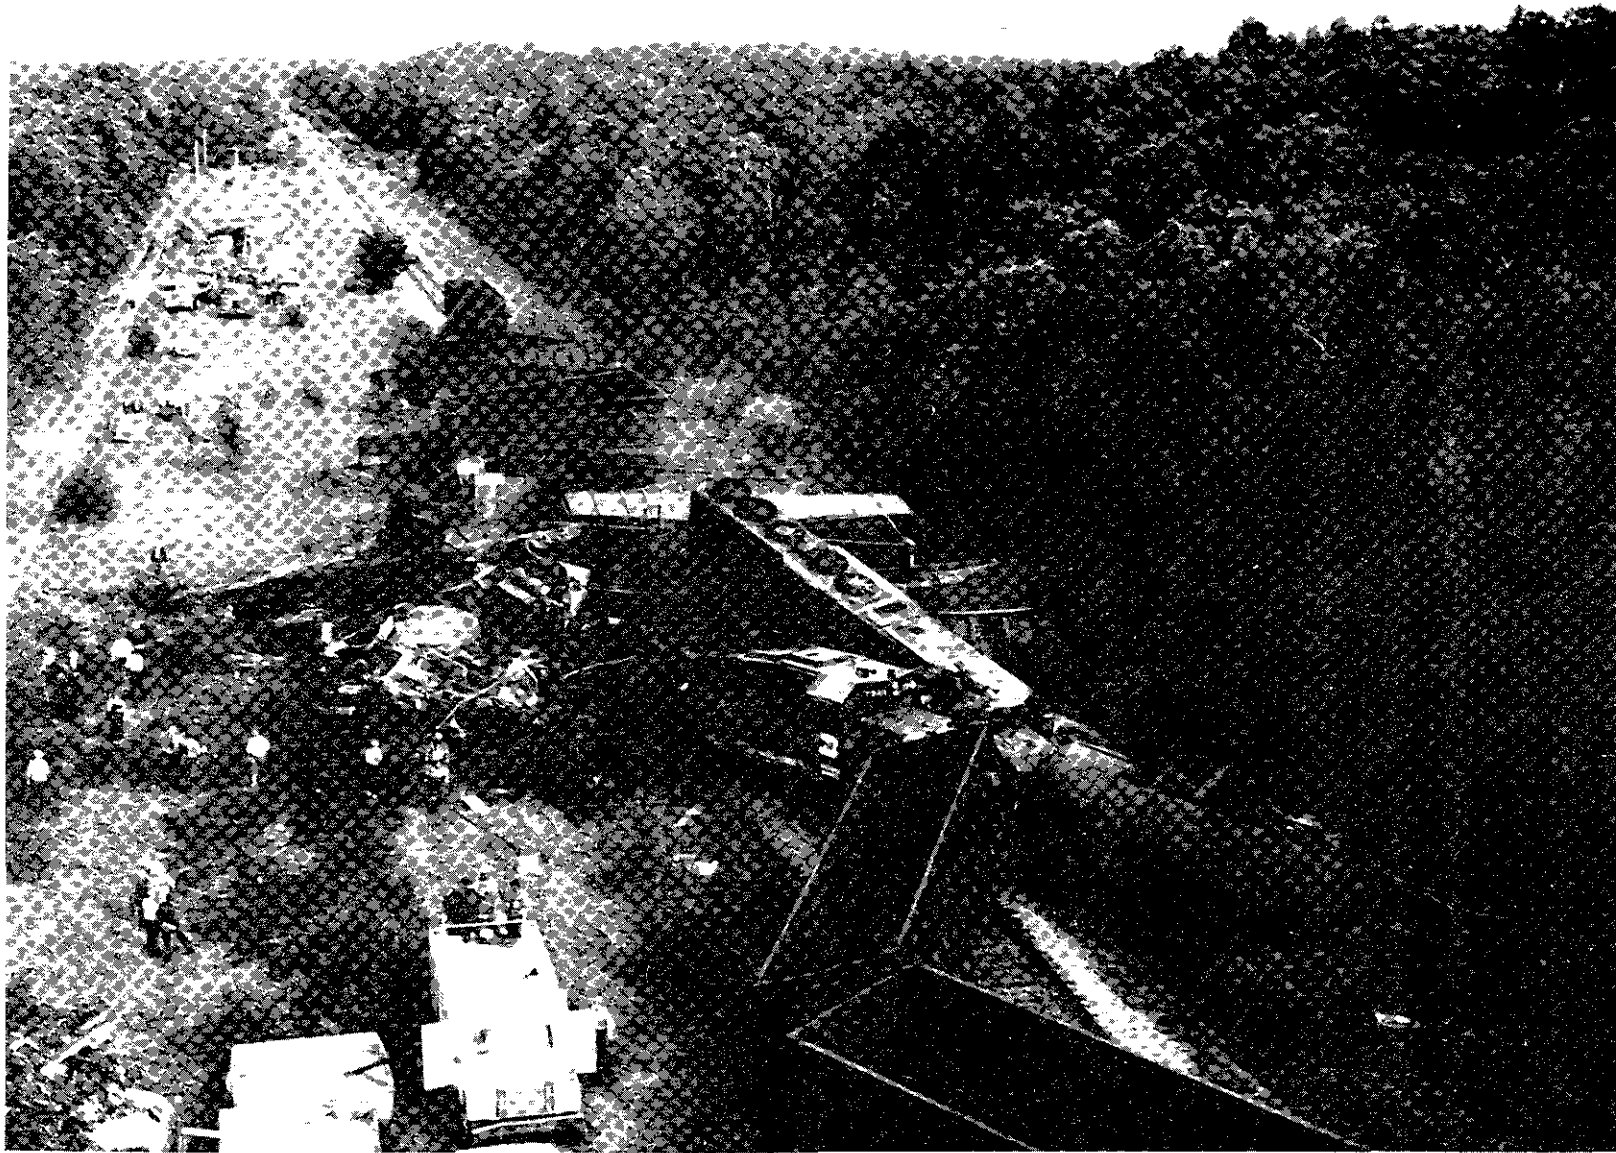
Figure 4.--View of accident site.

The three locomotive units in each of the trains were destroyed. (See figure 4.) The operating compartments of the lead locomotive unit of each train were crushed, and the units were sheared off at platform level. Of the 19 cars derailed in train Extra 7907 East, 10 were destroyed, 7 were moderately damaged, and 2 were lightly damaged. Of the 16 cars derailed in train Extra 6760 West, 8 were destroyed, 5 were moderately damaged, and 3 were lightly damaged. (See figures 5 and 6.) About 1,087 feet of main track was destroyed or damaged in the accident.
