NATIONAL TRANSPORTATION SAFETY BOARD

REAR END COLLISION OF TWO
BURLINGTON NORTHERN RAILROAD COMPANY
FREIGHT TRAINS
PACIFIC JUNCTION, IOWA
APRIL 13, 1983

NTSB/RAR-83/09

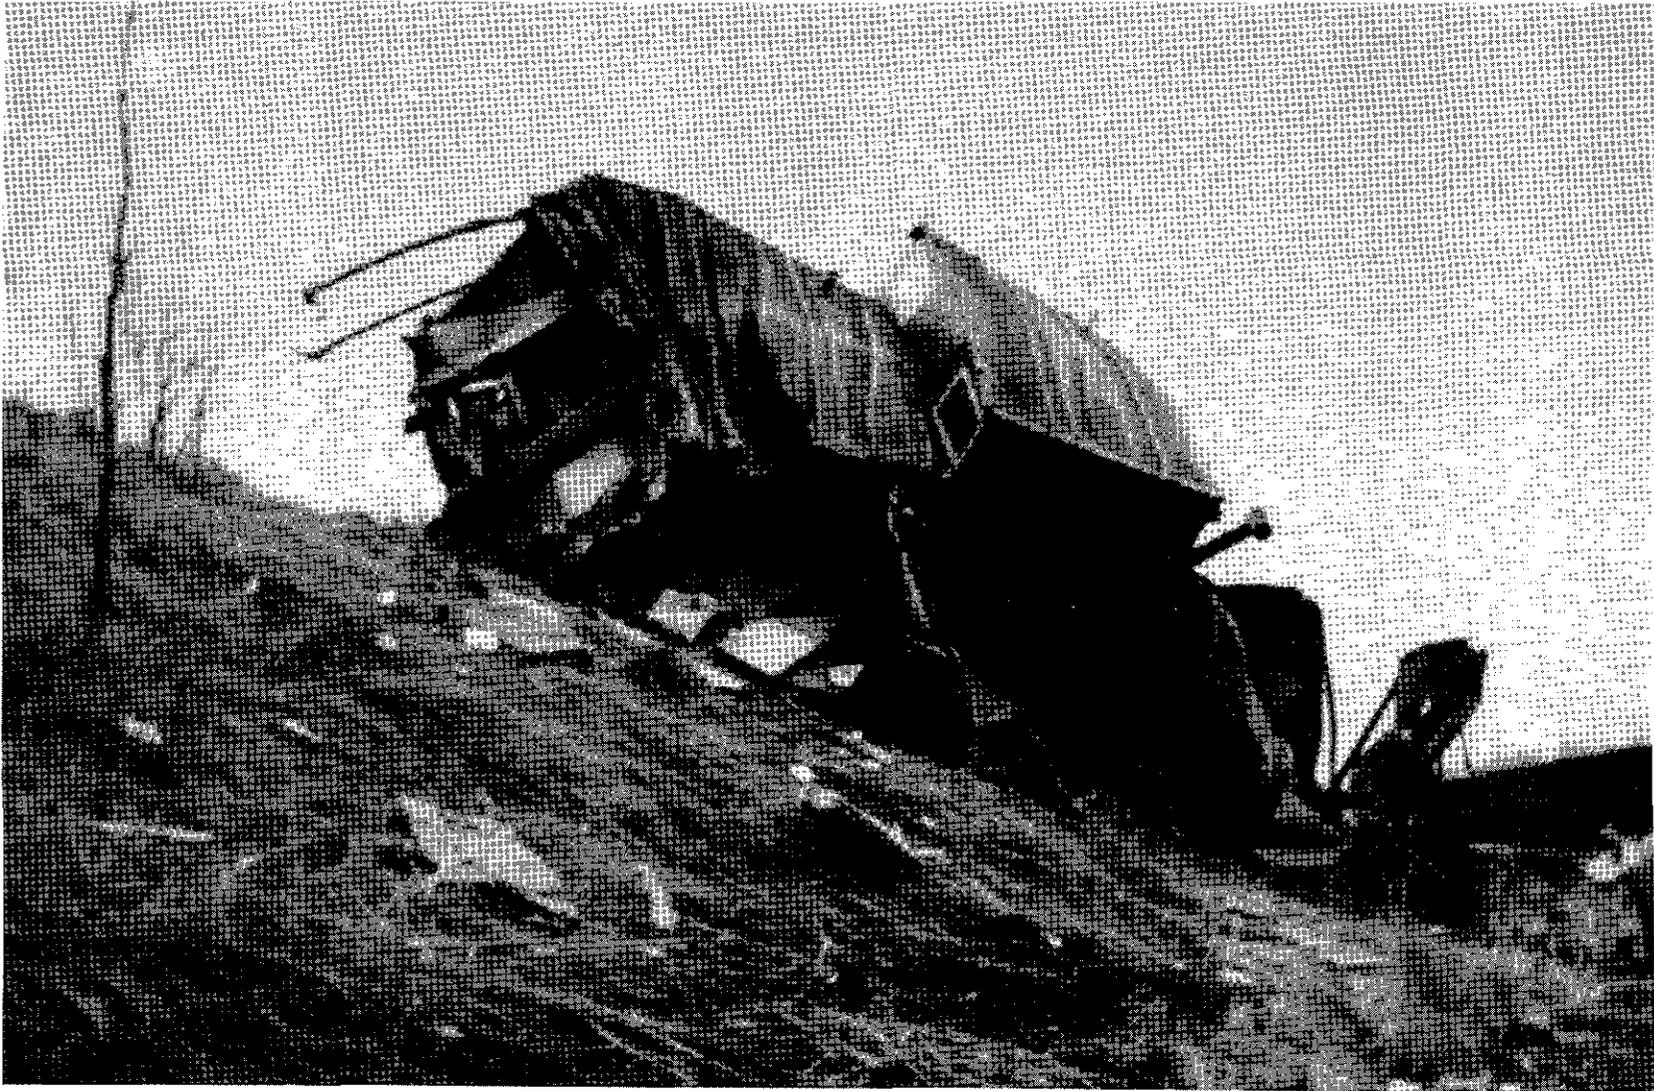
Figure 2.—Caboose of train 43J05.

The approaching train struck the caboose of train 43J05, moving the caboose about 60 feet forward and about 50 feet to the west. (See figure 2.) The rear crewmen of train 43J05 said that the approaching train was being operated under power until it derailed. No warning whistle was sounded to alert the men in the caboose of train 43J05 of the impending crash, and the headlight on the locomotive of the approaching train was never dimmed. They did not see anyone at the controls or any activity on the locomotive immediately before the collision.

The impact of train 64T85 destroyed the caboose of train 43J05, compressing it about 10 feet in length. The red rear marker light and the permanently mounted radio on the caboose were destroyed. Seven gondola cars were damaged moderately when body panels were dented and torn and trucks separated from car bodies.

The caboose of train 43J05 was crushed by the impact forces when it was struck by train 64T85. (See figure 2.) It is doubtful that the caboose occupants, who had jumped from the caboose and run up an embankment to safety, would have survived the deformation of the caboose and the violent movement caused by the impact forces. The rear brakeman stated that he was almost struck by the derailing caboose as he ran up the embankment.

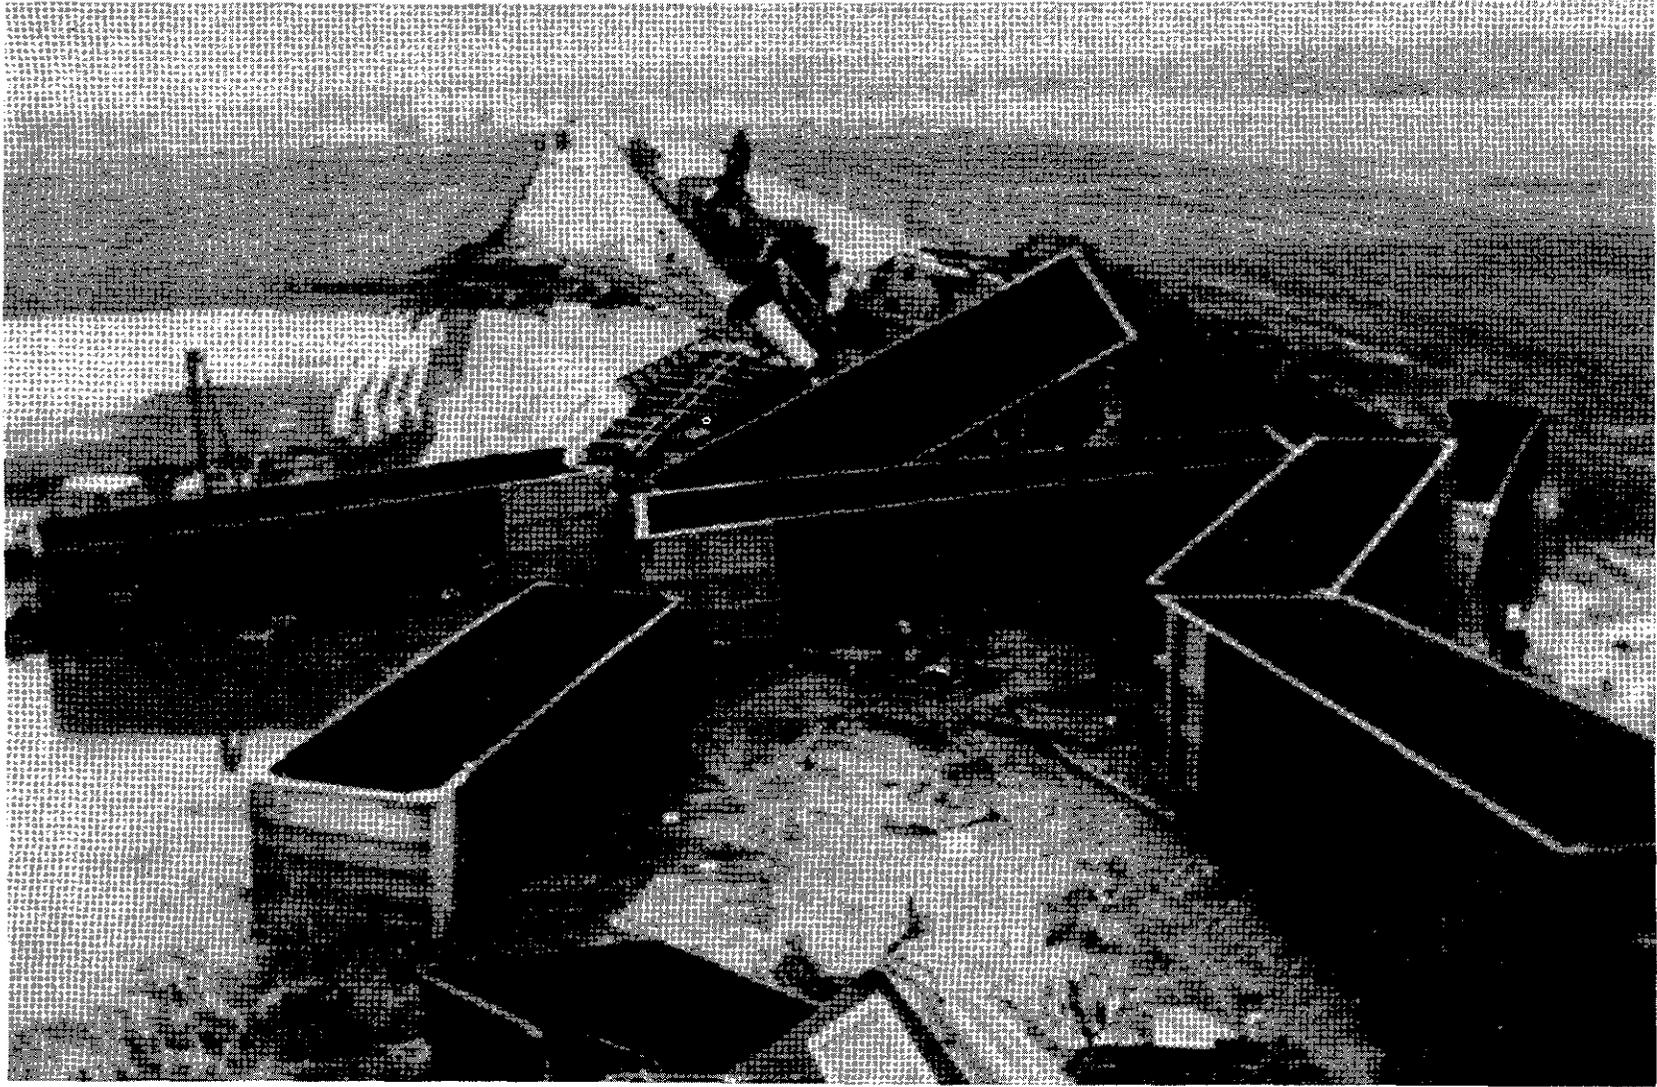
Figure 3.—Wrecked cars and locomotive units following collision.

The impact forces moved train 43J05 forward about 100 feet and caused its head-end crew to be jostled in the operating compartment. The caboose and seven cars of train 43J05 and the four locomotive units and eight cars of train 64T85 were derailed. The lead locomotive unit of train 64T85 stopped on the east side of the track at approximately a 45-degree angle to the track and about 435 feet north of the point of impact. The following three locomotive units stopped at various angles to the track behind the lead unit. The derailed cars of train 64T85 piled up either on top of the locomotive units or behind train 43J05. (See figure 3.) The enginecrew of train 43J05 and the rear-end crew of train 64T85 notified the operator at Pacific Junction of the accident by train radio, and the operator called the police and emergency services.
