NATIONAL TRANSPORTATION SAFETY BOARD

HEAD-ON COLLISION OF
BURLINGTON NORTHERN
RAILROAD COMPANY FREIGHT TRAINS
EXTRA 6311 WEST AND
EXTRA 6575 EAST
NEAR WESTMINSTER, COLORADO
AUGUST 2, 1985

NTSB/RAR-86/02

RAILROAD ACCIDENT REPORT

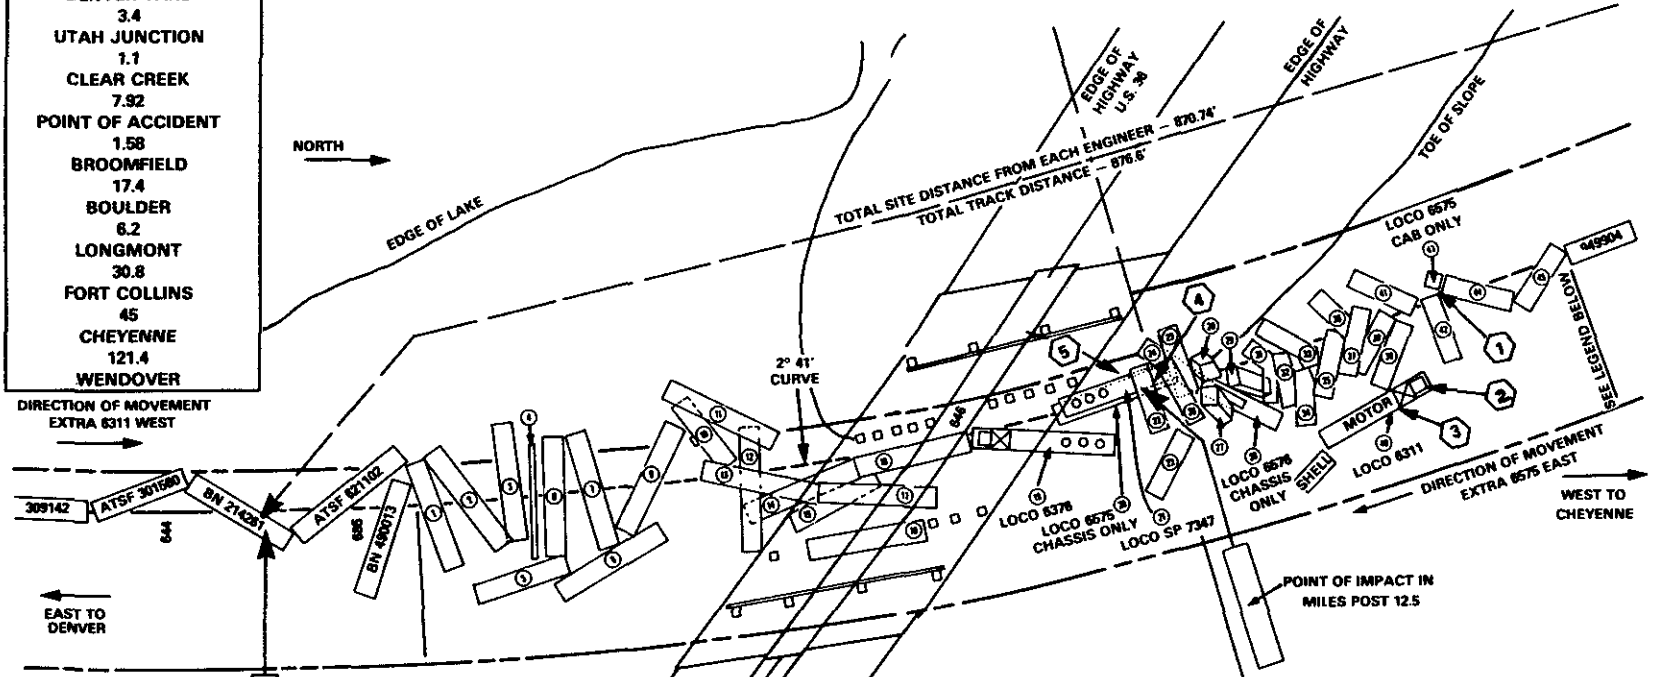
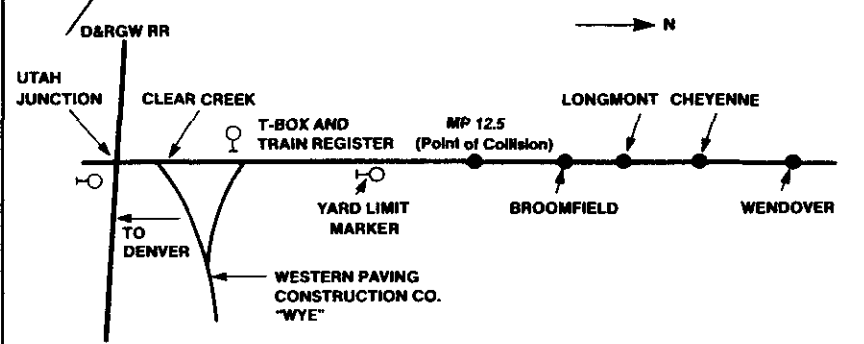
Figure 1.--Plan view of derailment.

Extra 6575 East.--Extra 6575 East, a unit gravel train 1/ operating between Longmont and Clear Creek, Colorado, was scheduled to leave Longmont at 2 p.m. (See figure 1.) Because there were no car inspectors located at Longmont, the three-man crew, consisting of the engineer, the conductor, and the brakeman, inspected the train and made a brake test, as required by Federal regulations. The inspection and brake test were completed at 3:15 p.m., and no exceptions were taken to the brakes or the mechanical condition of the equipment.

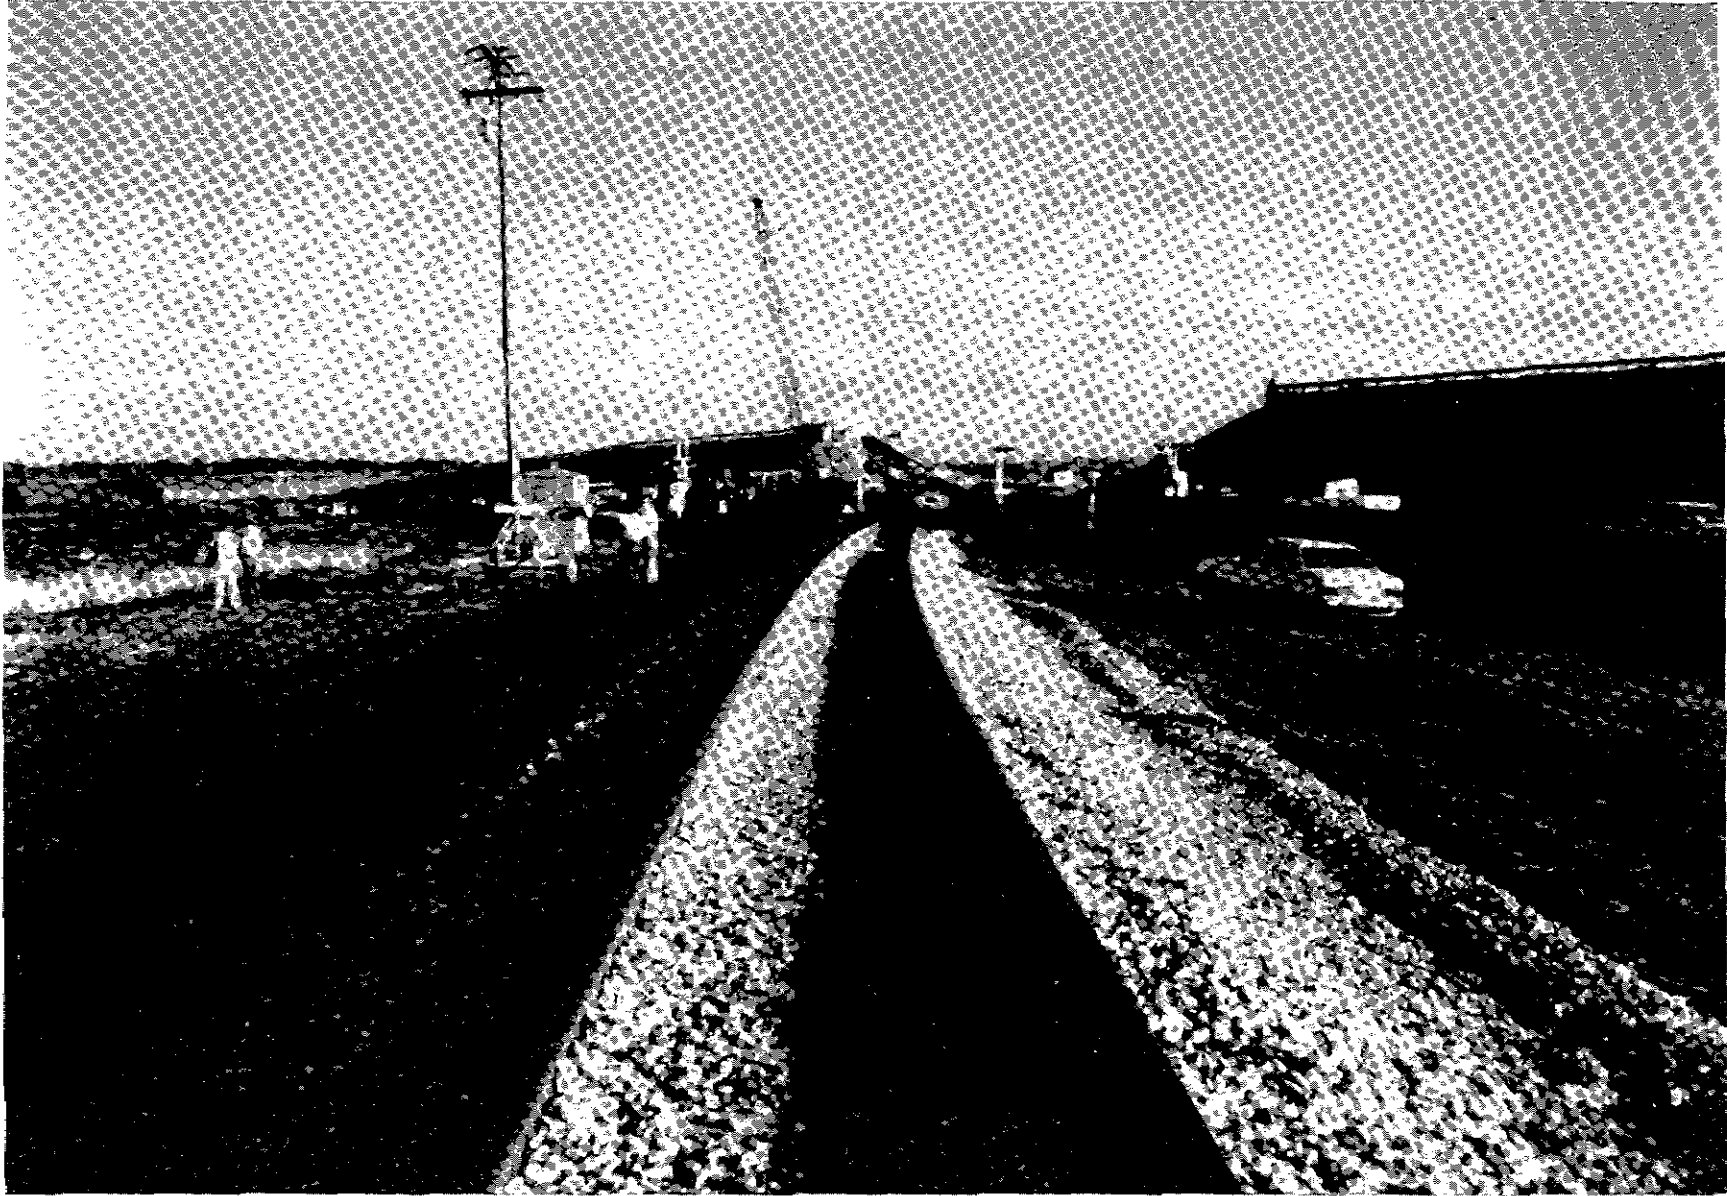
Figure 2.--Approach view eastbound of curve at MP 12.5 for Extra 6575 East.

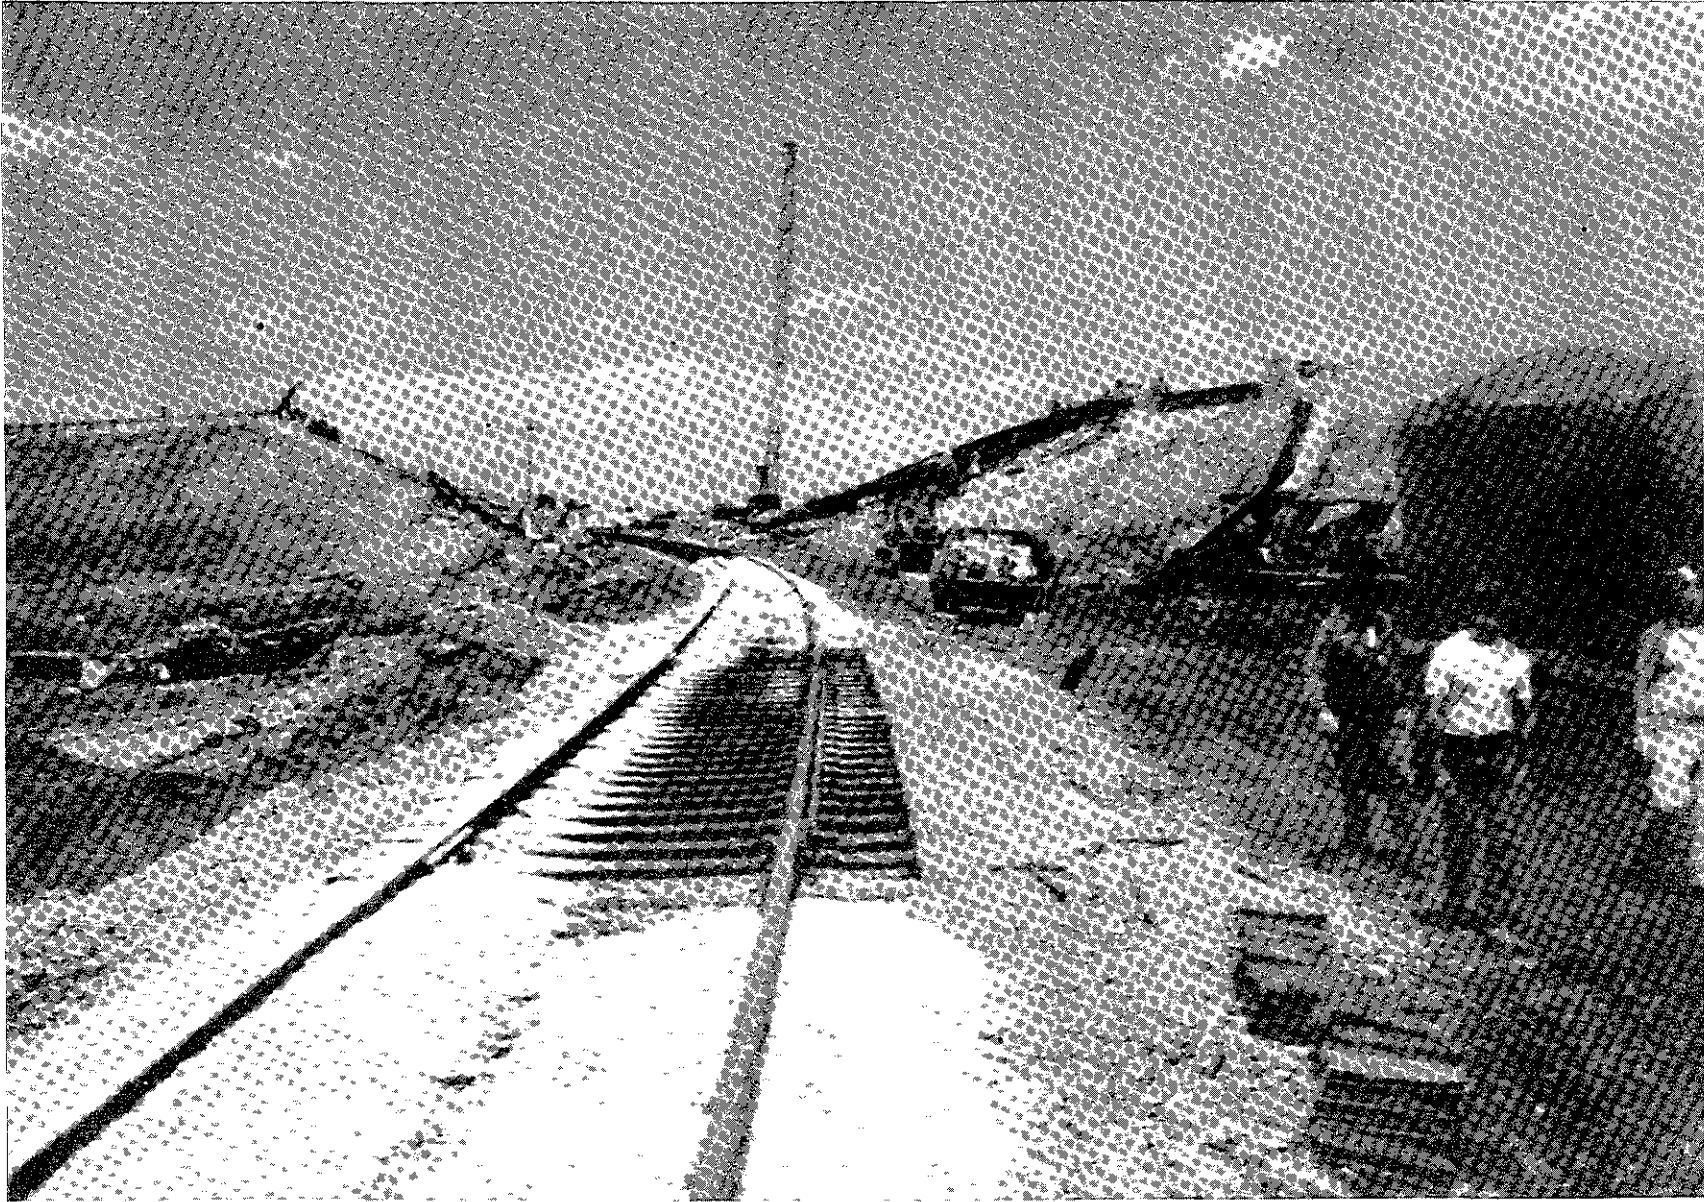
About 7:40 p.m., the train emerged from beneath a dual-lane bridge on U.S. Highway 36, the Boulder Turnpike, near MP 12.5. Extra 6311 West, which was traveling about 52 mph, collided head-on with Extra 6575 East, which was traveling about 48 mph. (See figure 3.)

Figure 3.--Approach view to curve at MP 12.5 for Extra 6311 West.

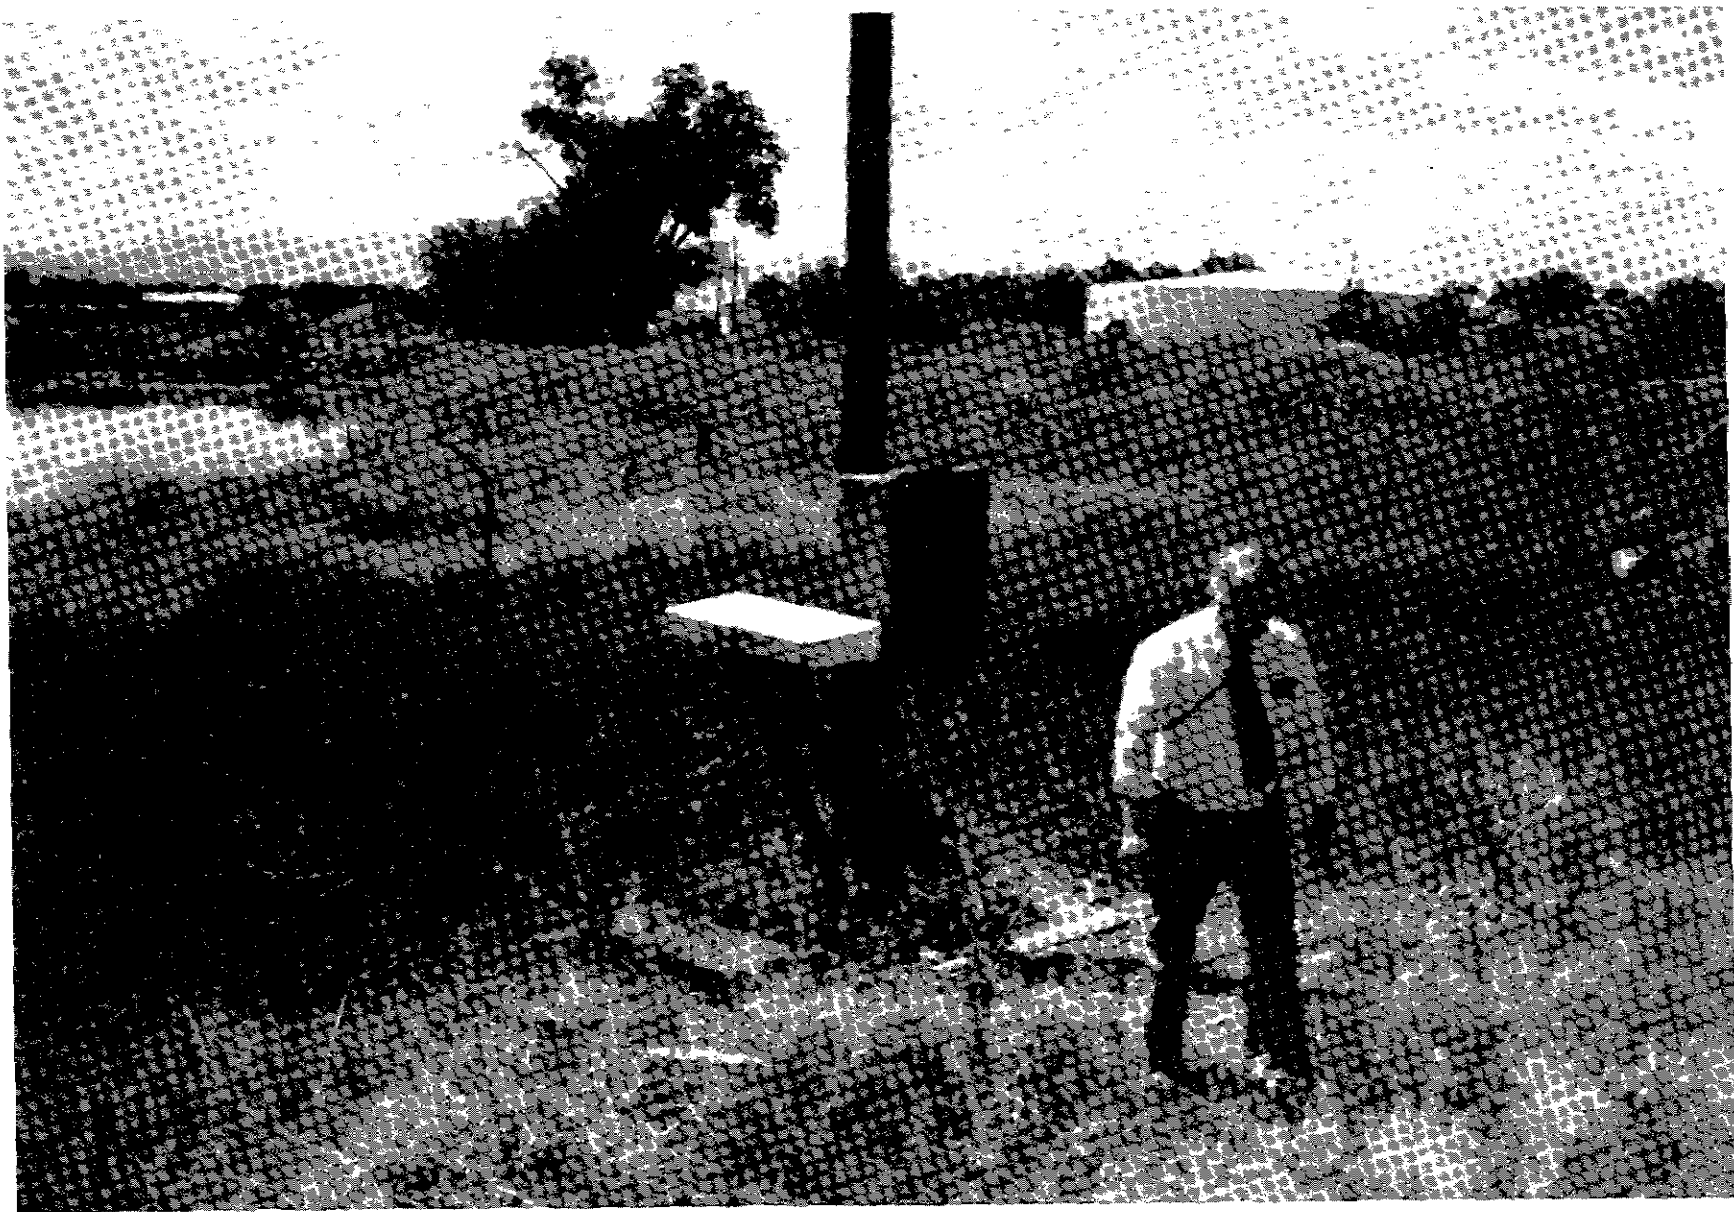
Figure 7.--Train register box and T-box at Clear Creek.

When one of the crewmembers on the locomotive of Extra 6311 West checked the train register at Clear Creek, he failed to perceive that the information recorded in the train register book was about Extra 6575 East of August 1. As a result of his misperception, he provided the other crewmembers with the incorrect information about Extra 6575 East. There were no surviving witnesses who could testify that they saw the crewmember unlock the register box, remove the train register book, and read the entries. The train was standing between the witness in the Western River Paving Construction Company so the witness' vision was blocked. However, since the 4:40 p.m. time quoted by a crewmember in the radio report to the conductor is a factual entry of record, the Safety Board concludes the train register book was removed from its repository and viewed by a crewmember. Since it is not known for certain who read the train register, the Safety Board could not determine the circumstances surrounding the dissemination of incorrect train register information. Although the tape recording of the radio message from the crewmember on the locomotive was not of good quality, probably because of the distance between Clear Creek and the Longmont radio base station, the reception of the message on the caboose by the conductor would have been more easily understood.
