NATIONAL TRANSPORTATION SAFETY BOARD

RAILROAD ACCIDENT REPORT

HEAD-ON COLLISION OF
BURLINGTON NORTHERN RAILROAD FREIGHT TRAINS
EXTRA 6714 WEST AND EXTRA 7820 EAST
WIGGINS, COLORADO
APRIL 13, 1984

READ-END COLLISION OF
BURLINGTON NORTHERN RAILROAD FREIGHT TRAINS
EXTRA 7843 EAST AND EXTRA ATSF 8112 EAST
NEAR NEWCASTLE, WYOMING
APRIL 22, 1984

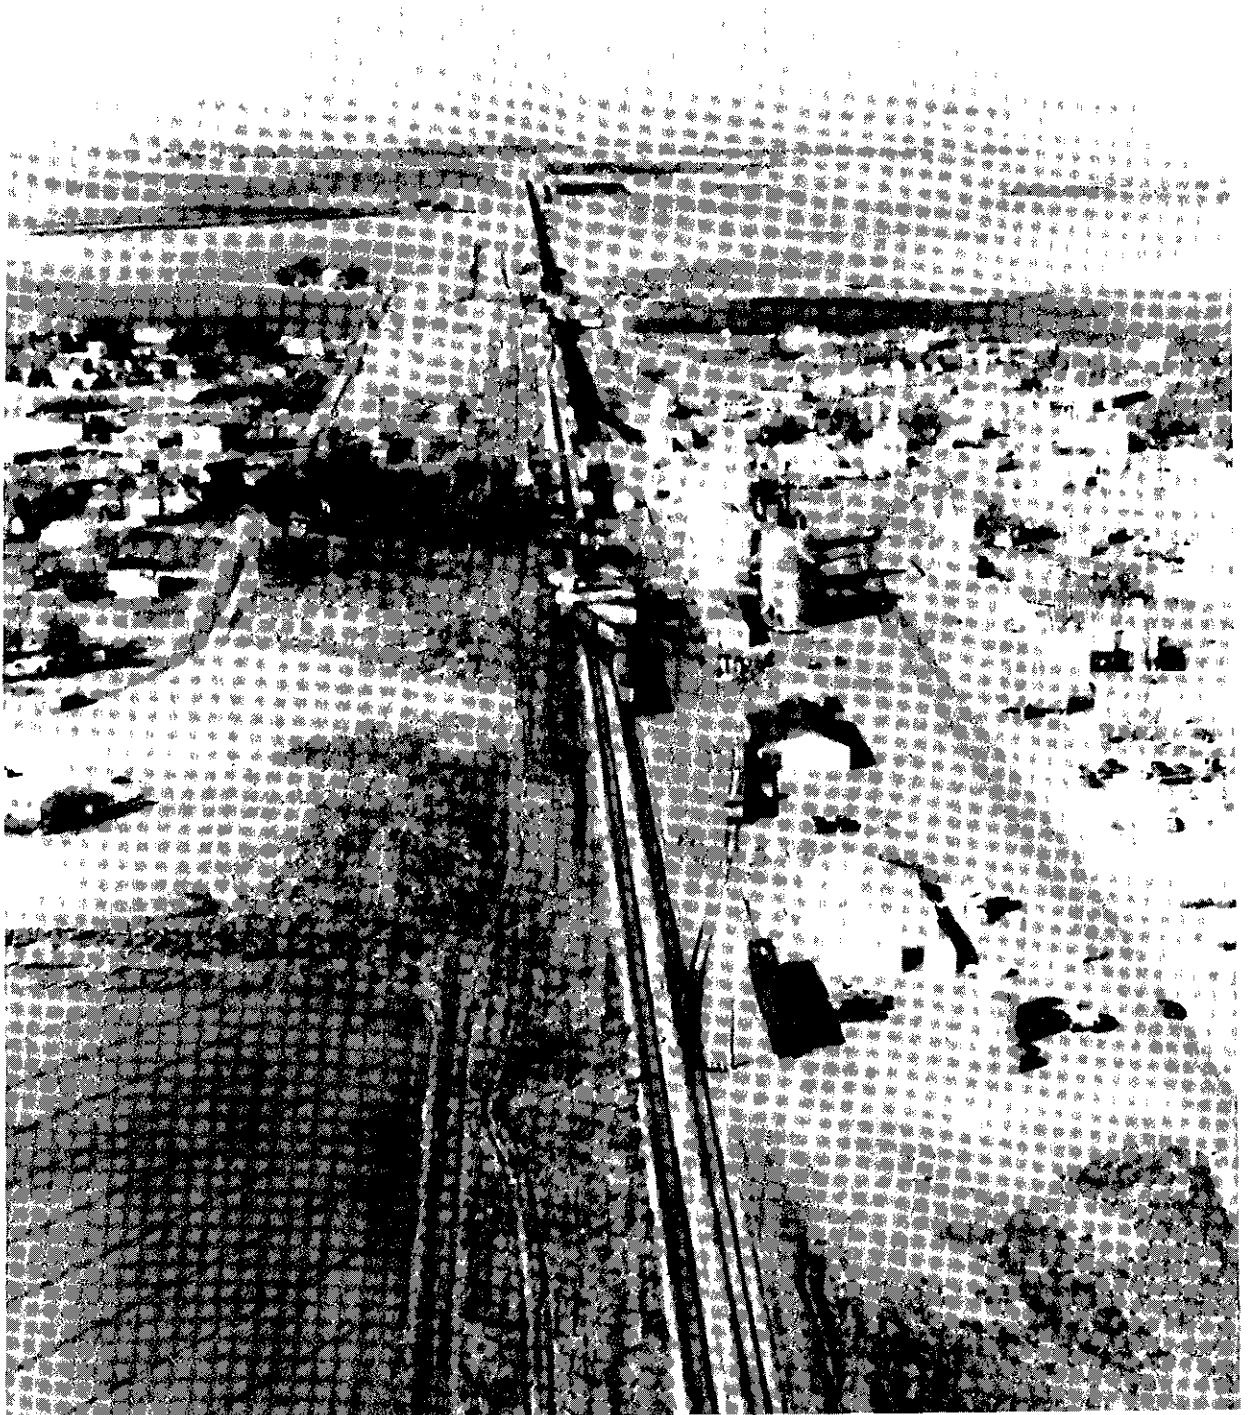
Figure 1.--Aerial view facing west at Wiggins, Colorado.
The BN main track is at the right and is occupied by the rear portion of
Extra 6714 West. The collision site and primary derailment area are
in the distance, beyond the edge of the town.

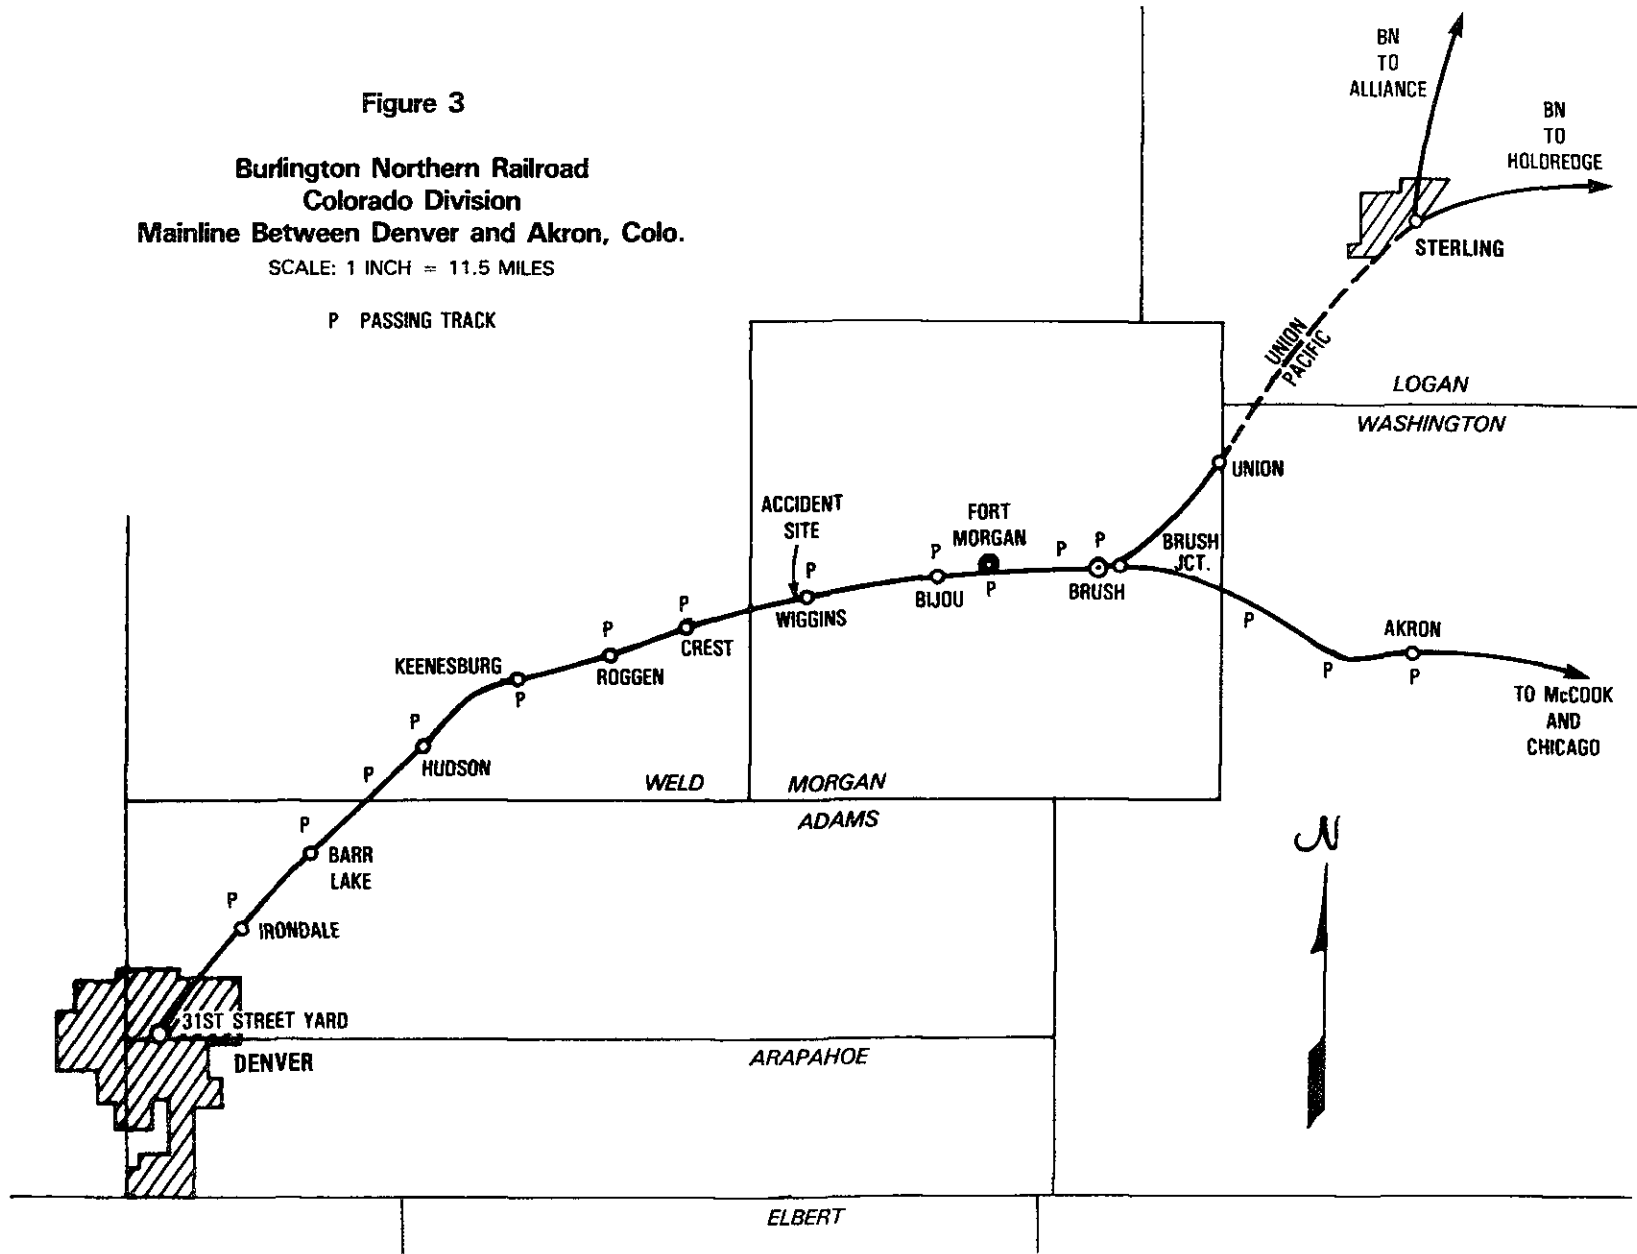
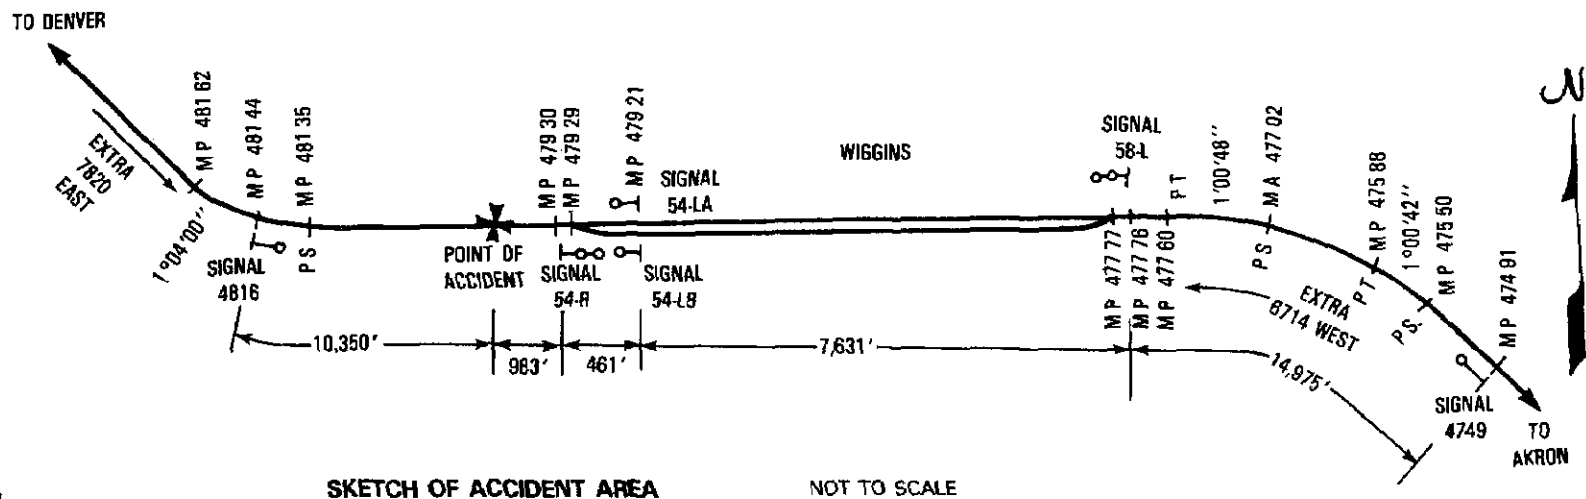
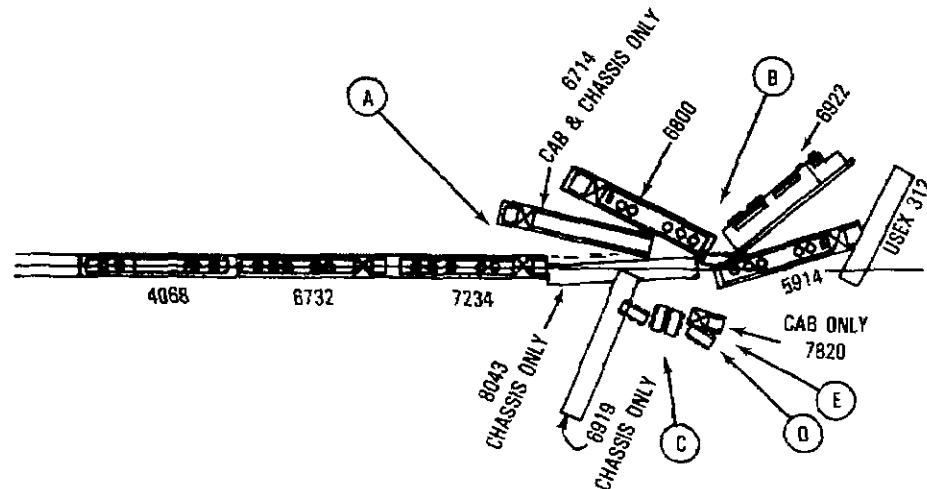
Figure 4

**Wreckage Distribution
and
Locations Where
Crewmembers Were
Found**

- A FIREMAN, EXTRA 6714 WEST
- B ENGINEER, EXTRA 6714 WEST
- C DISPATCHER, EXTRA 7820 EAST
- D FIREMAN, EXTRA 7820 EAST
- E HEAD BREAKMAN, EXTRA 6714 WEST

The force of the collision caused the lead locomotive units to be overridden; the carboodies of both were separated from the main frames and demolished. The bodies of the four train crewmembers and the dispatcher riding on Extra 7820 East were apparently ejected from the locomotive units during the collision sequence. The bodies of the engineer and fireman of Extra 6714 West were found about 20 feet apart to the north of the main track at or near the point of collision. The bodies of the other men were found south of the main track near the point of collision. These were located 20 to 30 feet apart with the head brakeman of Extra 6714 West farthest to the east, the fireman of Extra 7820 East in the middle, and the dispatcher farthest to the west. (See figure 4.)

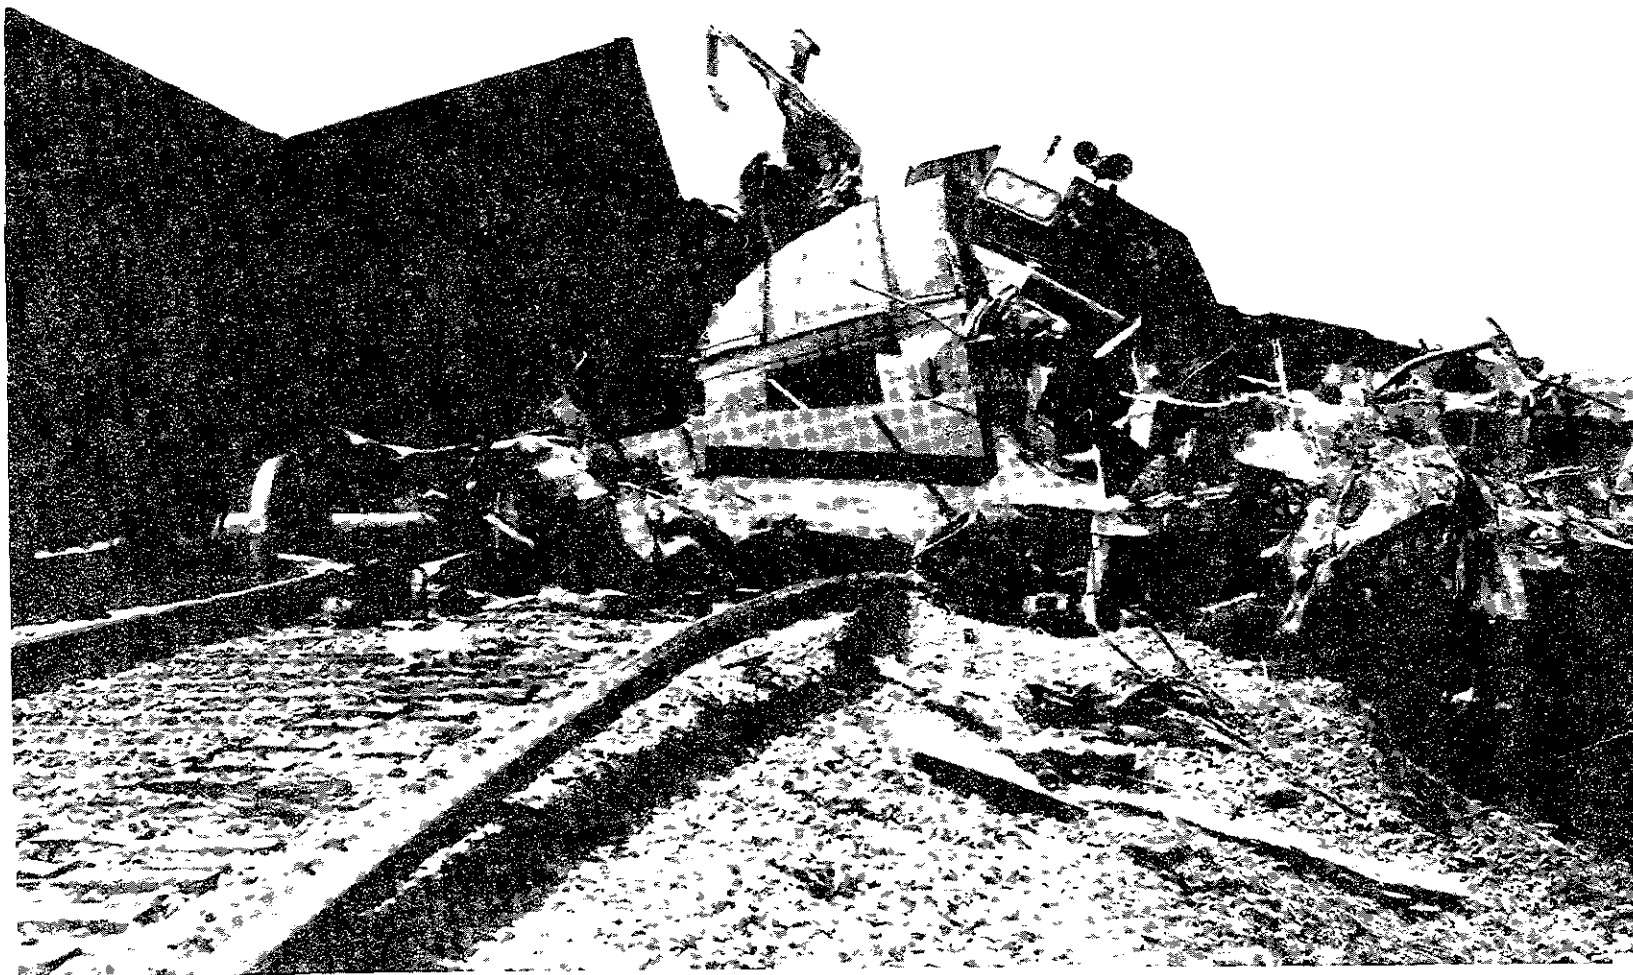
All five locomotive units and six of the cars of Extra 7843 East derailed in the collision; the locomotive units and 5 of the 6 cars were damaged heavily. The caboose of Extra ATSF 8112 East was destroyed as were 7 of the 12 coal cars in the train that were derailed as a result of the collision impact. During the collision/derailment sequence, the three rear cars of Extra 5533 East's train standing on the passing track were struck and derailed. These cars received moderate to heavy damage as a result. About 720 feet of track was destroyed.

The engineer and head brakeman of Extra 7843 East jumped from their locomotive before the collision and both escaped serious injury. The caboose of Extra ATSF 8112 East was completely crumpled and torn apart in the collision sequence. The largest remnant of the caboose was found crushed against the loaded coal hopper cars that had been ahead of it (see figure 8). A smaller remnant was impaled to the front end of one of Extra 7843 East's locomotive units, which veered north after striking the caboose. According to the rear brakeman of Extra 5533 East, he found the body of the conductor in what remained of the cupola in the larger remnant of the caboose. He stated, "The way it looked to me...he never got out of his chair." The body of the rear brakeman was found under the larger remnant of the caboose wreckage almost completely buried under dirt and ballast stone displaced during the collision/derailment sequence.

Figure 8.—Wreckage of the caboose of Extra ATSF 8112 East viewed facing west along the main track at Pedro. The third head locomotive unit of Extra 7843 East is behind the caboose. The cars at the extreme left are on the passing track and are at the extreme rear end of Extra 5533 East.
